AIRPROX REPORT No 2021127

Date: 18 Jul 2021 Time: 1106Z Position: 5620N 00313W Location: 10NM SW Dundee

PART A: SUMMARY OF INFORMATION REPORTED TO UKAB

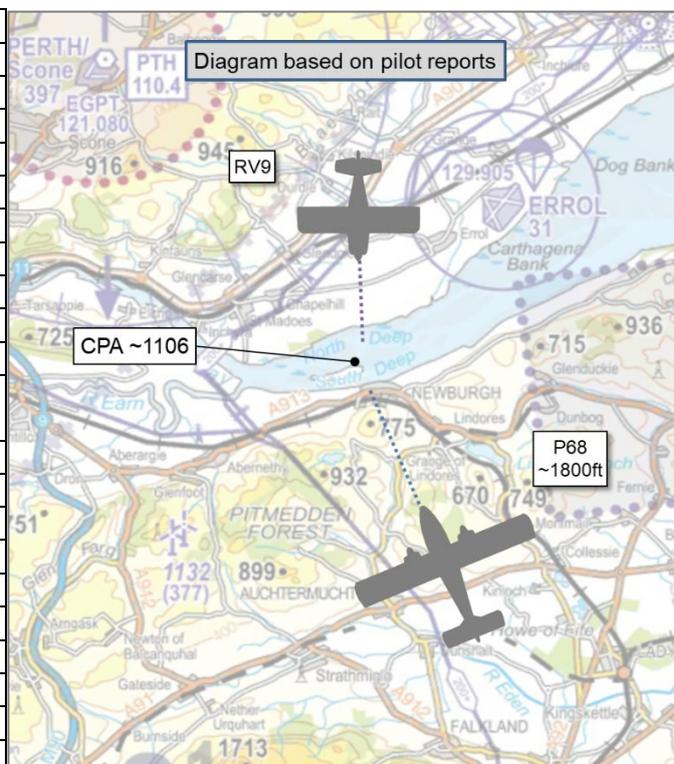
THE P68 PILOT reports that after completing a left turn to head northbound onto the next survey line they left Leuchars App and contacted Dundee App to request a Basic Service and conspicuity squawk. This was because their survey lines were creeping closer to Dundee and their extended centreline for RW09, as they were working the survey from west to east. They first spotted a C182 in the 12 o'clock high moving right to left, no factor (although they were about 200ft above). However, the conflicting traffic (Van's RV9), was unknown as they had their eyes fixed on the C182 at the time, it was 1 o'clock same height and less than 1 mile, converging. They were unable to see the conflicting RV9 due to the survey computer screen that was attached to the forward P2 window, coupled with their fixation on the C182. Thankfully, the camera operative in the back of the plane spotted the RV9 in enough time to give the pilot the whereabouts of the traffic, and after the pilot spotted the RV9 they were able to evade the conflicting traffic by performing a turn to the right. ATC was informed about the issue and once clear of the traffic they continued to survey. Unfortunately, Leuchars App could only offer a Reduced Traffic Service where Traffic Information was given on SSR transponding aircraft only. That would also be further reduced to a Basic Service as they dropped off radar coverage from time to time.

THE VAN'S RV9 PILOT reports that they were totally unaware of any Airprox so were struggling to provide any meaningful information. They did recall Perth Radio passing Traffic Information on a Partenavia survey aircraft to the south of Perth airfield, but did not see it.

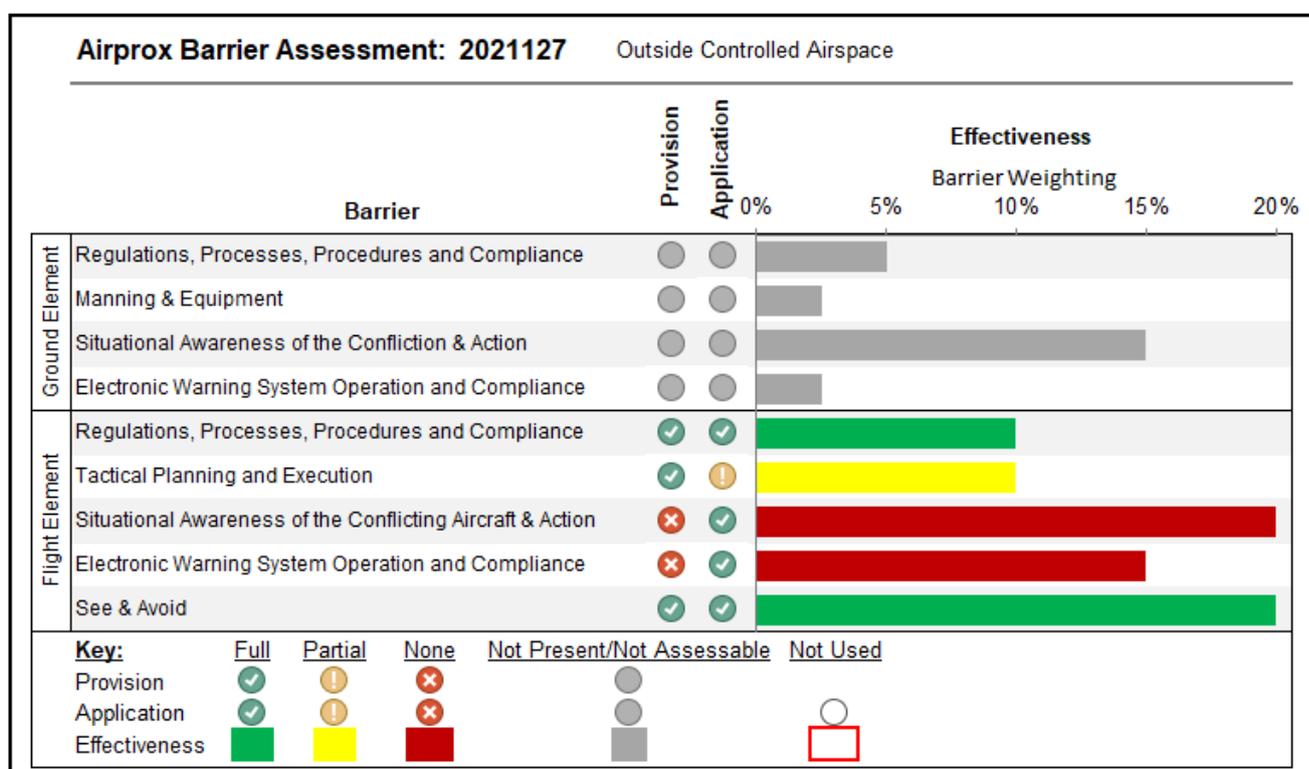
In assessing the effectiveness of the safety barriers associated with this incident, the Board concluded that the key factors had been that:

Tactical Planning and Execution was assessed as **partially effective** because the survey undertaken by the P68 was planned to continue over the period of time NOTAM'd by Leuchars that they were closed, resulting in the P68 operating without a surveillance-based radar service.

Situational Awareness of the Conflicting Aircraft and Action were assessed as **ineffective** because neither pilot had any situational awareness that the other aircraft was in the vicinity.

Electronic Warning System Operation and Compliance were assessed as **ineffective** because the FLARM and ADS-B on the RV9 could not detect the P68.
