AIRPROX REPORT No 2021128

Date: 22 Jul 2021 Time: 1218Z Position: 5117N 00108W Location: 2NM N Basingstoke

PART A: SUMMARY OF INFORMATION REPORTED TO UKAB

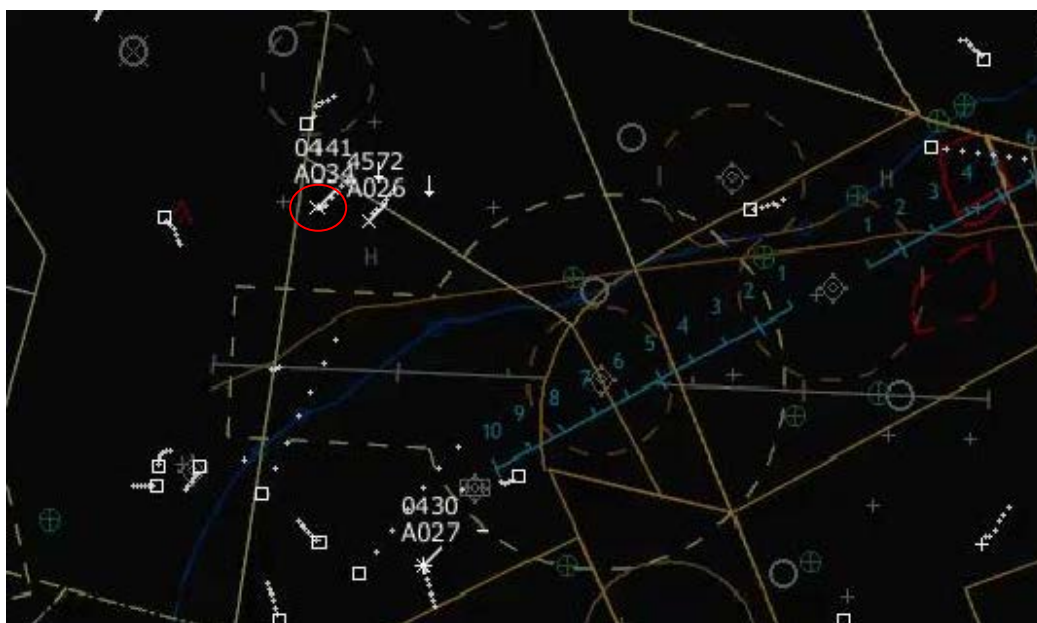
Figure 1: 1218:04

PA28(1) was on a Basic Service with Farnborough LARS West, operating in the NIGIT area. The LARS West frequency was busy, with medium to high workload including Traffic Services. PA28(1) was squawking 0441 (see Figure 1, screenshot taken from the Farnborough radar, PA28(1) circled in red).

At 1218:04 PA28(1) was at 3400ft, tracking 260°. The other aircraft [PA28(2) C/S], wearing a 4572 squawk, was on a similar track, 1.5NM east indicating 2600ft.

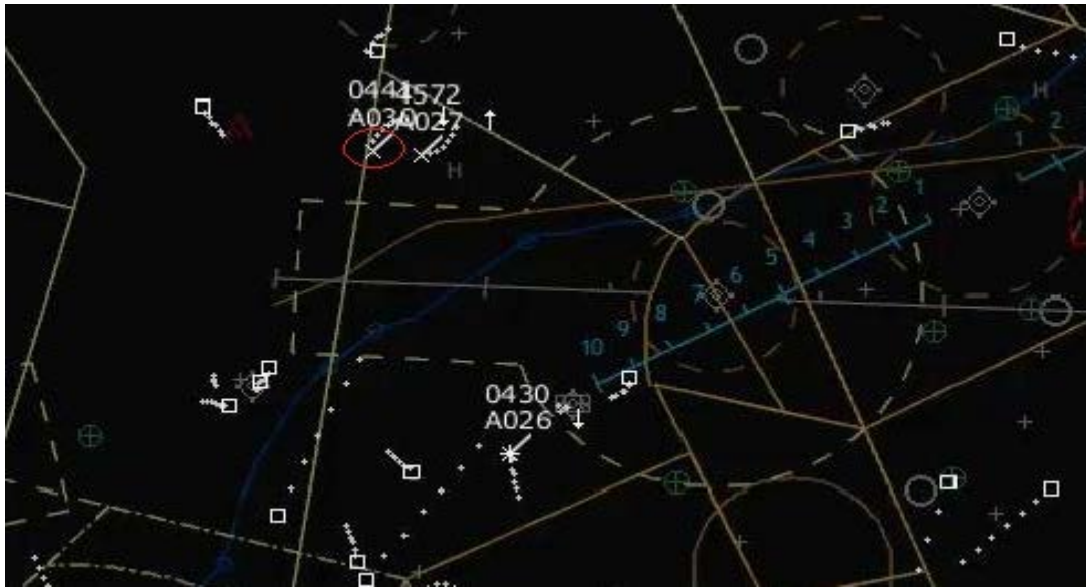
Figure 2: 1218:33

At 1218:11 the LARS West controller called traffic to another aircraft on their frequency and at 1218:33 (Figure 2) that pilot replied that they were visual. At this point PA28(1) made a hard left turn and descended to 2700ft, putting it exactly opposite direction of the 4572 traffic (PA28(2)), at the same level.

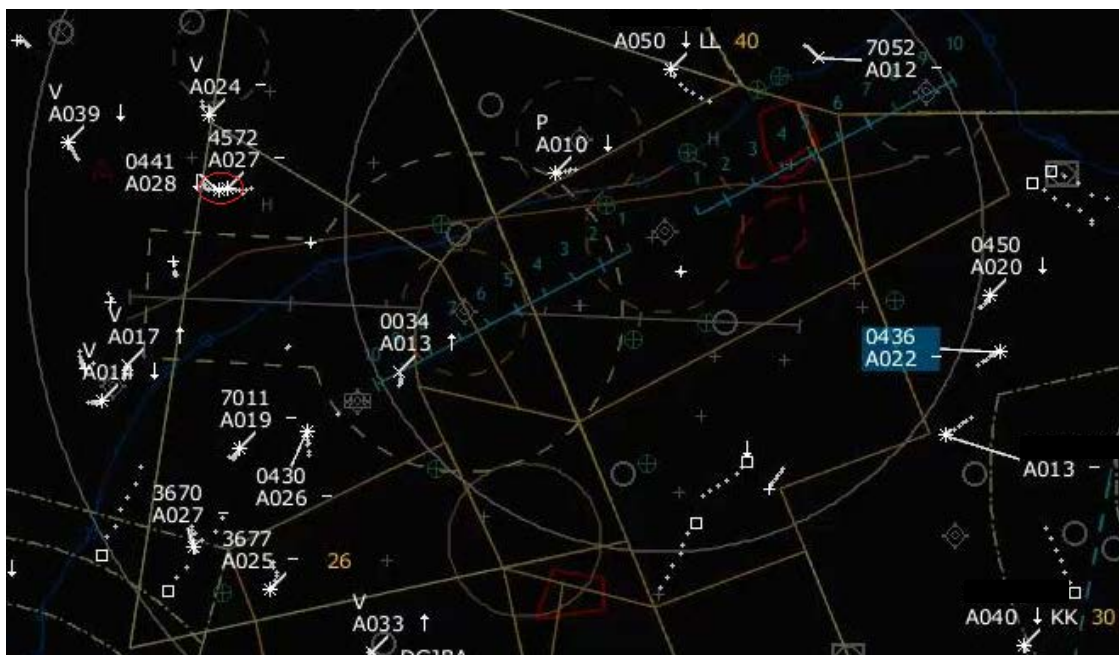
Figure 3: 1218:42

On the radar it appeared that the two aircraft passed each other, down their left-hand-sides, at the same level. The Airprox happened at 1218:42. The controller did not see this as they were concentrating on the traffic that was operating in the Guilford area, highlighted in blue at Figure 3 (0436 squawk).

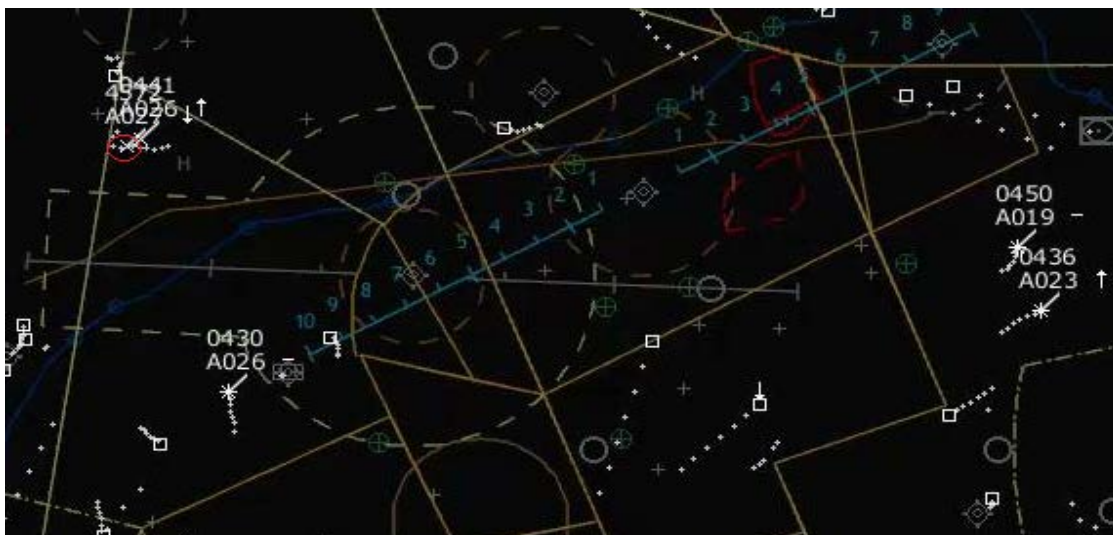
Figure 4: 1218:59 CPA

The aircraft were clear of conflict at 1218:59 (Figure 4).
