AIRPROX REPORT No 2021133

Date: 29 Jul 2021 Time: 1035Z Position: 5415N 00113W Location: 2NM N Sutton Bank

PART A: SUMMARY OF INFORMATION REPORTED TO UKAB

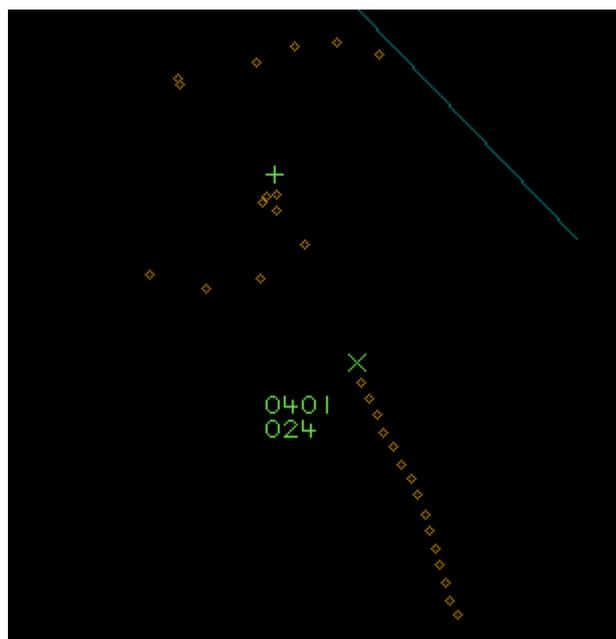
Figure 1: 1034:28

Analysis of the NATS radars showed the PA28, squawking 0401 (Leeming) transited through the area at FL024. The PA28 pilot did not submit a report, however, the Leeming flight strip indicated that the PA28 was flying on a pressure setting of 999hPa and therefore was at an altitude of approximately 2000ft. At Figure 1, a primary contact, probably the glider, could be seen, but this faded from radar. CPA most likely occurred around 1035:23, the PA28 could be seen to turn right and a comparison with the GPS track provided by the glider pilot indicated that the glider was in the vicinity at that time.

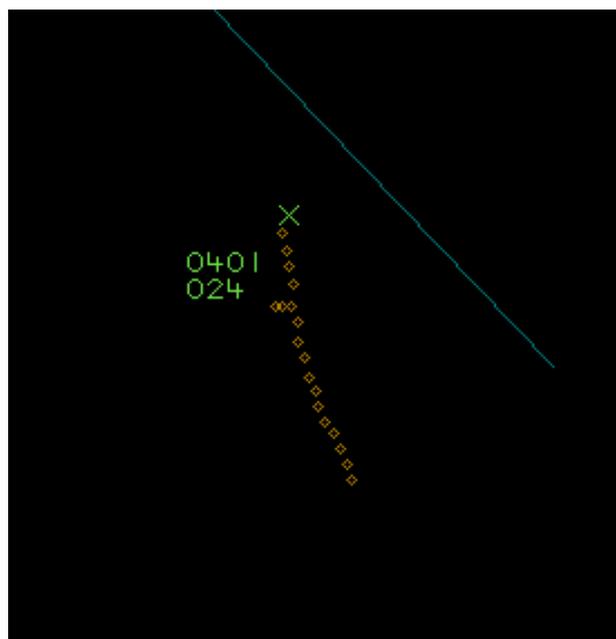
Figure 2: 1035:23 probable CPA

When determining the risk, members took into consideration the report from the glider pilot and the comparison of the GPS with the radar. They noted that although the glider pilot saw the PA28 late, as they were in a turn onto south, they did manage to take avoiding action and believed that the PA28 pilot also turned away. Consequently, members agreed that safety had been much reduced, with avoiding action taken at the last minute to avoid a collision; Risk Category B (**CF8**).
