AIRPROX REPORT No 2021137

Date: 03 Aug 2021 Time: 1327Z Position: 5443N 00314W Location: ~5NM NE of Cockermouth

PART A: SUMMARY OF INFORMATION REPORTED TO UKAB

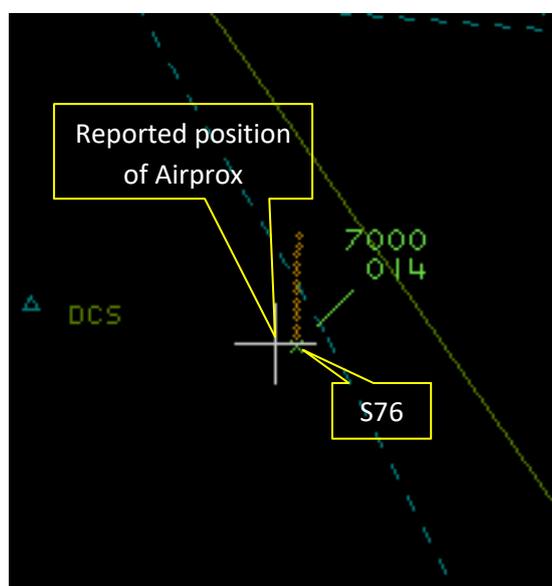
Figure 1 – 1326:36 – Estimated CPA

An analysis of the NATS radar replay was undertaken. The S76 was detected by the NATS radars shortly after departure and could be seen climbing on a southerly track to an altitude of 1100ft initially. As the S76 approached the area of the reported Airprox the aircraft climbed to 1400ft and passed the reported position of the Airprox at that altitude (see Figure 1). The paraglider was not detected by the NATS radars and the paraglider pilot was unable to supply a GPS log file of their flight.

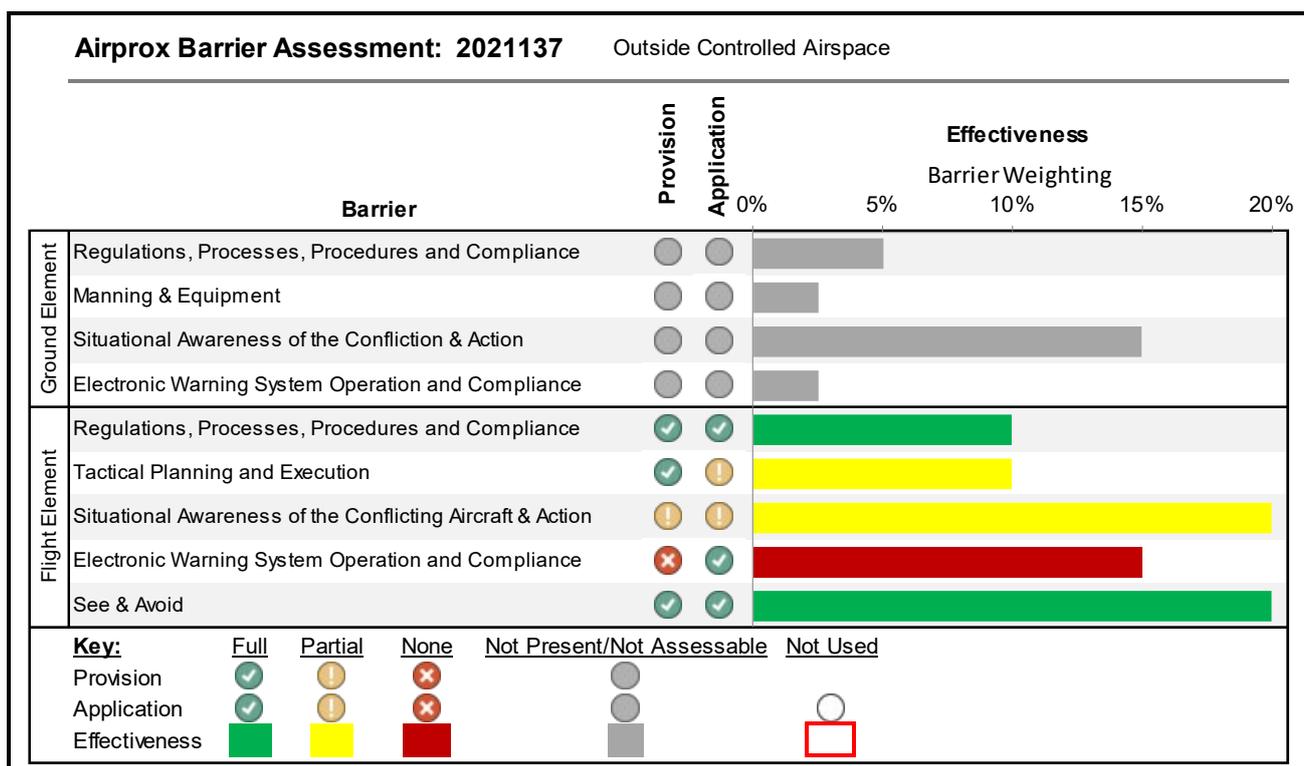
Tactical Planning and Execution was assessed as **partially effective** because the S76 pilot chose to route through the NOTAM'd paragliding activity (as they were entitled to) on the windward side of the hill, were it was more likely for them to have encountered paragliding activity.

Situational Awareness of the Conflicting Aircraft and Action were assessed as **partially effective** because the paraglider pilot did not have any situational awareness of the approaching helicopter, and the S76 pilot only had generic situational awareness of paragliding activity within the NOTAM'd area.

Electronic Warning System Operation and Compliance were assessed as **ineffective** because the TCAS II equipment on the S76 could not detect the non-transponding paraglider.
