## **AIRPROX REPORT No 2021139**

Date: 03 Aug 2021 Time: ~1030Z Position: 5226N 00103W Location: Husbands Bosworth circuit

### **PART A: SUMMARY OF INFORMATION REPORTED TO UKAB**

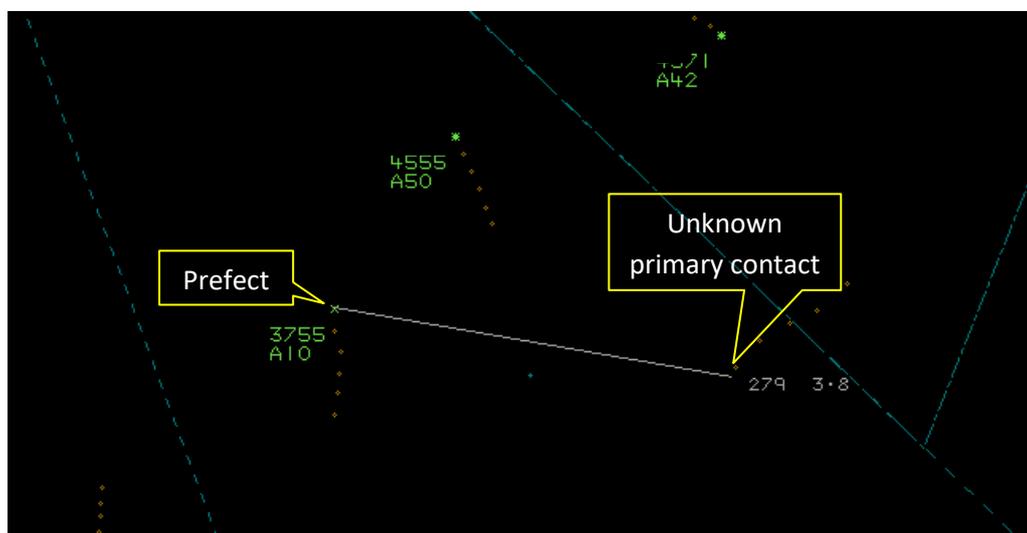
Figure 1 has been provided by NATS radars which are not utilised by Wittering controllers therefore may not be entirely representative of what the Wittering controller saw at the time.

Figure 1: CPA prior to unknown PT fading from radar.

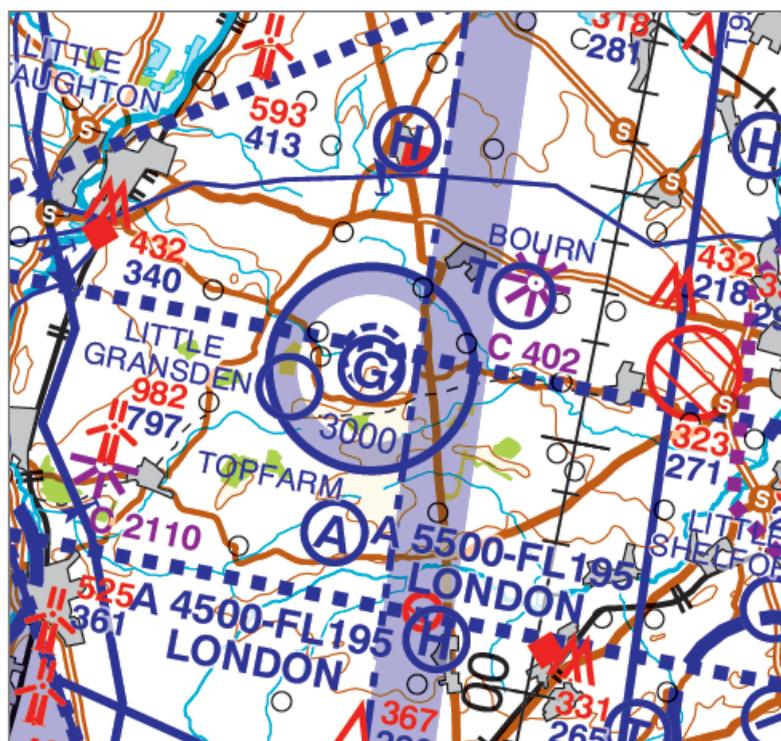
Turning to the actions of the Prefect pilot, members were surprised to learn that the moving map display in the Prefect did not display glider sites, and were heartened to hear from a military pilot member that these issues were being addressed – the member undertook to update the Board on progress in this regard. The military pilot member went on to add that a lack of instructor availability had led to instructors being unavailable for the planning stage of some flights and so the first sight that they had of the planned route was at the sortie briefing stage. The Board also heard that instructor pilots were not required to carry their own paper chart of the planned route and, given that the moving map in the Prefect lacked essential navigational information, the Board agreed that this had been a factor in this Airprox (**CF2**).

Figure 2 – Extract from the military 1:500,000 Low Flying Chart

The Board was encouraged to hear that, in light of this incident, instructor pilots are now required to carry their own paper chart on all flights, irrespective of whether or not they had been available for the mission planning. Returning to the Airprox itself, the Board agreed that the student's airsickness, and subsequent distraction of the instructor while dealing with an airsick student, had set in motion a chain of events that ultimately led to the Prefect flying through the circuit at Husbands Bosworth. Members noted that a misidentification of a turning point to the south of Husbands Bosworth had meant that the subsequent track had taken the Prefect into an area that military pilots are required to avoid (see Figure 2) and, subsequently, the Prefect pilot had neither avoided nor conformed with the pattern of traffic (**CF3**, **CF4**, **CF5**, **CF7**). Regarding their student's airsickness, the Board considered that the Prefect pilot's decision to continue
