AIRPROX REPORT No 2021141

Date: 09 Aug 2021 Time: 1105Z Position: 4959N 00609W Location: 8NM E St Mary's, Scilly Isles

PART A: SUMMARY OF INFORMATION REPORTED TO UKAB

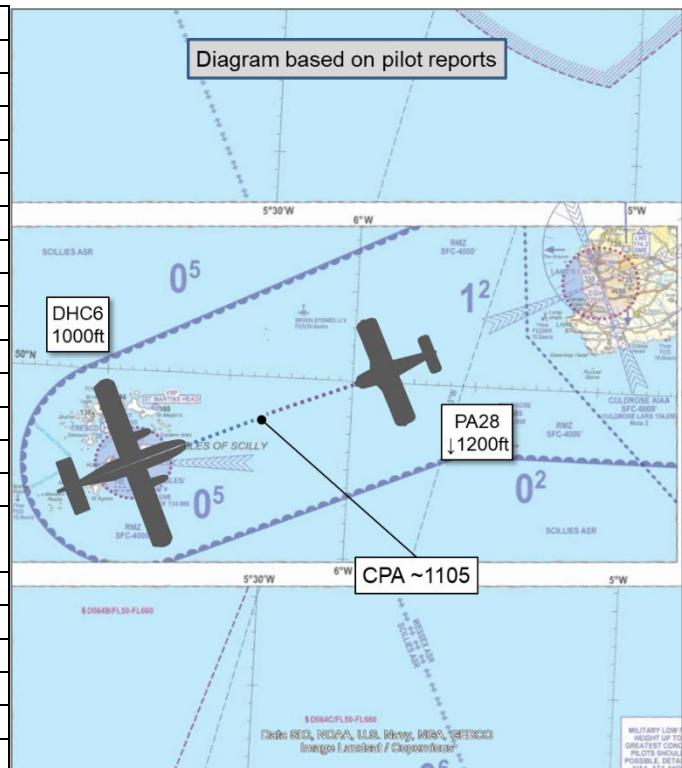
An Airprox was reported when a DHC6 and a PA28 flew into proximity at approximately 8NM east of St Mary's at around 1105Z on Monday 9th August 2021. Both pilots were operating under VFR in VMC, both were in receipt of a Basic Service from Scillies Approach.

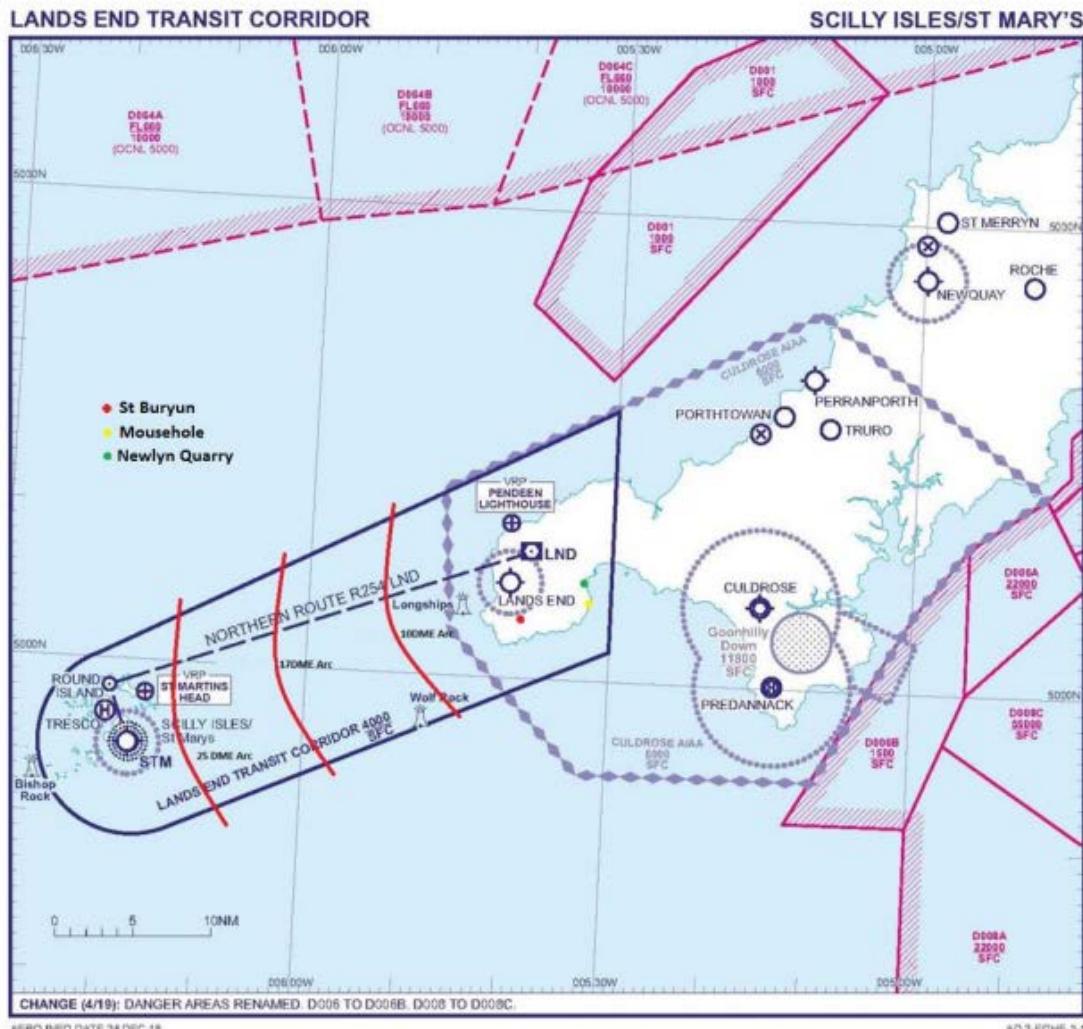
LET C Chart & Routine Position Reporting:

3.1 Local Operators will when operating VFR in the LETC use the co-located LND VOR/DME to make the following position reports which are based on a DME arc:

- 1) 10 DME SW LND 2) 17 DME SW LND 3) 25DME SW LND or Eastern Isles

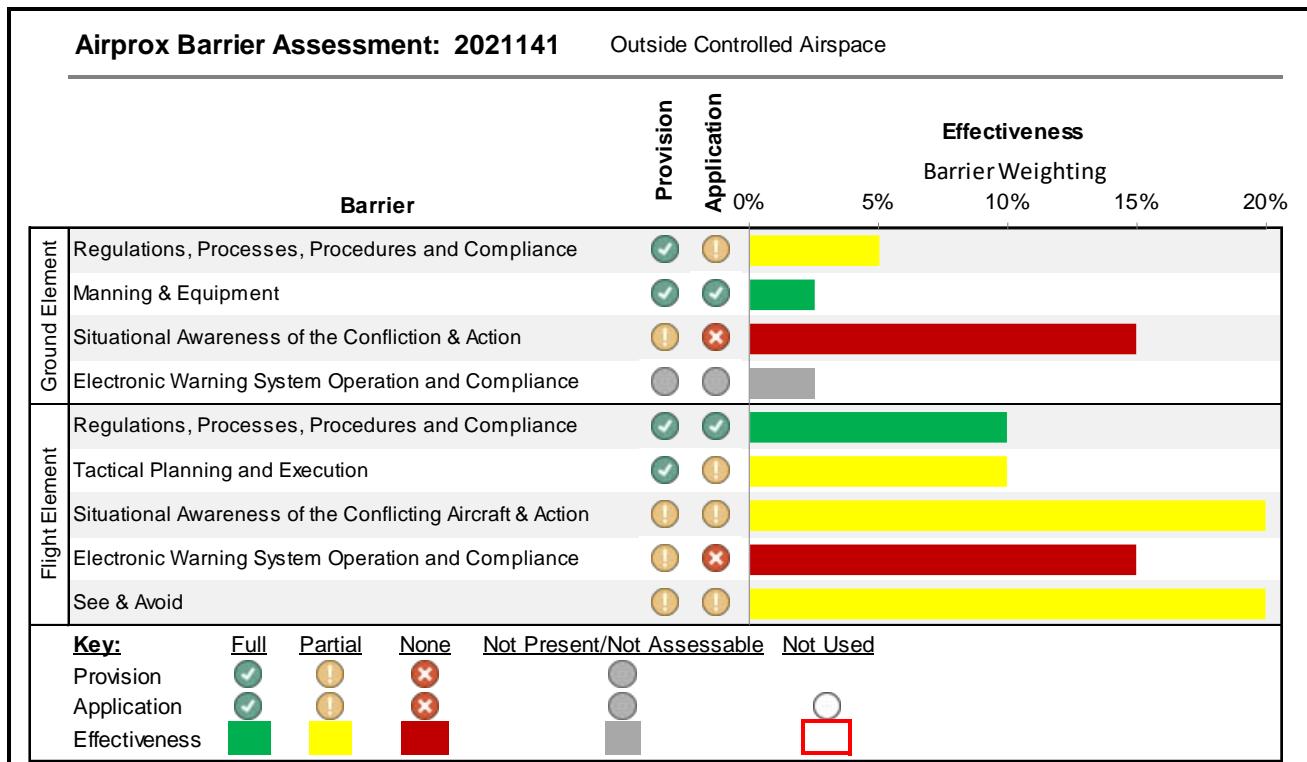
Safety Barrier Assessment⁵

Regulations, Processes, Procedures and Compliance were assessed as **partially effective** because the controller did not pass Traffic Information to the DHC6 on the PA28, in accordance with the LOA with the DHC6 company.

Situational Awareness of the Confliction and Action were assessed as **ineffective** because the controller thought that the PA28 had already passed the DHC6, so did not pass Traffic Information.

Tactical Planning and Execution was assessed as **partially effective** because neither pilot adapted their plan when they knew the PA28 was about to descend; the PA28 pilot heard the position of the DHC6 to be 22DME and knew that they had not yet passed that range and the DHC6 pilot also heard the other pilot's request for descent on the frequency.

Situational Awareness of the Conflicting Aircraft and Action were assessed as **partially effective** because both pilots only had generic situational awareness about the other.

Electronic Warning System Operation and Compliance were assessed as **ineffective** because the TAS on the DHC6 did not detect the PA28.

See and Avoid were assessed as **partially effective** because cloud caused some obscuration and so both pilots saw the other aircraft late.
