AIRPROX REPORT No 2021142

Date: 08 Aug 2021 Time: 1216Z Position: 5443N 00128W Location: 4NM SE of Durham

PART A: SUMMARY OF INFORMATION REPORTED TO UKAB

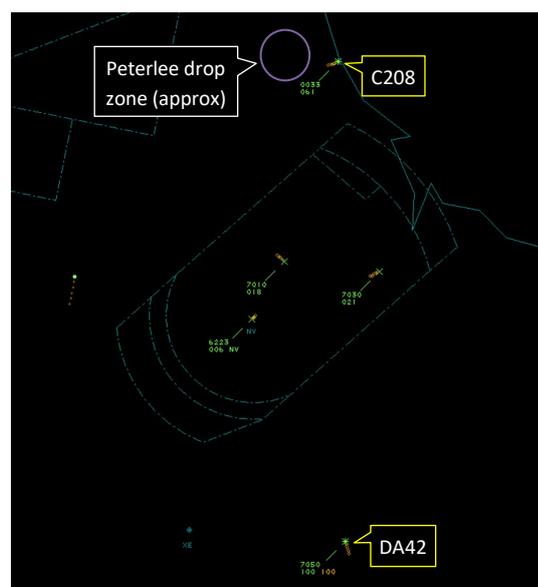
Figure 1 – 1204:00

At **1204:00** the Teesside Radar controller passed the details of the DA42 to the Newcastle Radar controller via the direct telephone line – the DA42 was still more than 15NM south of Teesside at the time. The C208 had appeared on the radar replay earlier at **1200:40** and was in a climb passing an indicated FL61 on the coastline, to the east of the Peterlee drop zone (Figure 1). At **1206:05** the Teesside controller rang the Newcastle controller to pass details on a second aircraft airborne from Teesside routing north. The Teesside controller then advised that the DA42 [pilot] had “*asked to route own navigation to NATEB*”, (reporting point overhead Newcastle), which was approved by the Newcastle controller (Figure 2).

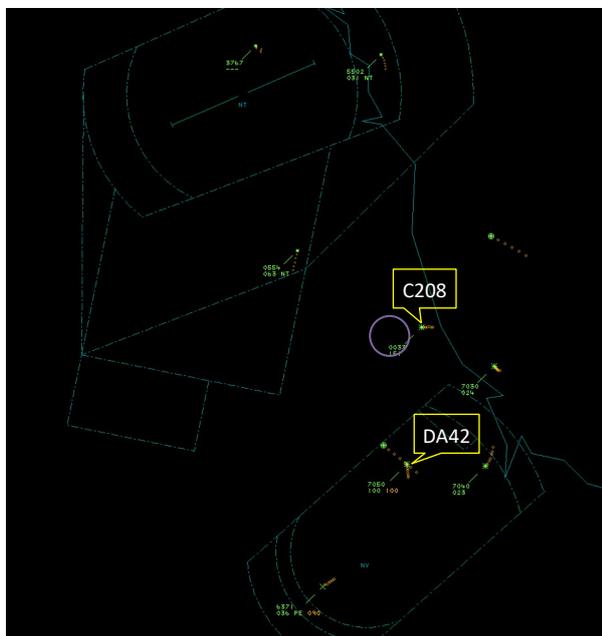
Figure 3 – 1212:30

At **1212:30** the Teesside controller asked the DA42 pilot to confirm that they were routing to NATEB. The pilot advised that they were routing to ASGEB (Figure 3). The Teesside controller acknowledged this and advised “*Peterlee airfield is active – paradropping up to FL160 – the airfield is in your 12 o’clock range of 8 miles*”. This was acknowledged by the pilot who requested a “*left turn to avoid*” which was approved by the controller at **1213:00**, after they had dealt with another aircraft on their final approach. The DA42 pilot advised that their heading would be 340° (Figure 4).

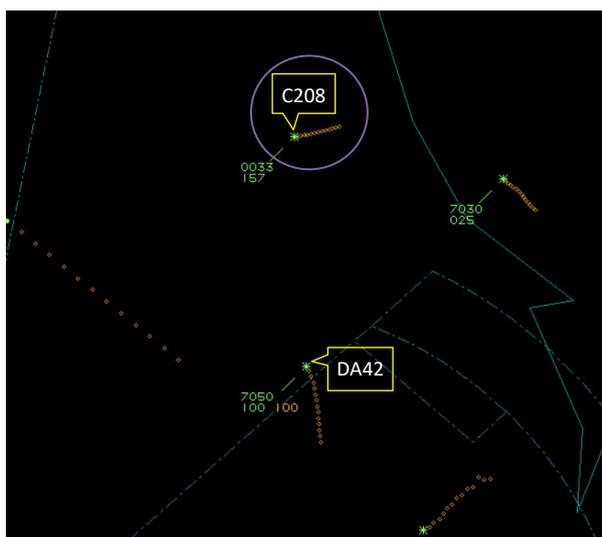
Figure 5 – 1213:46

At **1213:46** the Teesside controller rang the Newcastle controller again to advise that the DA42 was “*actually routing Alpha Sierra Echo Bravo (sic) – I don’t know where that is. He’s hard to understand. I’ve told him about Peterlee, and he’s now turning left heading 340 to avoid. He’s on his own - (interrupted by Newcastle controller) on his own nav*” which was acknowledged by the Newcastle controller (Figure 5). At **1214:00** the Teesside controller instructed the DA42 pilot to contact Newcastle Radar (with the frequency) (Figure 6).

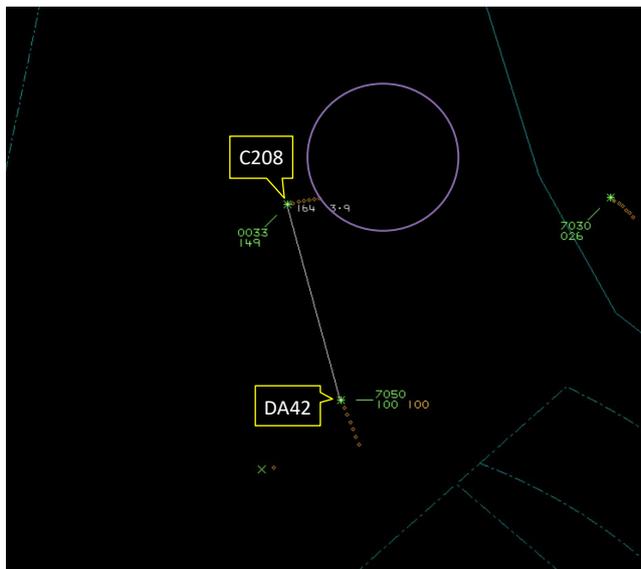
Figure 7 – 1214:50

At **1214:17** the pilot of the DA42 reported on the Newcastle Radar frequency, advising that they were heading 340° and maintaining FL100. The Newcastle Radar controller who was under training and under the supervision of an On-the-Job Training Instructor (OJTI) acknowledged this, advising that it was a Traffic Service, and instructed them to “*fly heading of 330 degrees - that will er take you clear of the Peterlee parachuting centre*” which was readback correctly by the pilot. The

Newcastle controller then passed Traffic Information; “*traffic er right one o'clock range of 5 miles is a paradropping aircraft at FL150*”. The DA42 [pilot] requested that the controller repeat the information as “*we had another station calling at the same time*”, (note - not on the Newcastle Radar frequency), which the controller did at **1214:50** (Figure 7). The Newcastle controller then took another initial call from the aircraft outbound from Teesside routing north, and confirmed a Deconfliction Service with them. Then, at **1215:18**, the controller instructed the DA42 [pilot] to “*fly heading 270 degrees*” which was readback by the pilot. The controller, who was also providing a Deconfliction Service to an aircraft inbound to Newcastle, gave that aircraft a turn onto base leg before, at **1215:38**, attempting to call the pilot of the C208 (twice) but for which they received no reply (Figure 8).

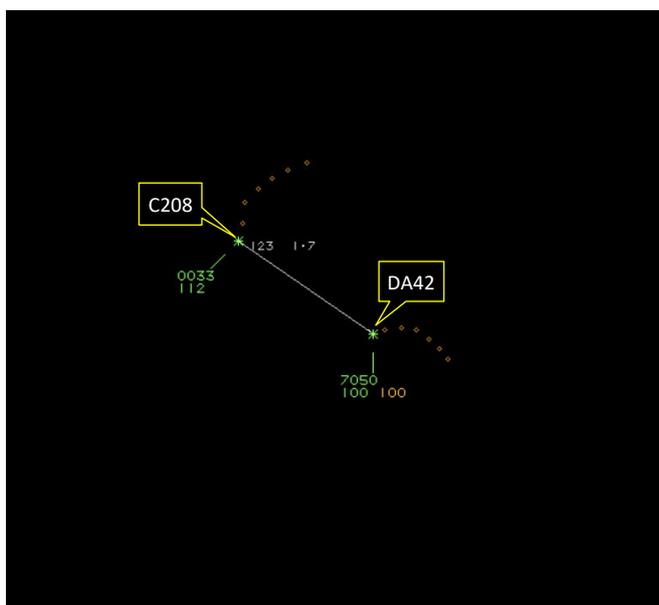
Figure 9 – 1216:03

The controller then received a call for climb from the Teesside outbound aircraft which they initially ignored and instead, at **1215:54**, passed updated Traffic Information to the DA42 [pilot]; “*traffic in your right one o'clock, range of two miles, er descending through FL110 – report visual*”. The DA42 pilot reported that they were visual at **1216:03** (Figure 9). At **1216:08** an aircraft departing Newcastle called on the radar frequency but was initially ignored by the controller. At **1216:17** the controller issued a turn onto the ILS for the inbound aircraft. CPA occurred at **1216:19** with the aircraft separated by 0.1NM laterally and 200ft vertically (Figure 10).
