**AIRPROX REPORT No 2021145**

Date: 10 Aug 2021 Time: 1116Z Position: 5049N 00115W Location: Lee-on-Solent

**PART A: SUMMARY OF INFORMATION REPORTED TO UKAB**

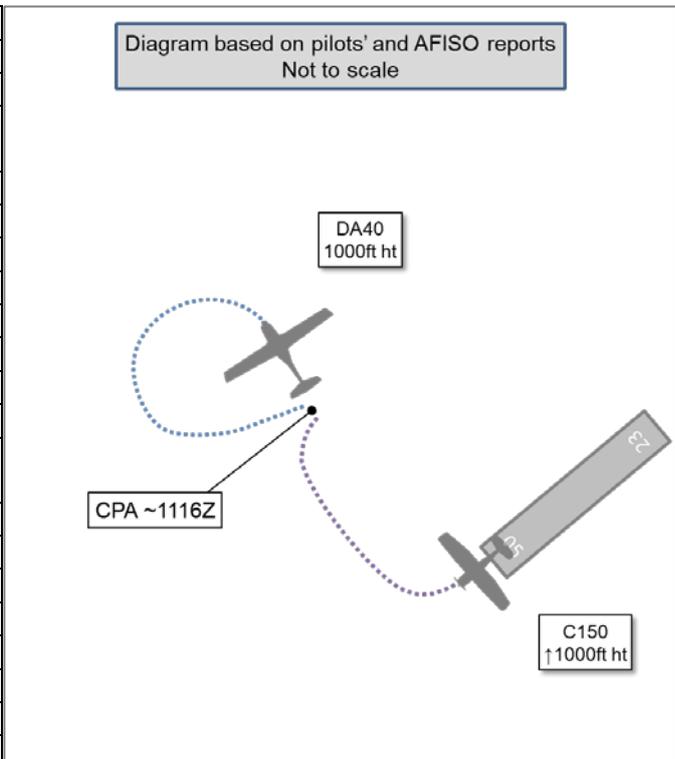
**THE DA40 INSTRUCTOR** reports conducting a training flight at Lee-on-Solent. The student had just completed a touch-and-go, however, during the crosswind leg, an aircraft joining downwind passed directly in front of them with minimal separation. The instructor took control and transmitted that they were going to orbit at the start of the downwind leg to give more separation to the traffic in front (a PA28 flying slower than them). Lee Information acknowledged the call. As they were completing the orbit to continue downwind, the instructor saw an aircraft on the upwind leg which turned early to crosswind and appeared to be trying to overtake them. The other aircraft was head-on and then started to turn right and, because the instructor was already in a left hand turn, they increased the angle of bank when they saw the left side of the other aircraft very close in front.

**THE C150 PILOT** reports that the circuit at Lee-on-Solent was busy with a number of visiting aircraft, as well as home based aircraft performing touch-and-goes and landings. The AFISO was informed that they intended to complete a single circuit with a touch-and-go, and then depart to a local airfield. There was an expected delay of some minutes before the AFISO advised that they could enter RW23 and take-off at their discretion. There were at least four other aircraft in the circuit, with two to join. They performed a standard take-off and climb-out from RW23, turned right onto the crosswind leg at the defined point for the circuit, climbed to 1000ft and established straight and level flight on the crosswind leg. They then saw a DA40 in a right-hand medium banked-turn in about the left 10/11 o'clock position, outside the circuit boundary at the crosswind/downwind corner. It appeared to be orbiting as it continued the turn from pointing downwind to pointing head-on, then slightly away. The DA40 then straightened up and its course appeared to be more converging, i.e. opposite direction to the right-hand circuit crosswind leg. The C150 pilot was unclear as to their intentions and turned to the right to keep clear. They cut the crosswind corner of the circuit and entered the downwind. At this stage the relative bearing

was 9 o'clock and they lost sight of the DA40 after it passed behind the left wing. They believed the DA40 pilot saw them well after they had seen the DA40. The R/T was busy and the C150 pilot did not have the opportunity to communicate at the time because they were focussed on the other aircraft throughout, were unsure of its immediate intentions and were manoeuvring to ensure that they could maintain clearance from the other aircraft. The C150 pilot continued with the circuit but the runway was occupied so performed a go-around. On turning crosswind they informed the AFISO that they would be departing; they felt that the circuit was too congested to attempt another touch-and-go.

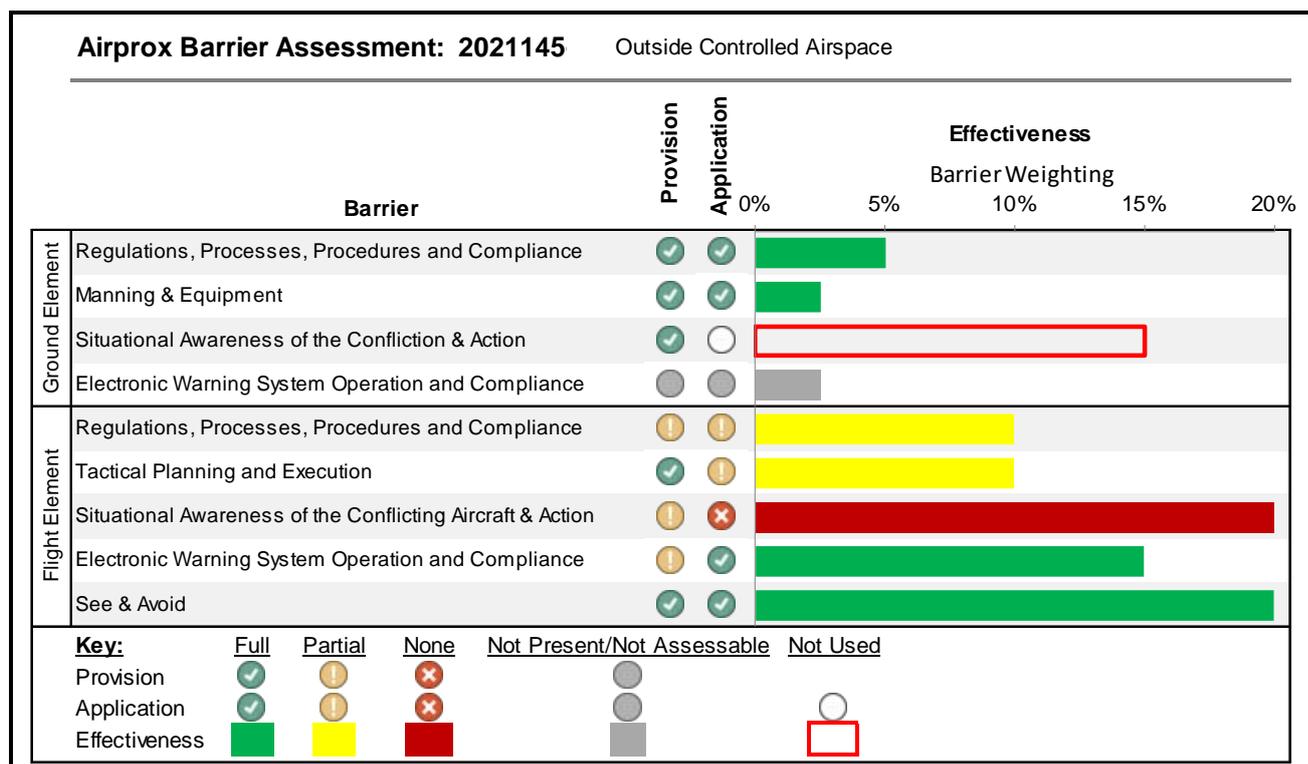
### Safety Barrier Assessment<sup>4</sup>

**Situational Awareness of the Confliction and Action** were assessed as **not used** because an AFIS does not include traffic sequencing in the visual circuit.

**Regulations, Processes, Procedures and Compliance** were assessed as **partially effective** because the DA40 and C150 pilots did not integrate with each other.

**Tactical Planning and Execution** was assessed as **partially effective** because the DA40 pilot did not allow sufficient room for the C150 behind before commencing their orbit and the C150 pilot did not allow sufficient room for the DA40 ahead before turning on to crosswind.

**Situational Awareness of the Conflicting Aircraft and Action** were assessed as **ineffective** because neither pilot was aware of the proximity or intentions of the other until at a late stage and their actions resulted in flight into close proximity.
