AIRPROX REPORT No 2021146

Date: 11 Aug 2021 Time: 1305Z Position: 5155N 00209W Location: Gloucester airport

PART A: SUMMARY OF INFORMATION REPORTED TO UKAB

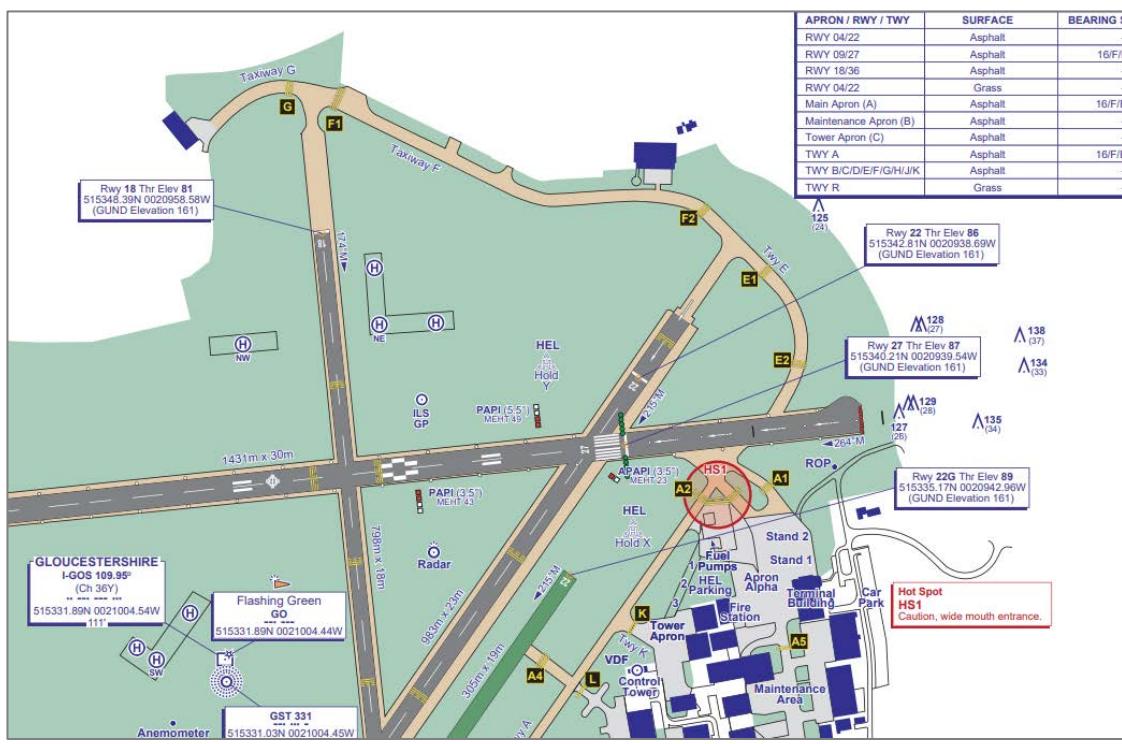
Figure 1 – Gloucestershire Aerodrome – extract from UK AIP

At 1302:23, the pilot of the B206 which was on Stand “One and a half” called; “we’re ready for lift, and it’s circuit right”. The trainee controller instructed them to taxi to holding-point A1 (Figure 1).

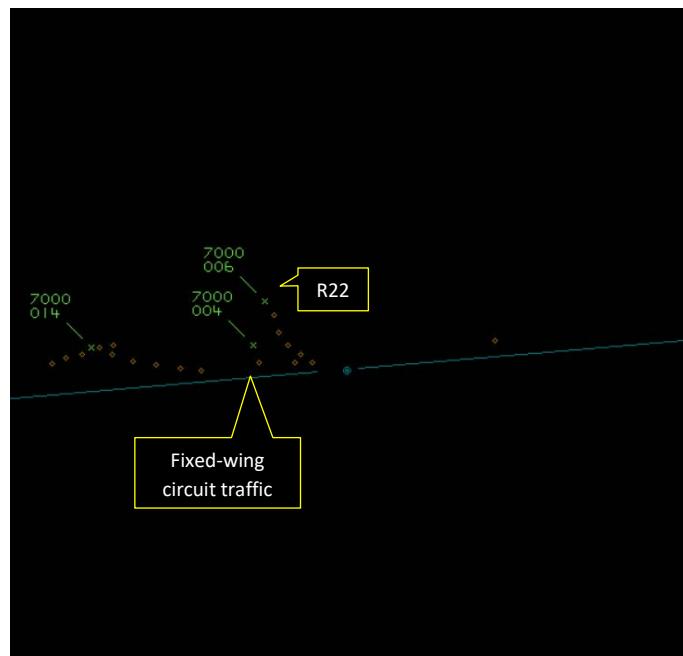
Figure 2 – 1303:21

A second helicopter in the helicopter parking area which had called two minutes earlier for departure, but received no response, called again at 1303:02. The OJTI gave them taxi instructions to Hold X. At 1303:21 the trainee controller instructed the B206 [pilot] to “cross runway 27, standard helicopter departure to the north. Cleared for take-off(surface wind)”. The B206 pilot replied “Cross 27. Cleared take-off (callsign)” (Figure 2).

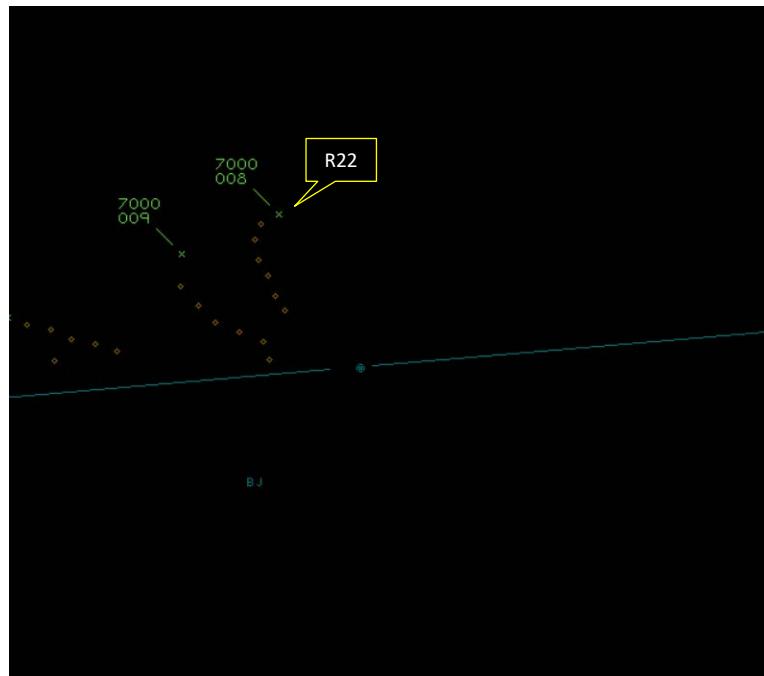
Figure 3 – 1303:54

At 1303:54 the [pilot of the] second helicopter holding at Hold X was given a clearance to cross RW27 on a standard helicopter departure to the north and then cleared for take-off. The pilot read back “*cleared to depart to the north, er just lifting now...*” (Figure 3).

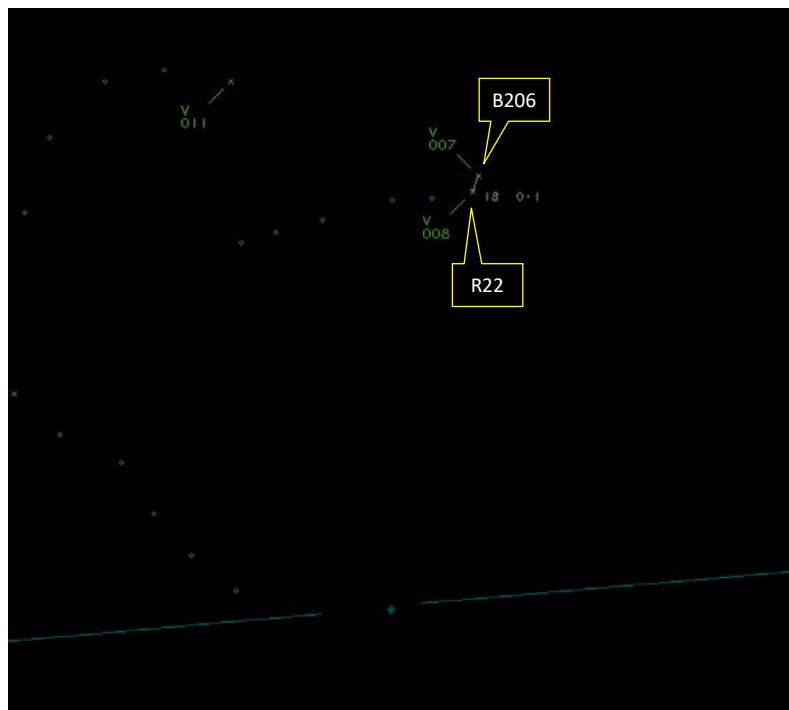
Figure 4 – 1304:42 – possible CPA

At 1304:40 [the pilot of] a PA28 in the fixed-wing circuit called downwind. Immediately following this, the R22 pilot reported “*downwind in the heli-circuit*”. It is at this point that the B206 became visible on the radar replay, which might have been coincident with CPA, but this could not be determined (Figure 4).
