AIRPROX REPORT No 2021148

Date: 13 Aug 2021 Time: 1159Z Position: 5206N 00009E Location: Duxford

PART A: SUMMARY OF INFORMATION REPORTED TO UKAB

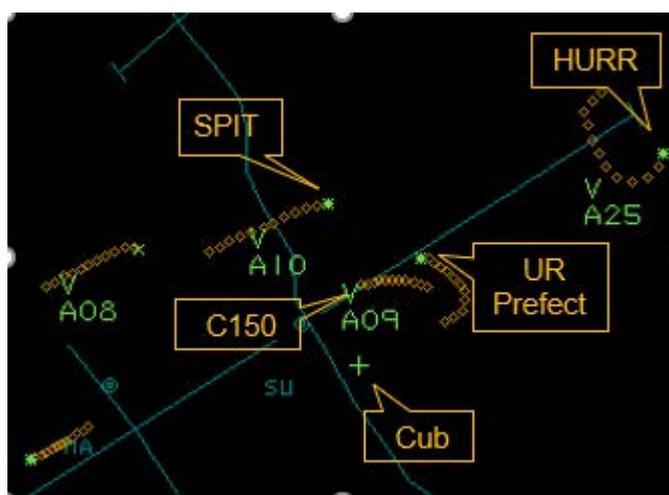
Figure 3 - 11:50:06 (Cub downwind)

At 1150:06 the Cub pilot reported, "*downwind for the option, 24 grass.*" The FISO responded, "*roger the Spitfire is just halfway around the right base.*" (Figure 3)

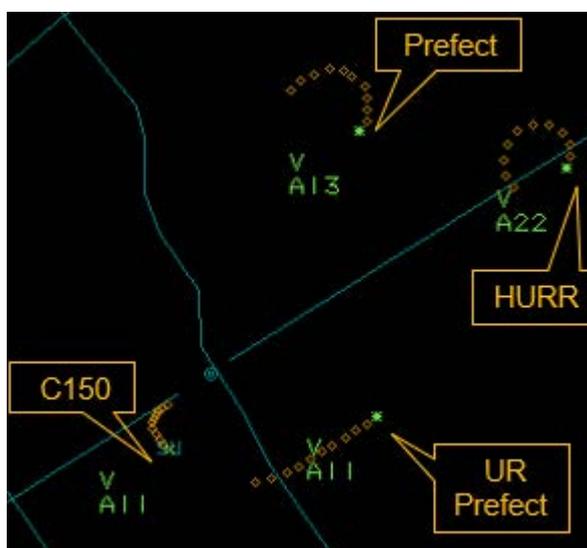
Figure 6 - 11:52.30 (Cub has faded from radar)

At 1152:30 the Cub pilot called "*final for the option.*" The FISO responded, "*option at your discretion, grass runway, surface wind 260° 15 up to 20 kts.*" The pilot read back, "*option at our discretion.*" (Figure 6)

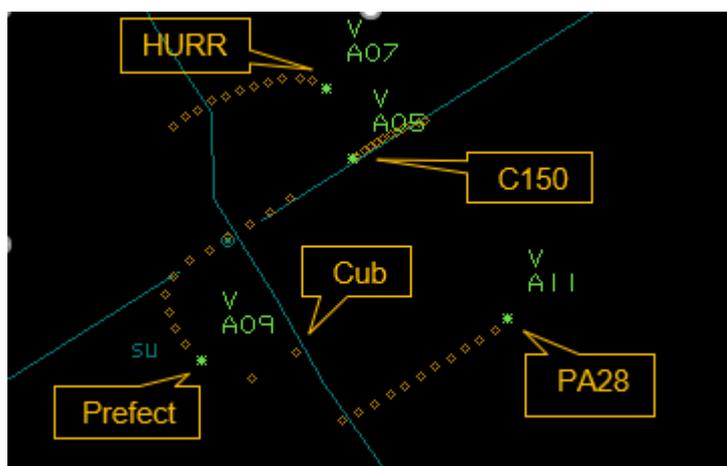
Figure 9 - 1156:22

At 1156:22 there was an unreadable transmission, followed by two at once and then the Prefect pilot reported, *“downwind (unintelligible word) land.”* The FISO responded, *“there is a Cub ahead of you in the late downwind left-hand position and another one ahead of him.”* The pilot responded, *“visual.”* (Figure 9)

At 1156:22 when the Prefect pilot reported, *"downwind (unintelligible word) land."* The FISO responded, *"there is a Cub ahead of you in the late downwind left-hand position and another one ahead of him."* The pilot reported, *"visual."* The Prefect pilot is unlikely to have known which runway the Cub pilot would be approaching.

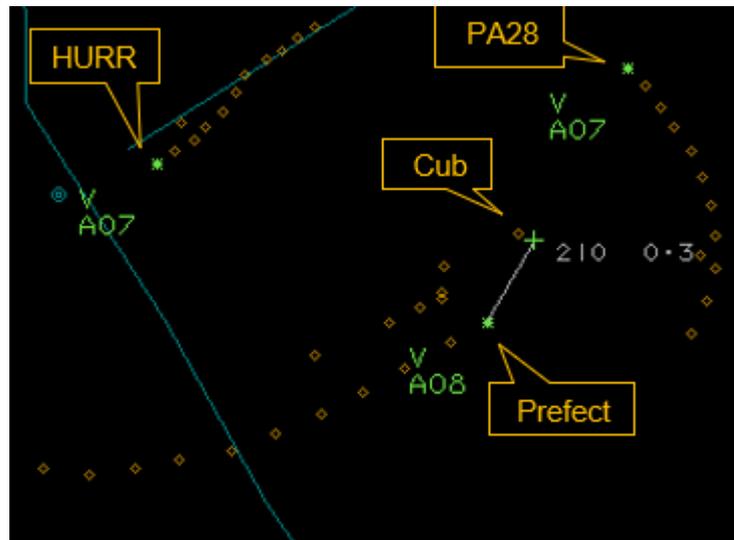
Figure 11 - 11:57.05

Between 1157:05 and 1157:45 a pilot called east of the airfield, requesting airfield information, and joining instructions, and was given instructions to join for RW24 left-hand and advised that the circuit was active with 3 or 4 in. The pilot asked if a straight-in approach was possible and the FISO said that they didn't know exactly where the pilot was, and that a straight-in approach would be at the pilot's discretion, to report at 4NM and then reconfirmed that the circuit was active. The pilot responded that they were at 4NM and the FISO responded, "roger then, look out for traffic, I think there are three of them ahead of you, and report 2NM". The pilot read back, "report two miles." (Figure 11)

Immediately prior to the Airprox occurring the FISO was engaged in a very lengthy RTF exchange that took place between 1157:05 and 1157:45, with the pilot of the aircraft inbound from the east, followed immediately by an aircraft reporting final and the pilot being told to

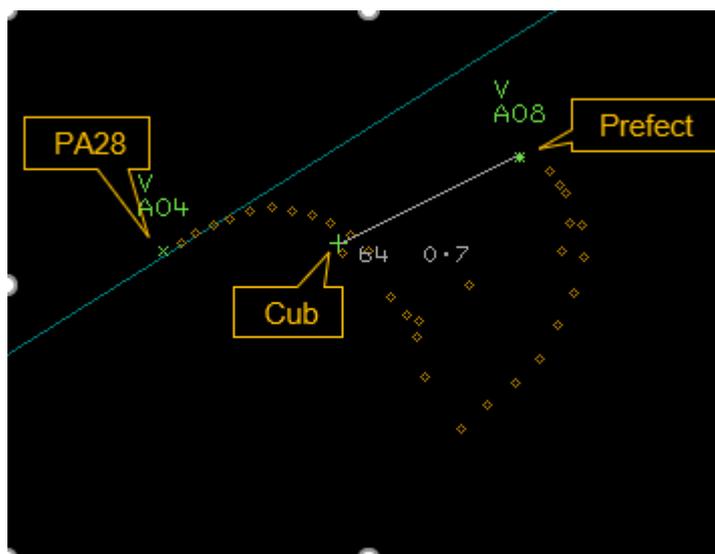
Figure 13 – 1158:08 (the Cub subsequently faded from radar & did not reappear)

At 1158:10 the FISO issued a land at your discretion RW24L to the Prefect pilot and passed the instant wind of 240° 12kt. There was no response from the pilot. (Figure 13)
