AIRPROX REPORT No 2021150

Date: 16 Aug 2021 Time: 1105Z Position: 5130N 00000W Location: 2NM W of London City Airport

PART A: SUMMARY OF INFORMATION REPORTED TO UKAB

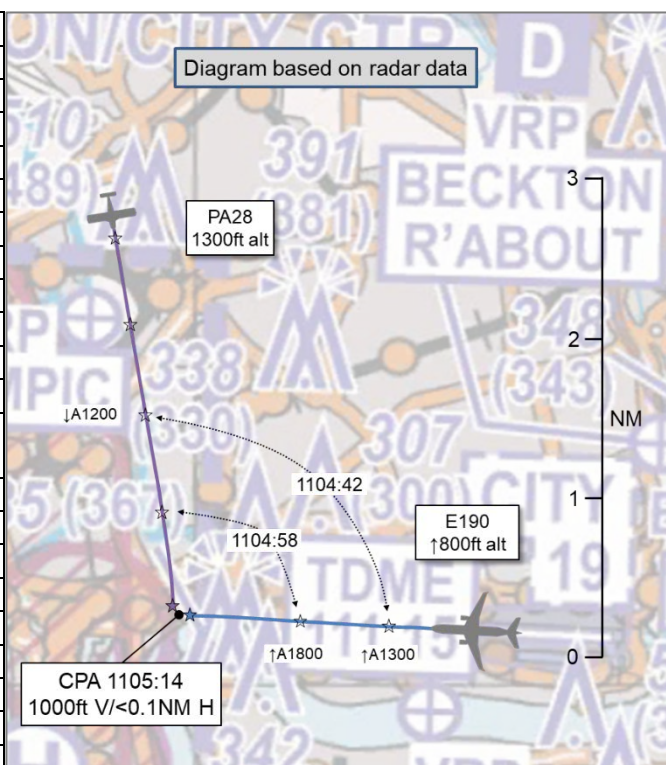
Recorded	Aircraft 1	Aircraft 2
Aircraft	E190	PA28
Operator	CAT	Civ FW
Airspace	London/City CTR	London/City CTR
Class	D	D
Rules	IFR	VFR
Service	ACS	ACS ¹
Provider	London City Tower	London City Tower
Altitude/FL	2200ft	1200ft
Transponder	A, C, S	A, C
Reported		
Colours	White, blue	White, red
Lighting	Strobe, nav anti-col and landing	Strobe
Conditions	VMC	VMC
Visibility	>10km	5-10km
Altitude/FL	1000ft	1200
Altimeter	QNH (1017hPa)	QNH (NR hPa)
Heading	272°	360°
Speed	180kt	100kt
ACAS/TAS	TCAS II	Not fitted
Alert	TA	N/A
Separation at CPA		
Reported	600ft V/0m H	2000ft V/2NM H
Recorded	1000ft V/<0.1NM H

1105:13 The two aircraft crossed over 2NM west of the field, [the E190] indicated 2100ft, [the PA28] (squawking 7030) indicated 1200ft.

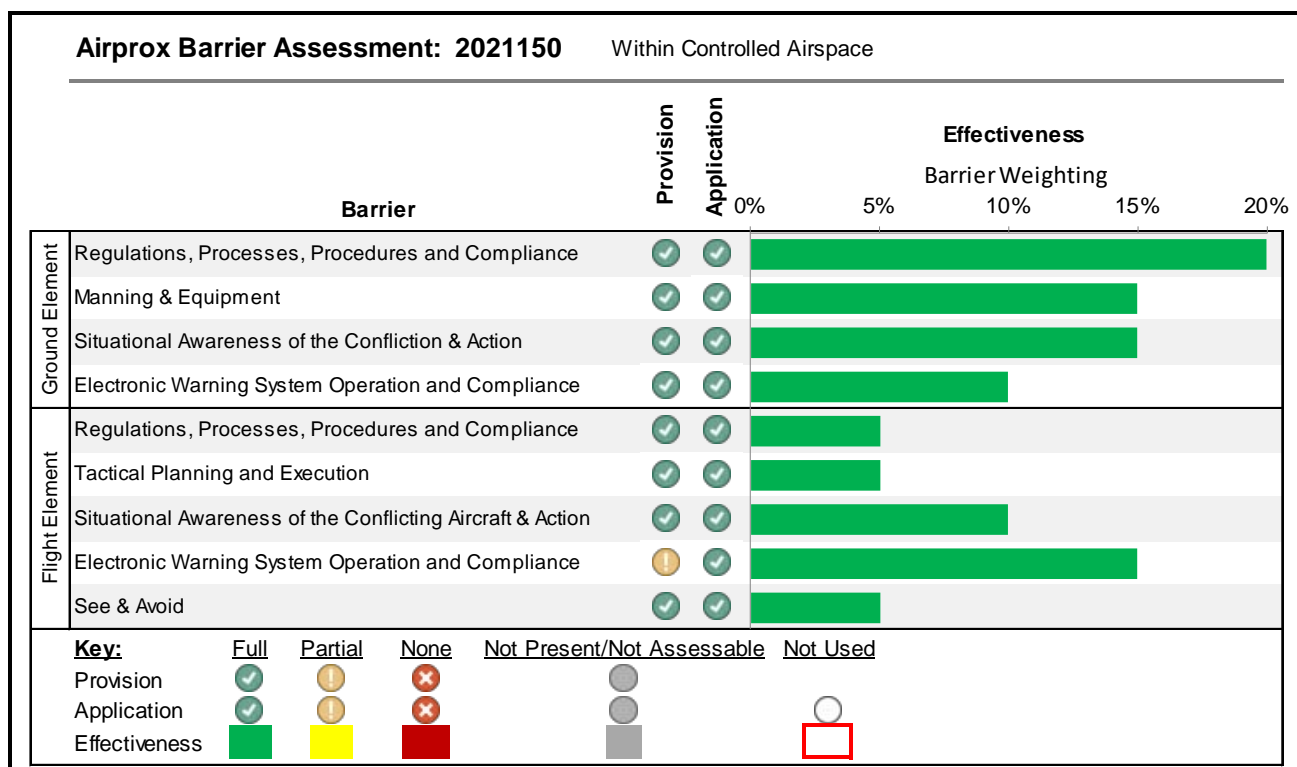
Safety Barrier Assessment⁵

In assessing the effectiveness of the safety barriers associated with this incident, the Board concluded that the recognised barriers to mid-air collision had all been fully effective in this case.
