AIRPROX REPORT No 2021153

Date: 19 Aug 2021 Time: 1338Z Position: 5119N 00015E Location: 1NM S Brands Hatch

PART A: SUMMARY OF INFORMATION REPORTED TO UKAB

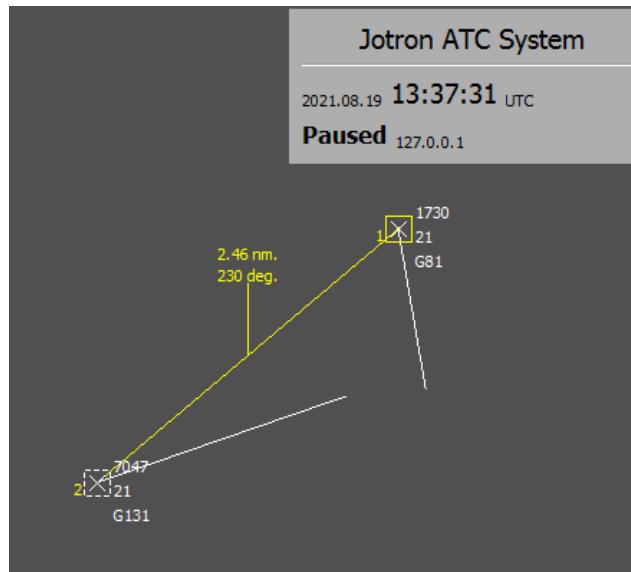
Figure 1 – approximately one minute before the Airprox

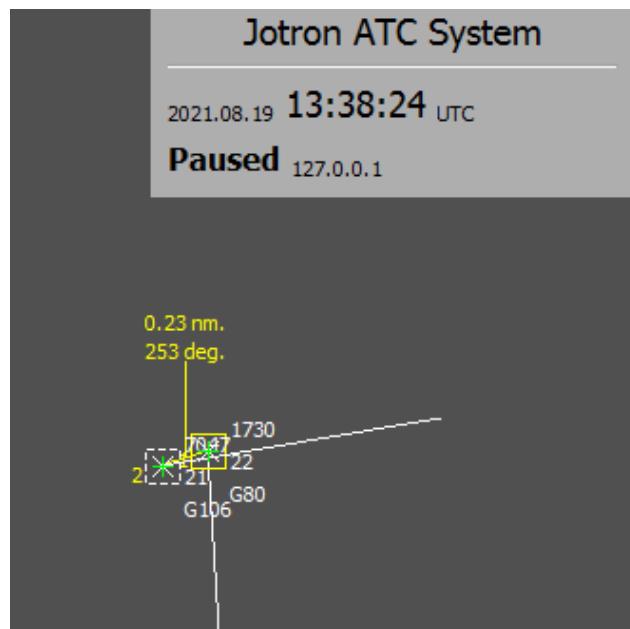
Figure 4 – when the “aircraft to my right” transmission is made

When the transmission ‘aircraft to my right’ was made, the distance between [the C152 and the PA28] was 0.23NM and 100ft. The next sweep shows [C152] has passed in front of the 7047 squawk. The controller, from their report, had a vague recollection of a transmission of ‘aircraft to my right’ being made, but nothing else reported on frequency.

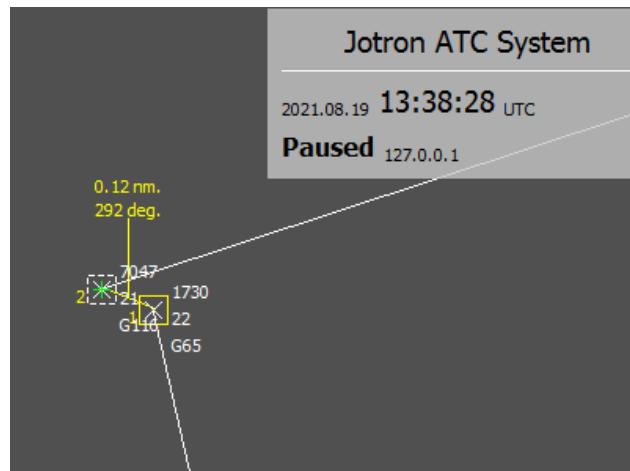
Figure 5 – the closest measured point, but [C152] has passed the 7047 squawk. 0.12NM and 100ft

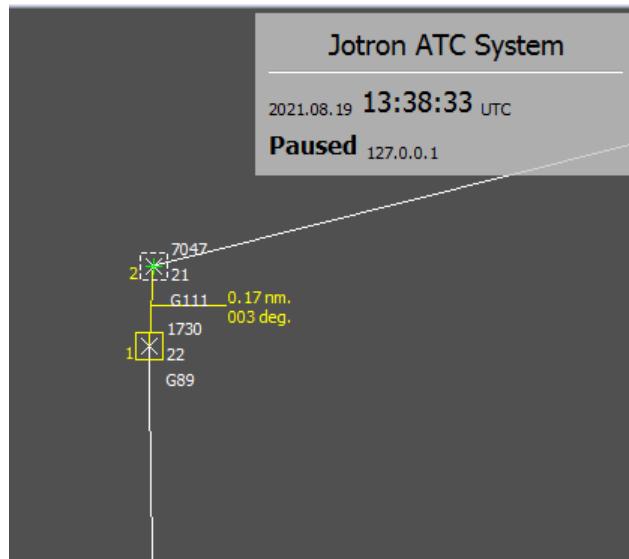
Figure 6 – zoomed to show [C152] has passed to the south of 7047
