AIRPROX REPORT No 2021160

Date: 25 Aug 2021 Time: ~1820Z Position: 5638N 00449W Location: Glencoe mountain resort

PART A: SUMMARY OF INFORMATION REPORTED TO UKAB

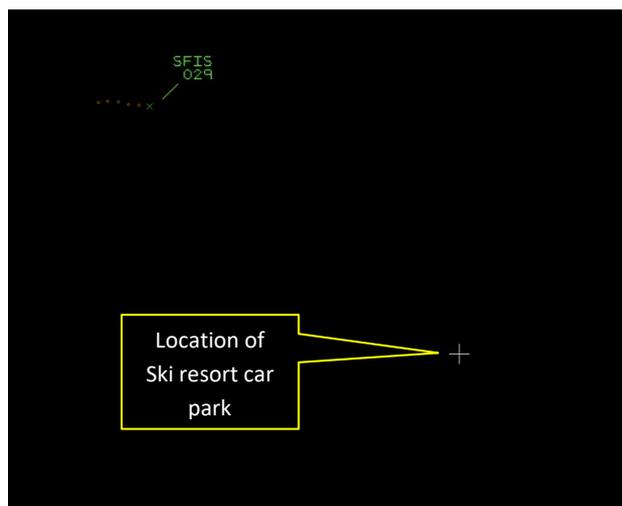
An analysis of the NATS radar replay was undertaken. The C152 was observed on radar until 1816:36 at which point it disappeared (Figure 1). It reappeared at 1822:30 in a position approximately 7.8NM away (Figure 2). The groundspeed of the C152 recorded on the radar was ~83kts meaning the maximum distance it could have flown in that time is 8.3NM, therefore, it is likely that it did not follow a direct routing between these points. The paraglider pilot supplied the UKAB Secretariat with a GPS log file from which their area of operation has been extracted, as shown in the diagram. As the C152 pilot's routing between the recorded radar returns was unlikely to have been direct, this could have allowed them to pass near to, or through, the northern part of the area of operation of the paraglider.

Figure 1. 1816:36 – C152 disappears from radar.

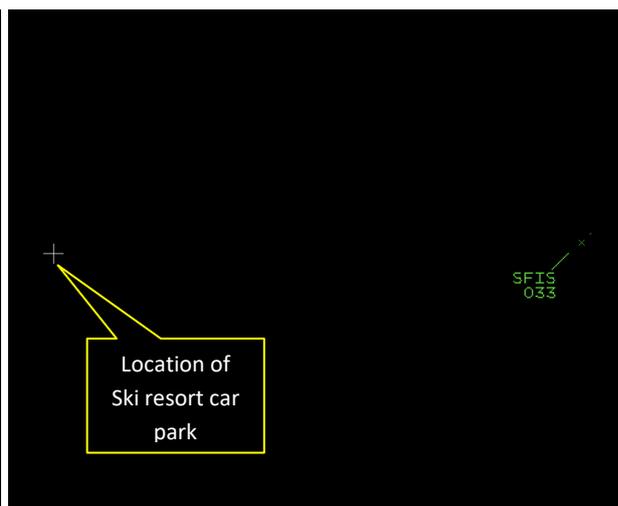
Figure 2. 1822:30 – C152 reappears on radar.

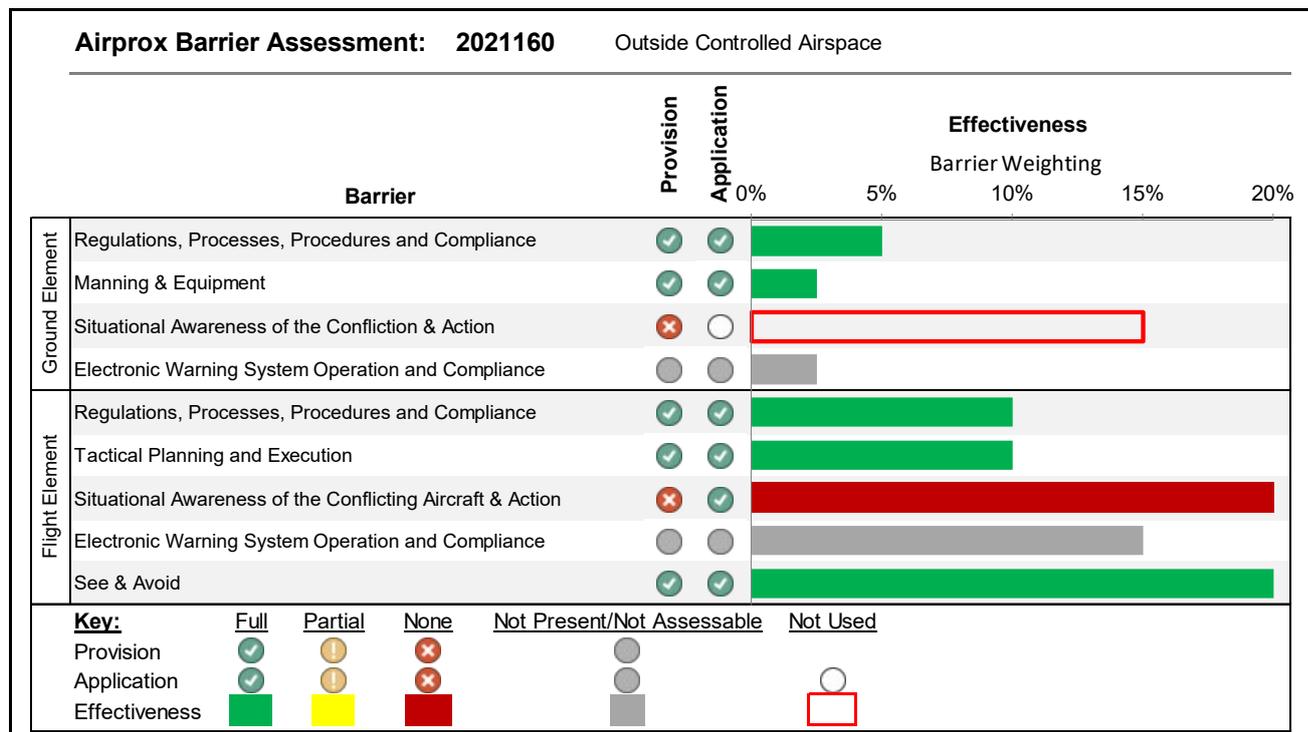
Situational Awareness of the Confliction and Action were assessed as **not used** because under a Basic service, the FISO is not required to monitor the flight

Situational Awareness of the Conflicting Aircraft and Action were assessed as **ineffective** because neither pilot had any knowledge regarding the presence of the other aircraft prior to sighting it.
