## **AIRPROX REPORT No 2021163**

Date: 31 Aug 2021 Time: 1049Z Position: 5044N 00134W Location: Milford on Sea

### **PART A: SUMMARY OF INFORMATION REPORTED TO UKAB**

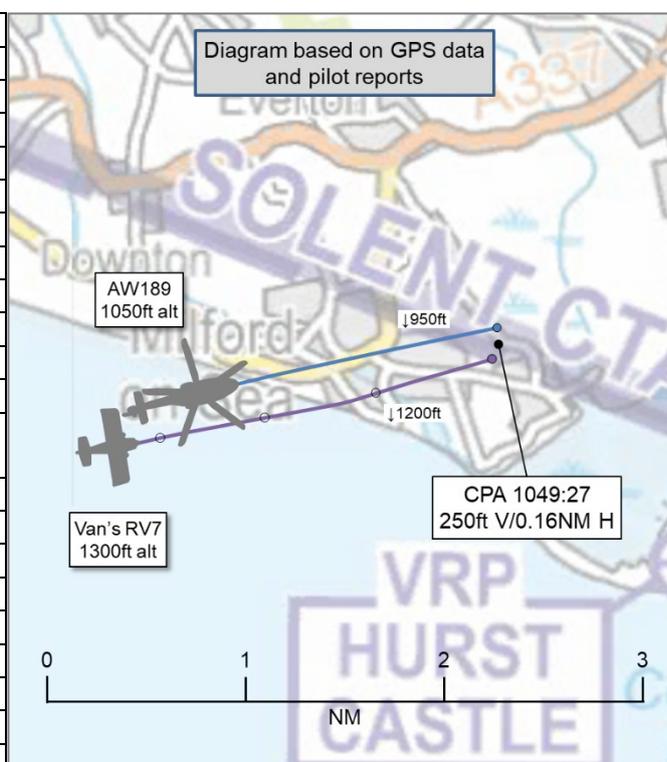
Recorded	Aircraft 1	Aircraft 2
Aircraft	AW189	Van's RV7
Operator	Coast Guard	Civ FW
Airspace	London FIR	London FIR
Class	G	G
Rules	VFR	VFR
Service	AFIS	AFIS
Provider	Lee-on-Solent	Lee-on-Solent
Altitude/FL	950ft	1200ft
Transponder	A, C, S	A, C, S
Reported		
Colours	Red, white, blue	Red, yellow
Lighting	Position, anti-col, landing	Strobe, navigation
Conditions	VMC	VMC
Visibility	>10km	>10km
Altitude/FL	1000ft	1200ft
Altimeter	QNH (1029hPa)	QNH (NK hPa)
Heading	080°	080°
Speed	120kt	130kt
ACAS/TAS	TCAS II	Not fitted
Alert	RA	N/A
Separation at CPA		
Reported	0ft V/200m H	300ft V/>0.5NM H
Recorded	250ft V/0.16NM H <sup>1</sup>

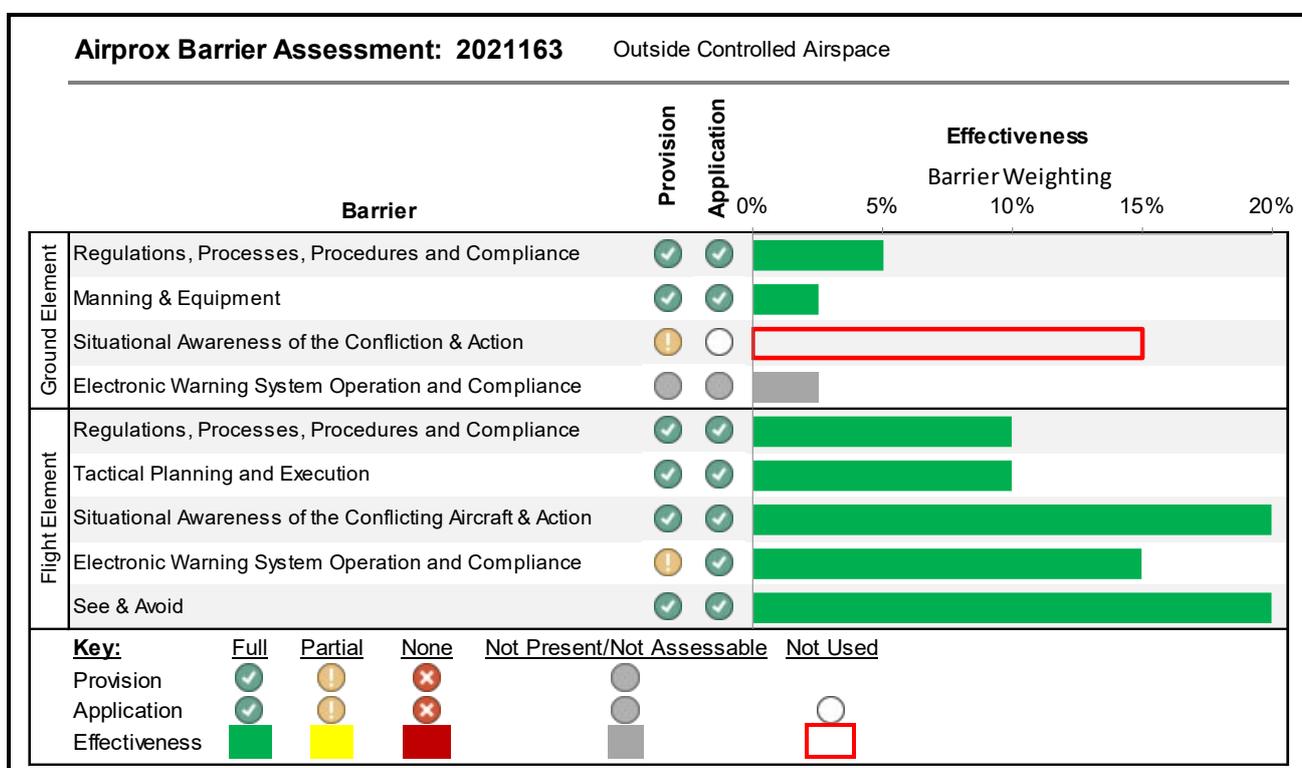
In assessing the effectiveness of the safety barriers associated with this incident, the Board concluded that the key factors had been that:

**Situational Awareness of the Confliction and Action** were assessed as **not used** because the Lee-on-Solent AFISO was not required to monitor either aircraft's flightpath.
