AIRPROX REPORT No 2021165

Date: 31 Aug 2021 Time: 1316Z Position: 5144N 00008E Location: North Weald aerodrome

PART A: SUMMARY OF INFORMATION REPORTED TO UKAB

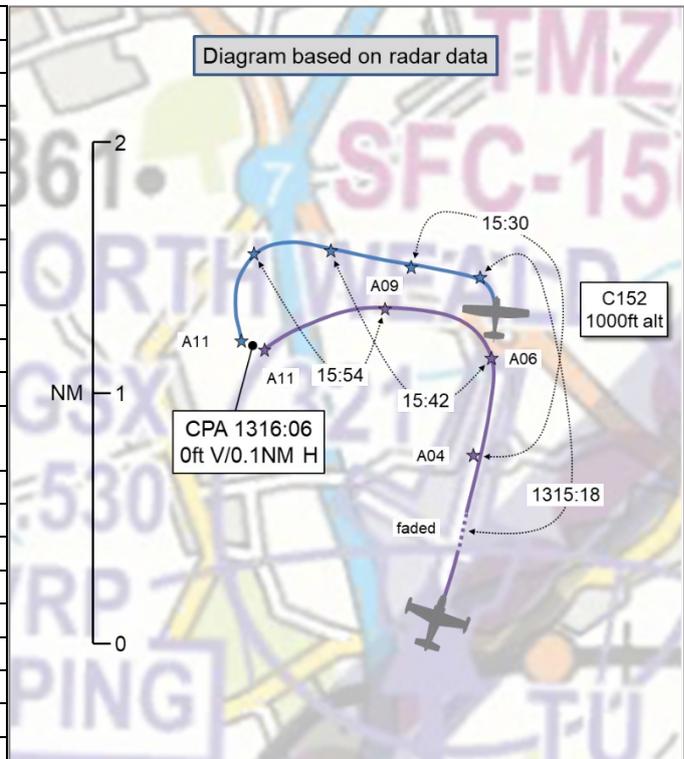
THE C152 INSTRUCTOR reports undertaking an instructional flight in the left-hand circuit for RW02. They had previously demonstrated one circuit to the student, who had not flown in the circuit before. During the final approach of this first circuit they heard the Jet Provost (JP) pilot announce their intention to join from the west [they believed]. They did not copy all of the transmission due to the high workload teaching environment inside the cockpit. After the touch-and-go, the student was given control on the upwind leg. The rest of the upwind and crosswind legs then continued without event. The student turned left to enter the downwind leg and rolled out on a heading of approximately 180° (the downwind leg converges with the runway in order to satisfy noise abatement concerns). Immediately after rolling out from the turn, the instructor looked out of the left side window in order to check for aircraft joining crosswind and saw the JP slightly below and in the 8 o'clock position at a range of about 100-200m. The JP was in a left wing low, nose high attitude, indicative of a climbing left turn. Though time was limited, the instructor assessed that their relative trajectories were on a collision course, took control of the aircraft without delay and initiated a right turn to avoid conflict, during which they lost sight of the JP as they went 'belly up' to it. The instructor was not visual with the JP at the point of estimated minimum separation due to the attitude of the aircraft. Having rolled out of the avoiding turn they saw the JP again, which was now well ahead and to the right on a wider downwind leg than themselves. The instructor did not hear any radio transmissions from the JP pilot after their joining call, although it was entirely probable these were made without being assimilated due to the high workload teaching environment mentioned previously. The instructor was, however, surprised by the short time frame in which the JP pilot had joined the circuit from the west [they believed] and presumably performed a touch-and-go, go-around or run-and-break to enter the circuit. No R/T calls were made at the time of the event, and the rest of the flight continued routinely. The instructor made a phone call to North Weald operations shortly after landing and spoke to the A/G Operator on duty at the time of the incident. They had not seen the event, although they did believe that the JP pilot had flown round them and overtaken on the right hand side rather than in fact overtaking from below and left as they had seen from the air. The instructor did not believe the JP crew made visual contact with the C152 during the event.

THE NORTH WEALD A/G OPERATOR reports that the JP returned to the circuit at 1310 from a local sortie to the east, carried out a run-and-break, and entered the circuit. A police helicopter had just departed and the C152 was in the circuit. The JP pilot was on final at 13:13, after the run-and-break. The C152 pilot was turning downwind, but hadn't called their position. The JP pilot called downwind at 13:15 and the C152 pilot at 13:16. On that circuit, the JP pilot overtook the C152.

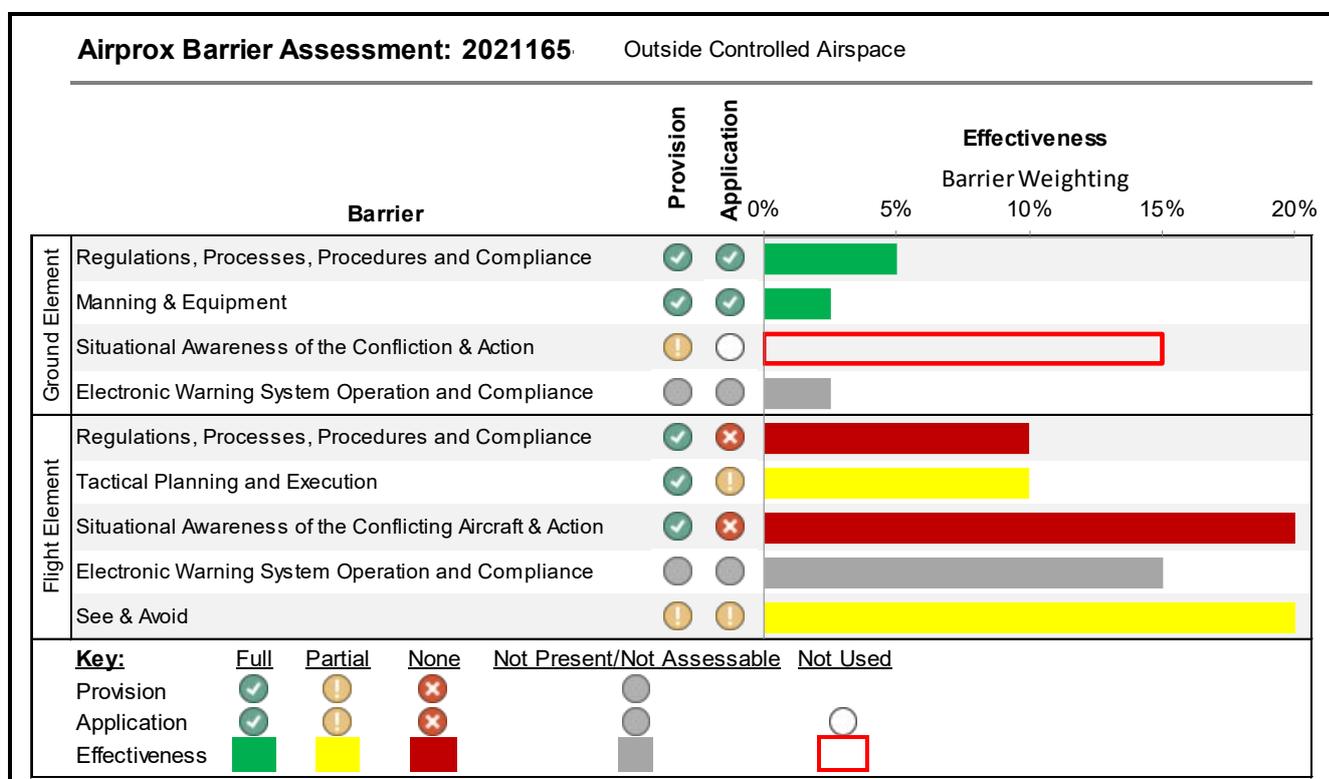
Situational Awareness of the Confliction and Action were assessed as **not used** because the A/G Operator was not required to monitor the traffic in the circuit.

Regulations, Processes, Procedures and Compliance were assessed as **ineffective** because the JP pilot did not integrate with the C152, ahead in the visual circuit.

Tactical Planning and Execution was assessed as **partially effective** because the JP pilot did not clear their flight path before turning into conflict with the C152.

Situational Awareness of the Conflicting Aircraft and Action were assessed as **ineffective** because the JP pilot had no SA on the position of the C152 and hence could not take appropriate action.

See and Avoid were assessed as **partially effective** because the C152 pilot saw the JP but at a late stage and had to take emergency avoiding action.
