## **AIRPROX REPORT No 2021166**

Date: 01 Sep 2021 Time: 1346Z Position: 5146N 00044W Location: Halton

### **PART A: SUMMARY OF INFORMATION REPORTED TO UKAB**

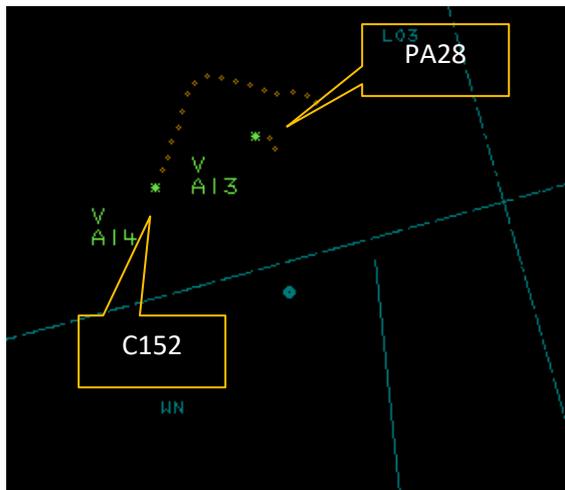
Figure 1:1345:11

Although Halton operates without radar, the Airprox could be seen on the NATS area radar. The PA28 first appeared on radar at 1345, the C152 could be seen already established downwind in the

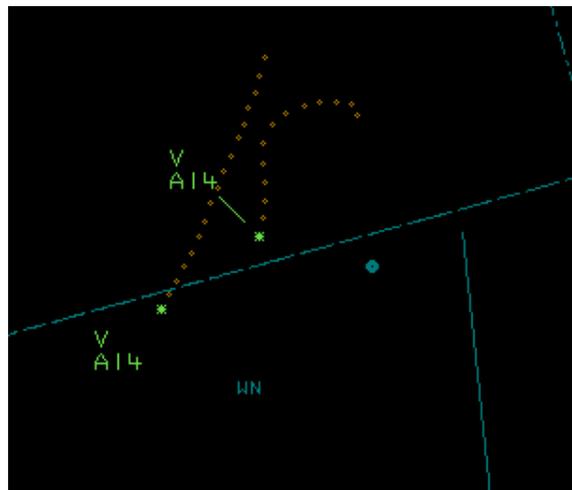
Figure 2:1345:51

visual circuit (Figure 1). By 1345:51, the PA28 had flown a tighter circuit inside the C152 (Figure 2). The PA28 continued with the tighter visual circuit and when the C152 turned onto a standard base-leg the two aircraft converged at the same altitude (Figures 3 and 4). CPA occurred at 1346:31 at <0.1NM and 100ft (Figure 5).

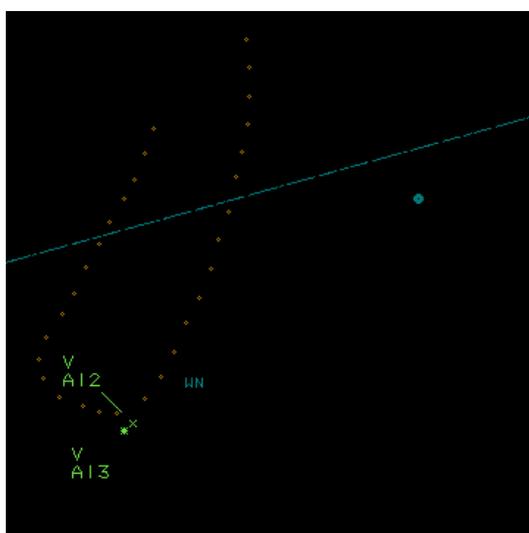
Figure 5: 1346:31 - CPA

When assessing the risk, the Board took into consideration the reports from both pilots and the radar replay. They noted that although the pilots had managed to take some avoiding action, it had been a late sighting by both and came following a call from the AFM on the ground. They therefore agreed that safety had not been assured and there had been a risk of collision (**CF10**); Risk Category B.
