AIRPROX REPORT No 2021173

Date: 05 Sep 2021 Time: 1317Z Position: 5216N 00009E Location: 5NM N Cambridge airfield

PART A: SUMMARY OF INFORMATION REPORTED TO UKAB

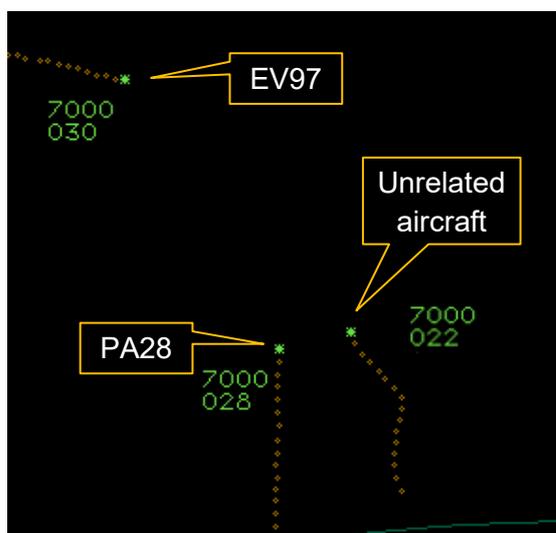
Figure 1 – 1315:30

An analysis of the radar replay was undertaken along with the RT recordings from Cambridge. The PA28 pilot was recorded on the Cambridge frequency at 1310:50 passing information regarding their routing. After this time, from the radar tracks, it can be seen that they continued on a relatively constant heading and maintained their altitude. There was an unrelated aircraft observed on radar at 1315:30 which flew parallel to, and then converged with, the PA28 (Figure 1). The unrelated aircraft then passed below the PA28 shortly after 1316:00 (Figure 2) and cleared to the west.

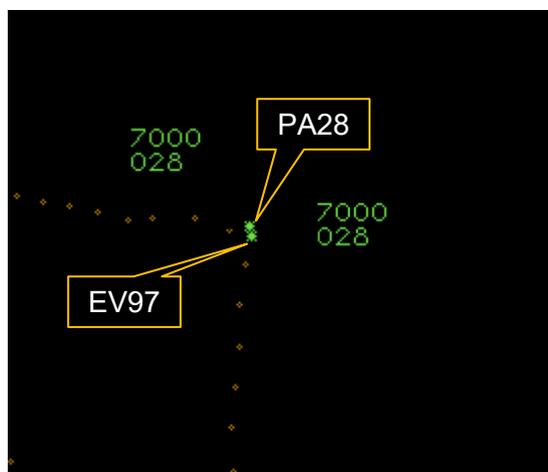
Figure 3 – CPA

The EV97 was observed to also have been maintaining a relatively constant track and altitude up to the point at which CPA occurred, which happened between radar sweeps. The minimum recorded separation occurred approximately 1sec after actual CPA and was at 1316:42 (Figure 3). On the following radar sweep, the left turn made by the pilot of the EV97 was visible, and a descent registered on the Mode C readout, before the pilot then resumed their original heading.
