AIRPROX REPORT No 2021175

Date: 02 Sep 2021 Time: 1035Z Position: 5207N 00001E Location: 7NM SW Cambridge airfield

PART A: SUMMARY OF INFORMATION REPORTED TO UKAB

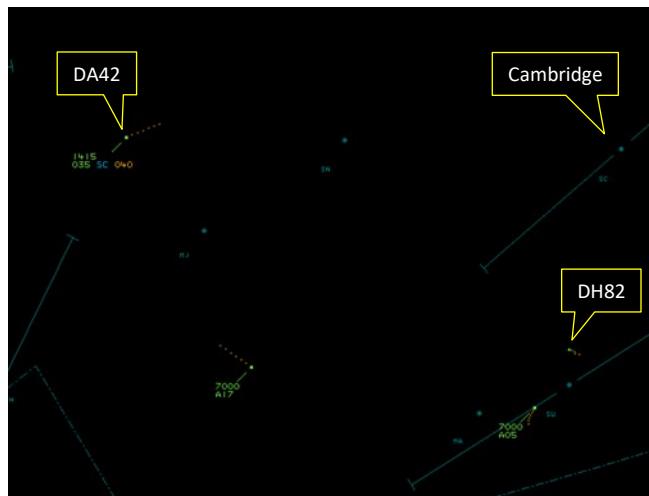
Figure 1 – 1028:30

At **1027:45**, having passed the missed approach instructions to the DA42 pilot, the Cambridge controller then turned them onto a base leg for their approach. At **1028:30** the controller descended the DA42 to 3000ft. On the area radar replay, a primary-only contact believed to be the DH82 had only just appeared (Figure 1).

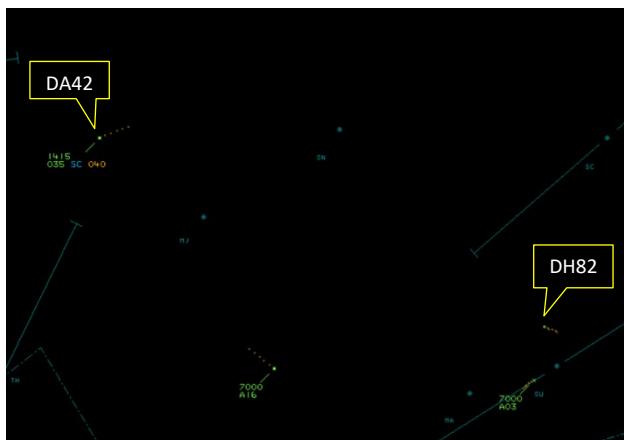
Figure 2 – 1028:50

At **1028:46** a telephone call was made to Duxford by Cambridge advising them that the Cambridge 05 RNP was active with a DA42. At **1028:50** the Duxford FISO was heard to call the pilot of the DH82 three times without receiving a reply, and once again at **1029:46** (Figures 2 and 3).

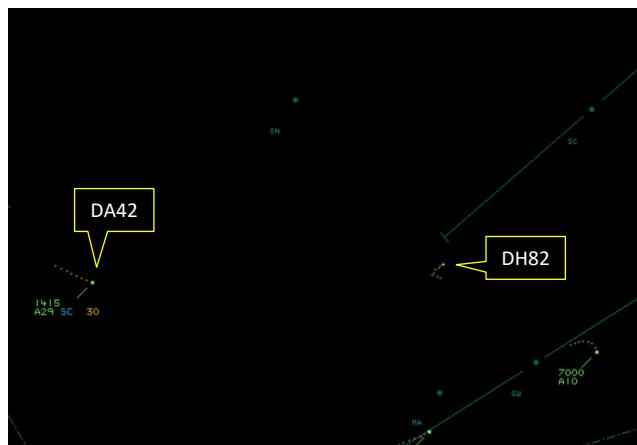
Figure 4 – 1031:20

At **1029:57** the Cambridge controller instructed the DA42 pilot to turn on to a heading of 110°. Then, at **1031:20** the controller gave the DA42 pilot their position as being 2 miles west of BEPOX, (the Initial Approach Fix for the RNP approach to RW05 at Cambridge), and cleared them for the approach requesting a report as they passed BEPOX (Figure 4).

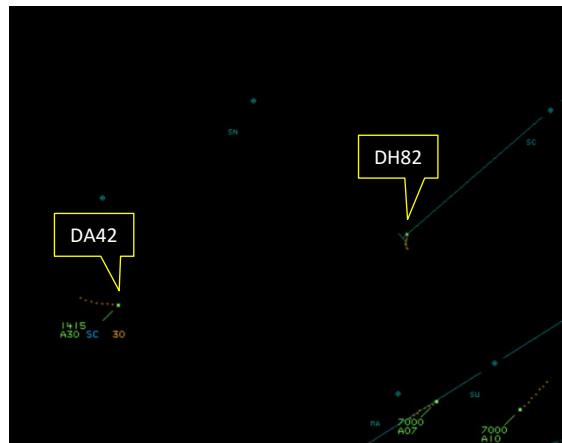
At **1032:10** the contact believed to be the DH82 was seen to pass through the Cambridge RW05 final approach (Figure 5).

Figure 5 – 1032:10 (8NM lateral separation between the aircraft)

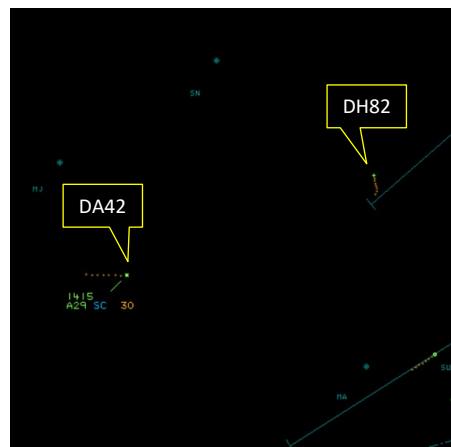
Figure 6 – 1032:48

At **1032:48** the pilot of the DA42 reported passing BEPOX and they were instructed to report established on the final approach track. The DH82 was 7NM to the east-northeast of the DA42 at this time (Figure 6).

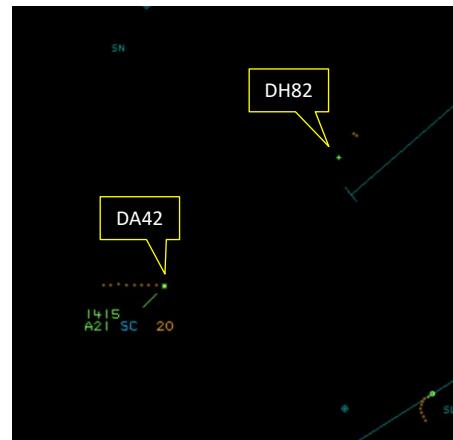
Figure 7 - 1033:58

At **1033:58** the Cambridge controller passed the following Traffic Information to the pilot of the DA42: “*traffic just operating half mile west of a 4 mile final, manoeuvring, no height information. Advise if you get that traffic in site [sic] at any time (unintelligible) wish to break off the approach*”. On the area radar replay, the contact believed to be the DH82 had disappeared 20sec earlier, 5.8NM to the northeast of the DA42, and then reappeared 4.2NM to the northeast (Figure 7).

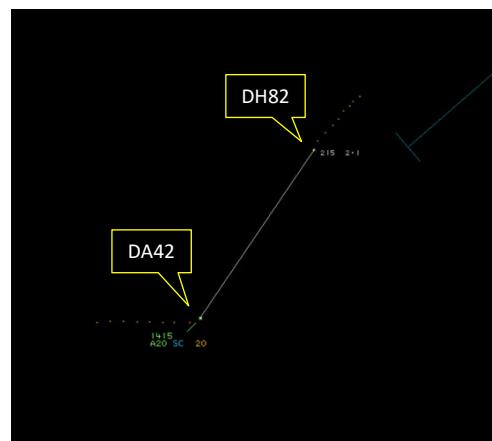
Figure 8 – 1034:42

At 1034:42 the Cambridge controller updated the Traffic Information; “previously mentioned traffic is now in your left 11 o’clock, 2 miles, no height information. Converging, opposite direction. Do you have the traffic in sight?” (Figure 8).

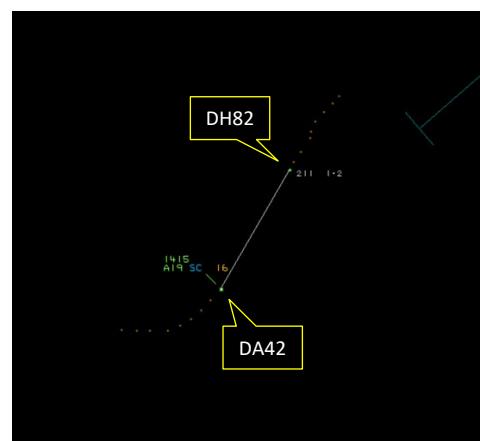
Figure 9 - 1034:58

Then at 1034:58 the controller instructed the DA42 pilot “avoiding action turn right heading 090°, climb to altitude 3000ft” (Figure 9).

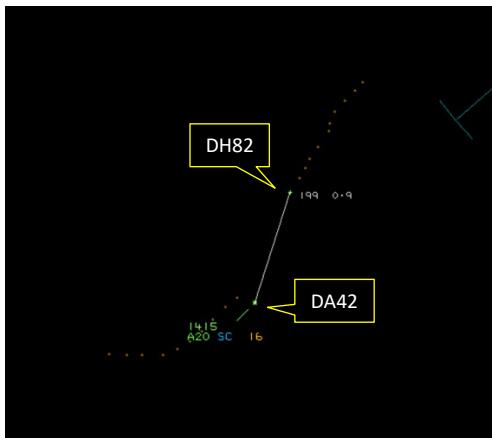
Figure 10 – 1035:06

At **1035:06** the DA42 was seen to be in a turn to the right (Figure 10), and at **1035:09** a new controller, believed to be the OJTI was heard to say; “*avoiding action. Turn right now heading 090°.*” This was coincidental with CPA (Figure 11).

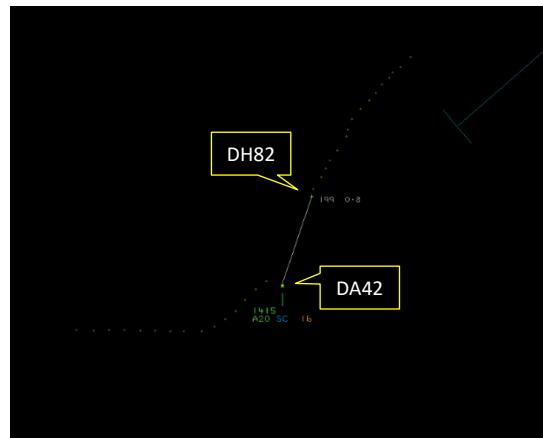
Figure 11 – 1035:09 - CPA
