## AIRPROX REPORT No 2021178

Date: 11 Sep 2021 Time: 0900Z Position: 5329N 00225W Location: Barton ATZ

### PART A: SUMMARY OF INFORMATION REPORTED TO UKAB

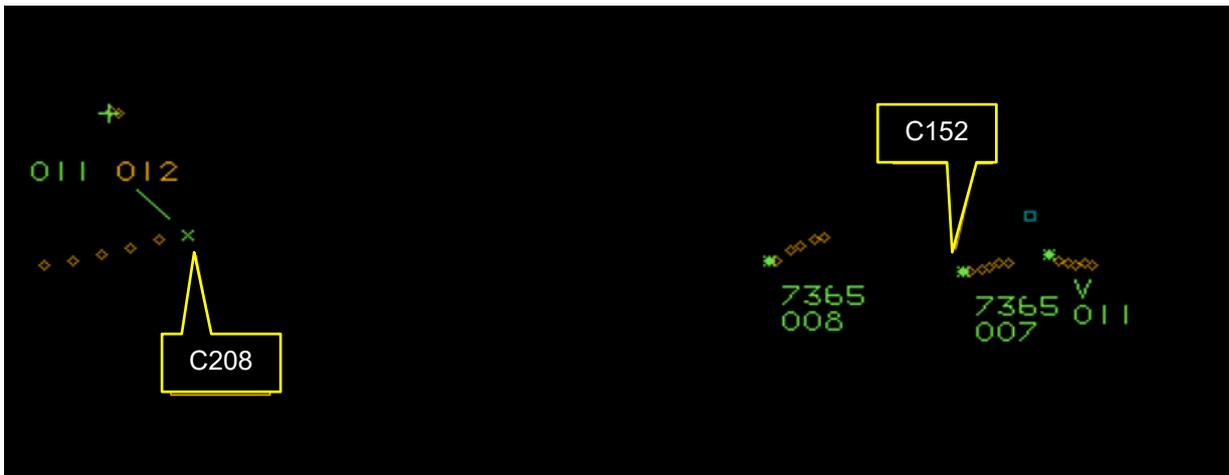
At **0858.30** the C152 pilot reported going around, this was acknowledged by the FISO (Figure 1).

Figure 1 – 08:58.30 (C208 was 3.5NM from the ATZ boundary)

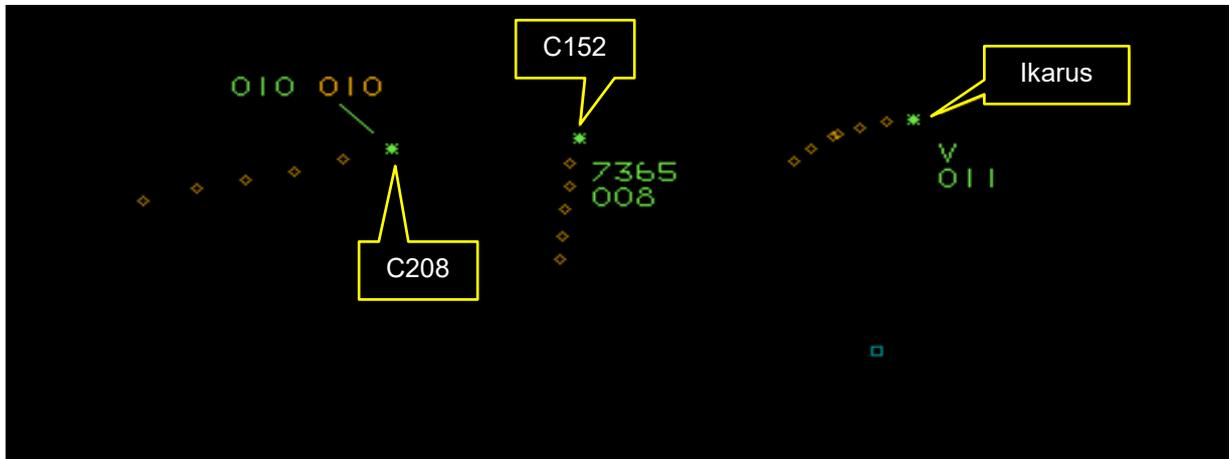
At **0859:58** the C208 pilot was continuing to join downwind with the C152 on the crosswind leg (Figure 2).

Figure 2 – 0859.58 (C208 1.9NM from the Aerodrome and was inside the ATZ)

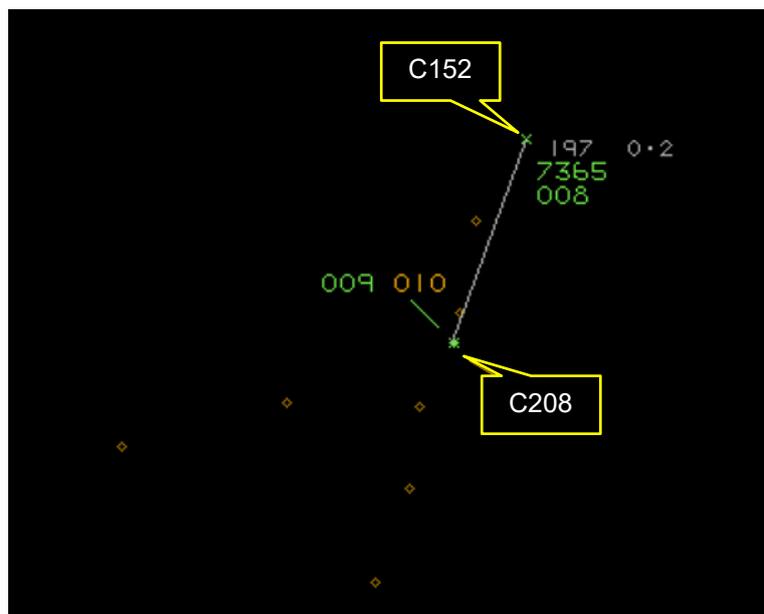
At **0900:12** CPA occurred, with the two aircraft separated by 0.2NM laterally and 100ft vertically (Figure 3).

Figure 3 – CPA (C152 turned downwind 1.5NM from the Aerodrome)
