AIRPROX REPORT No 2021184

Date: 16 Sep 2021 Time: 1729Z Position: 5211N 00107W Location: DTY VOR

PART A: SUMMARY OF INFORMATION REPORTED TO UKAB

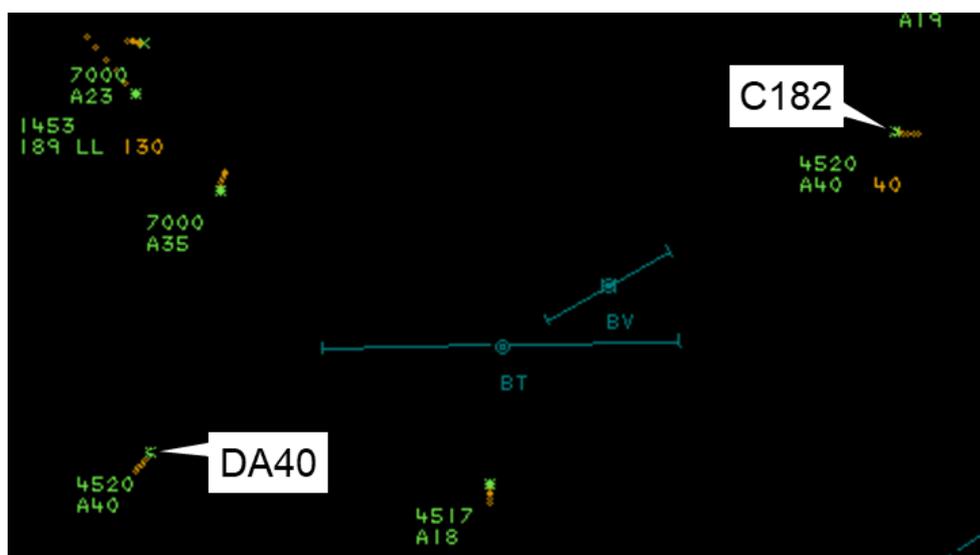
Figure 1 – 17:21.20

At 17:21.20 the C182 pilot called the Oxford Radar controller, with information Kilo, QNH1016 and requested a Traffic Service. The controller advised that it would be a Basic Service only. The pilot responded, "Basic Service roger, we're squawking 4520." The controller reminded the pilot that the airfield would be closing in 9 minutes, for a 30-minute controller break. The pilot acknowledged the reminder.

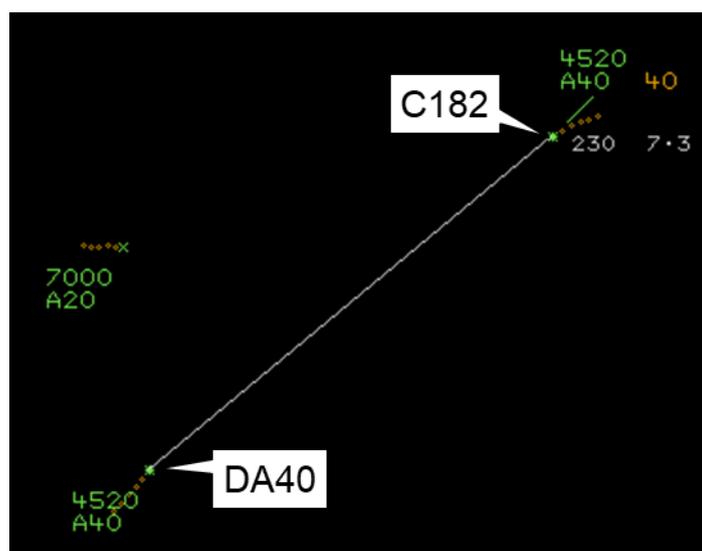
Figure 2 - 17:26.50

Between 17:26.20 - 17:26.50 the pilot of an inbound helicopter made their initial RT call to the controller, and the controller told the pilot to standby. The controller turned their attention to the

departure via DTY and instructed the pilot to call London Control. The pilot of another unrelated aircraft requested a frequency change, and this was approved.

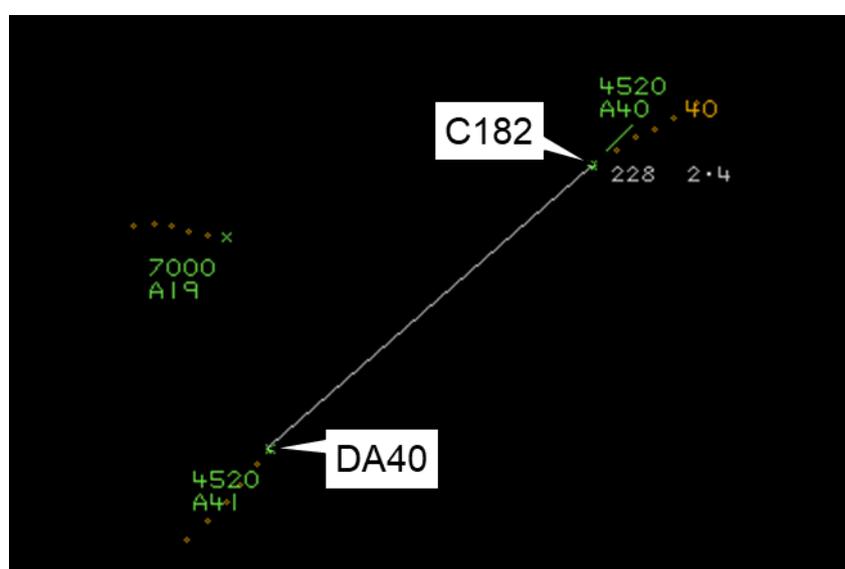
Figure 3 - 17:28.00

Between 17:27.00 - 17:28.00 the controller returned to the pilot of the inbound helicopter and the pilot advised them of their ETA for Oxford. The controller advised the pilot of the imminent closure of the airfield in 3 minutes time, and the pilot advised that they could be at the airfield in 4 minutes. The pilot was instructed to standby. A few seconds later the controller instructed the pilot to squawk 4520, provided the QNH of 1016, and a Basic Service was agreed. The controller asked the pilot for best possible speed inbound, and the pilot agreed.

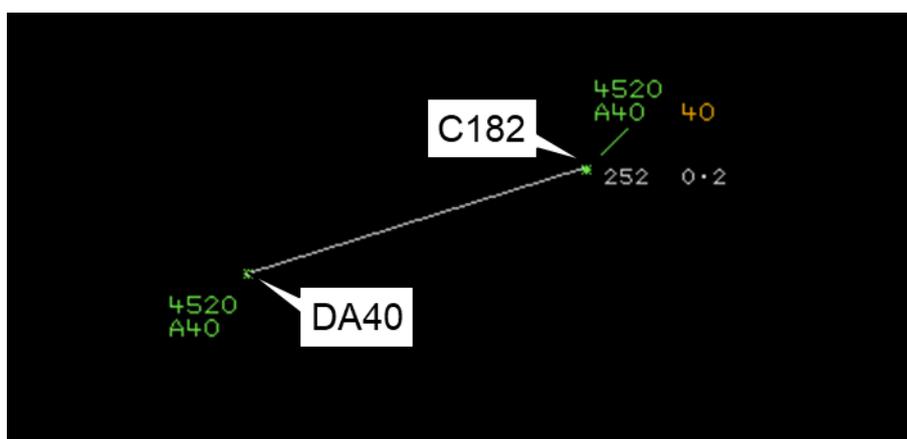
Figure 4 – 17:28.31 CPA

CPA occurred at 17:28.31 with both aircraft indicating altitude 4000ft and 0.2NM between the two aircraft.

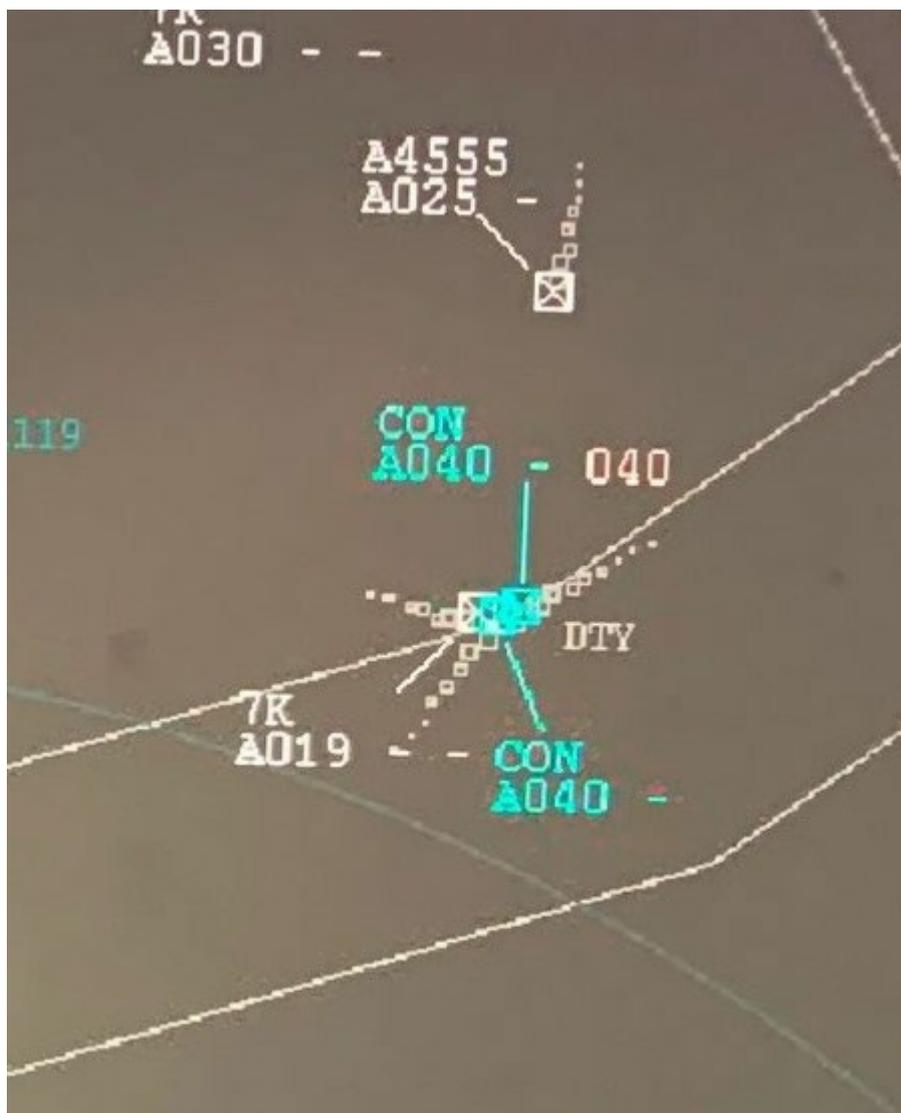
C182 vs DA40 CPA

The two aircraft can be seen from the Radar Replay to continue on converging tracks (seemingly tracking towards the DTY VOR) with both Mode C readouts indicating 4000ft. Just prior to the CPA the following exchange occurred between [C182 C/S] and the Oxford Radar controller:

The CPA occurred at approximately 17:29 over the DTY VOR (See Attachment: C182 vs DA40 CPA).
