AIRPROX REPORT No 2021186

Date: 16 Sep 2021 Time: ~1329Z Position: 5213N 00002W Location: 0.5NM N Bourn airfield

PART A: SUMMARY OF INFORMATION REPORTED TO UKAB

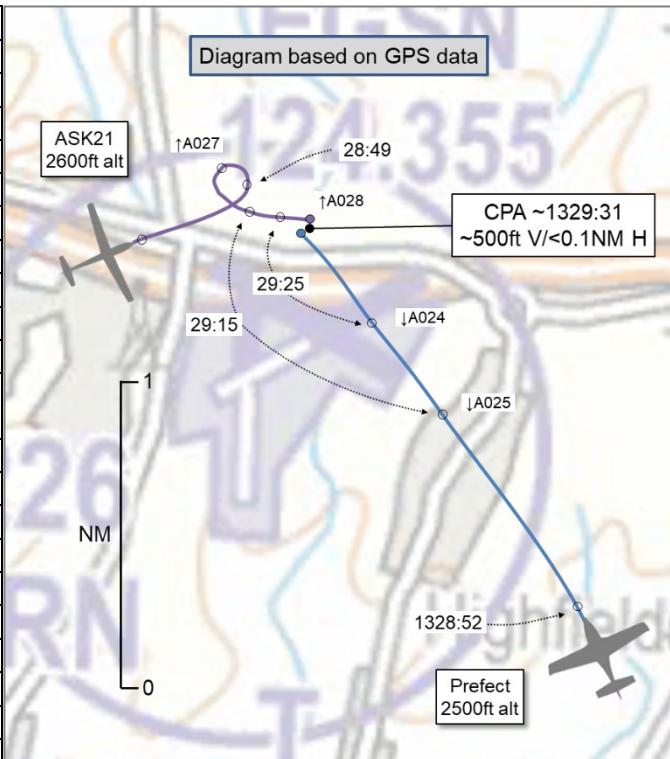
GPS logs were used by the UKAB Secretariat to construct both the diagram and determine the CPA. The time stamps from the GPS logs at CPA do not exactly align and so some interpolation of aircraft tracks and altitudes between data points was used to determine the time and separation.
