## **AIRPROX REPORT No 2021187**

Date: 17 Sep 2021 Time: 1235Z Position: 5715N 00214W Location: 2.5NM N Aberdeen

### **PART A: SUMMARY OF INFORMATION REPORTED TO UKAB**

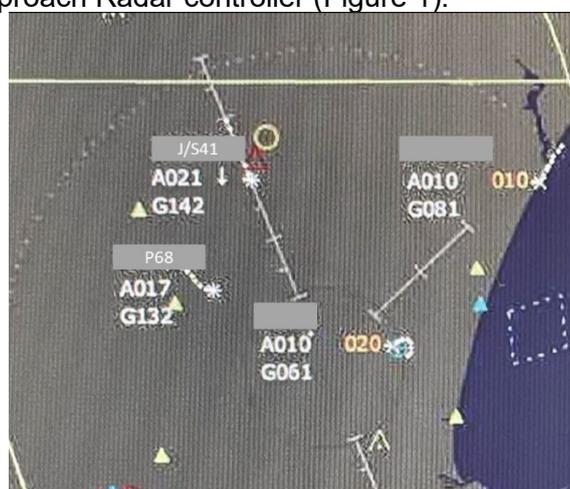
Figure 1

At **1234:09** the pilot of [P68 C/S] reported becoming visual with the traffic but the ADC was engaged in a phone call with the Approach Radar controller (Figure 1).

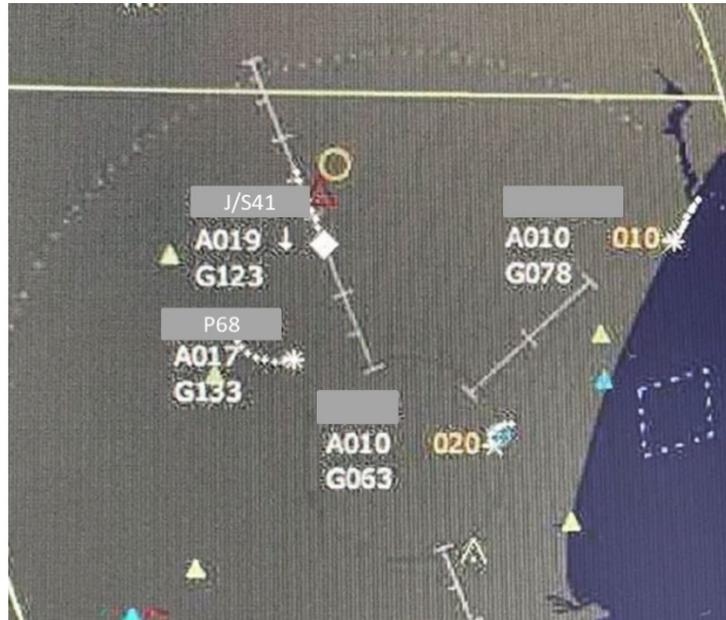
Figure 2

1234:27 ADC: “[P68 C/S] *did you say you were visual?*”  
 [P68 C/S]: “*Affirm, visual with the traffic.*”  
 ADC: “*Position number 2, Runway 16.*”

This was correctly read back by the pilot (Figure 2).

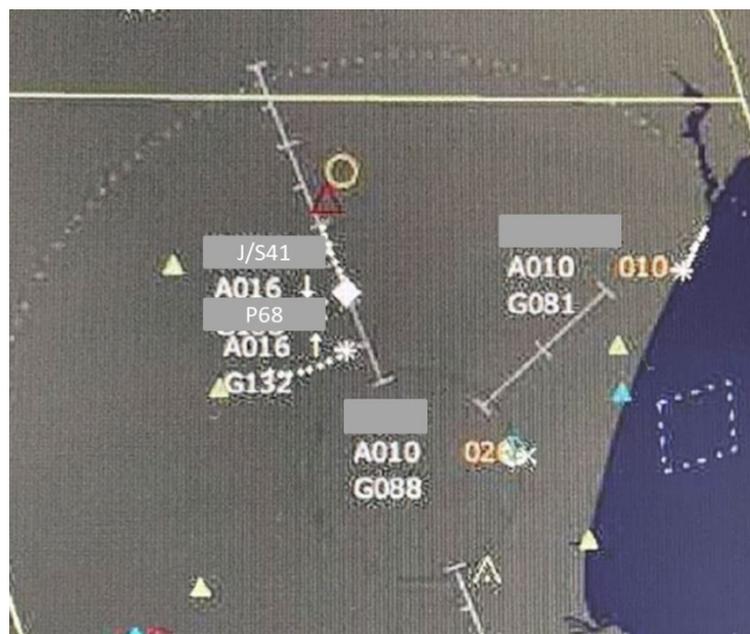
Figure 3

At 1234:30 [P68 C/S] was 0.5NM west of the final approach track, abeam 3NM final approach position. [J/S41 C/S] was approximately 5NM from touchdown. [P68 C/S] commenced a slight left turn to the northeast, appearing to position behind [J/S41 C/S].

The separation between the two aircraft was 1.4NM/0ft with [J/S41 C/S] tracking 160° with groundspeed of 106kts and [P68 C/S] tracking 060° and groundspeed of 132kt (Figure 3).

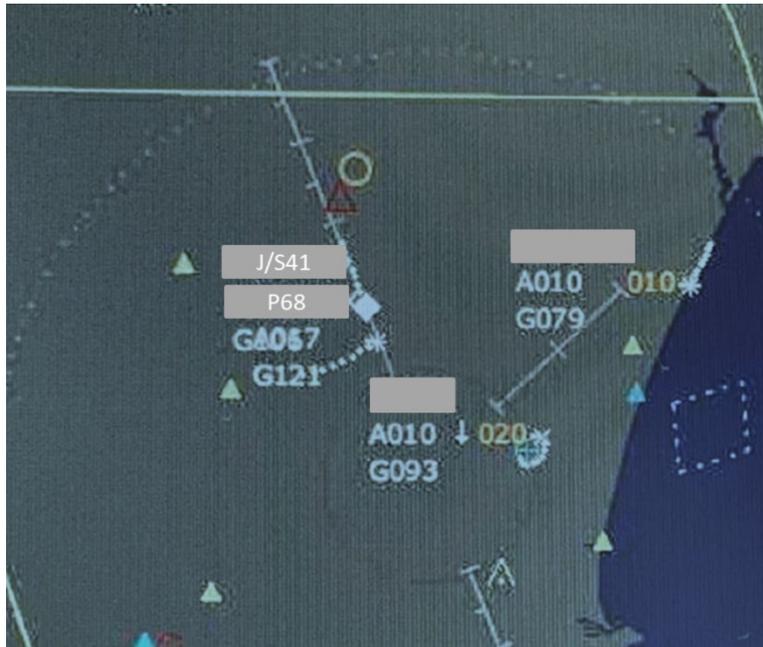
Figure 4

[J/S41 C/S] was at 1500ft tracking 160° at 110kts while [P68 C/S] was at 1700ft tracking 060° at 126kts. Separation was now 0.87NM/200ft with [P68 C/S] flying through the final approach track in front of [J/S41 C/S] (Figure 4).

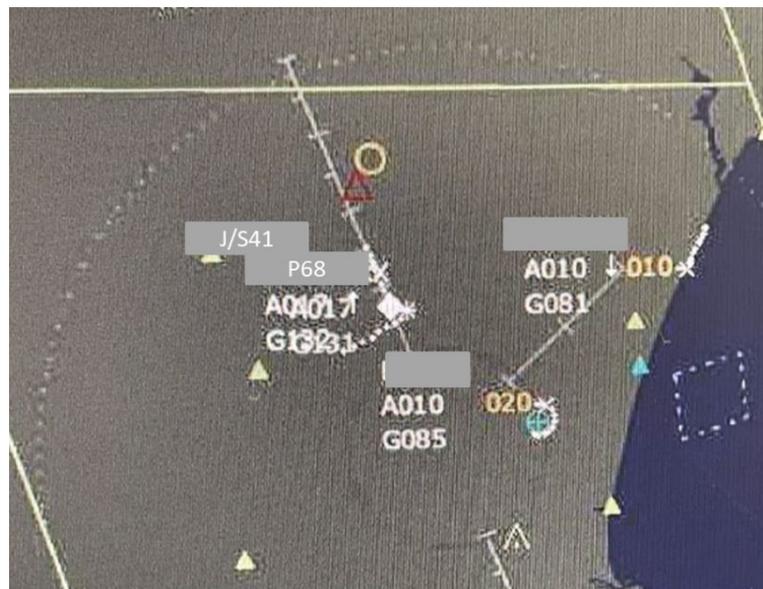
Figure 5

ADC: "[P68 C/S] I thought you said you were visual with the Jetstream positioning behind?"

[P68 C/S]: "Affirm, visual, just positioning behind now."

ADC: "They are going around now, you are not meant to fly over someone when they are on final approach."
