AIRPROX REPORT No 2021188

Date: 16 Sep 2021 Time: 1326Z Position: 5110N 00105W Location: 1.5NM W Lasham airfield

PART A: SUMMARY OF INFORMATION REPORTED TO UKAB

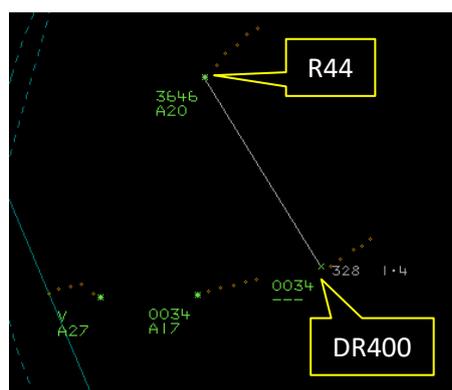
Figure 1 - R44 proximity to the DR400 prior to the Airprox.

Forty seconds prior to the start of the radar replay, Traffic Information was passed to the R44 pilot regarding two conflicting tracks. It is unknown what the second track was squawking at the time as the first was highlighted and believed to be a glider and a tug. Separation was 1.4NM, height was unknown. The R44 pilot reported visual with both reported tracks.

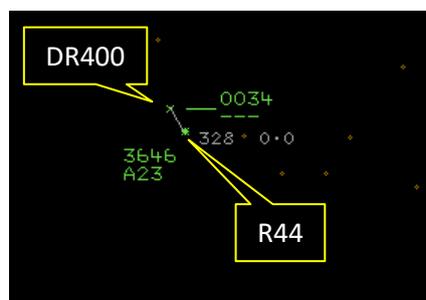
Figure 2: - CPA

The horizontal CPA was measured at 0NM, height was unknown.
