## **AIRPROX REPORT No 2021189**

Date: 17 Sep 2021 Time: ~1037Z Position: 5114N 00136W Location: Thruxton airfield visual circuit

### **PART A: SUMMARY OF INFORMATION REPORTED TO UKAB**

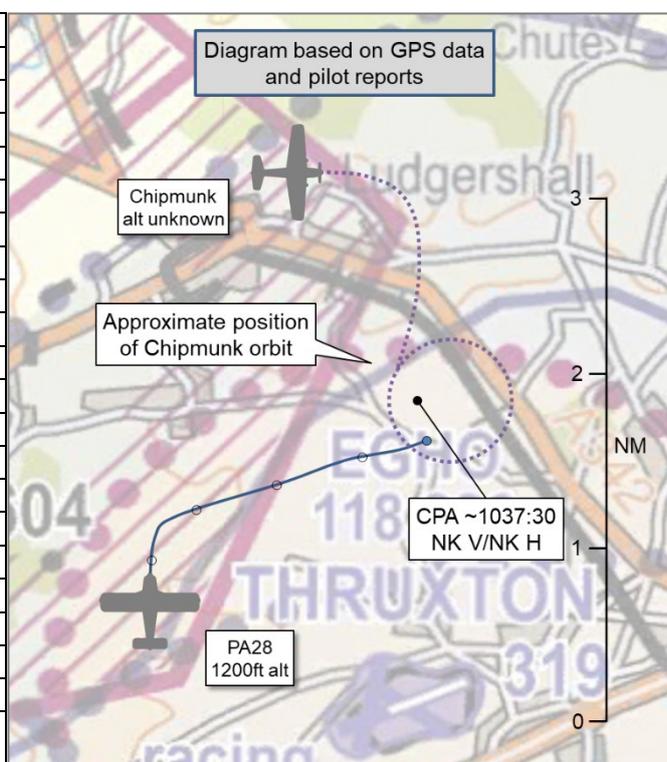
**THE PA28 PILOT** reports that they departed RW25RH circuit to level off at 1200ft QNH for a downwind departure due to the active MATZ above. [The Chipmunk pilot] radioed for a base-leg join (non-standard for Thruxton) and was initially on a constant bearing approaching from their left from 0.5NM distance. The Chipmunk passed about 0.25NM in front of them, from left-to-right and approximately 50-100ft above. [The Chipmunk pilot] radioed that they spotted another joining aircraft and said they would do a "left orbit on base". At this point, [the Chipmunk] was in their 1 o'clock, turning left onto the same heading as them. The PA28 pilot radioed a warning "to the orbiting aircraft on base left, stop the orbit or you risk a collision" hoping [the Chipmunk pilot] would cease the turn and fly in the same direction as them. [The Chipmunk pilot] ignored the warning and continued to turn left towards them and passed down their left wing, 50ft above and 300ft to their 9 o'clock. At this point, [the Chipmunk] was flying the reciprocal downwind heading. [The Chipmunk pilot] then radioed to say they had seen [the PA28] and carried on turning onto base, behind and to their left, and landed shortly after. The PA28 pilot's options were limited as they couldn't tell if [the Chipmunk] would pass to their left-hand side or if [the Chipmunk pilot] would fly a tighter turn resulting in a head on crash. If the PA28 pilot turned right, they would have overflown a noise abatement area (Appleshaw village<sup>1</sup>) and lost sight of the other aircraft and then been on similar base leg heading in close proximity to the other aircraft. [The Chipmunk pilot] was orbiting on the corner of downwind and base leg.

An analysis of the NATS radar replay was undertaken; the PA28 was not detected by the NATS radars at any point in the lead-up to or during the Airprox, and the Chipmunk was only detected intermittently as a primary radar track, and was also undetected for the duration of the Airprox event. Consequently, no radar data pertinent to the Airprox was available. However, the PA28 pilot was able to supply a log file containing positional and altitude information which was used to construct the diagram; unfortunately, no such data was available for the Chipmunk.
