AIRPROX REPORT No 2021192

Date: 21 Sep 2021 Time: 1233Z Position: 5159N 00035W Location: 5.5NM S Cranfield airport

PART A: SUMMARY OF INFORMATION REPORTED TO UKAB

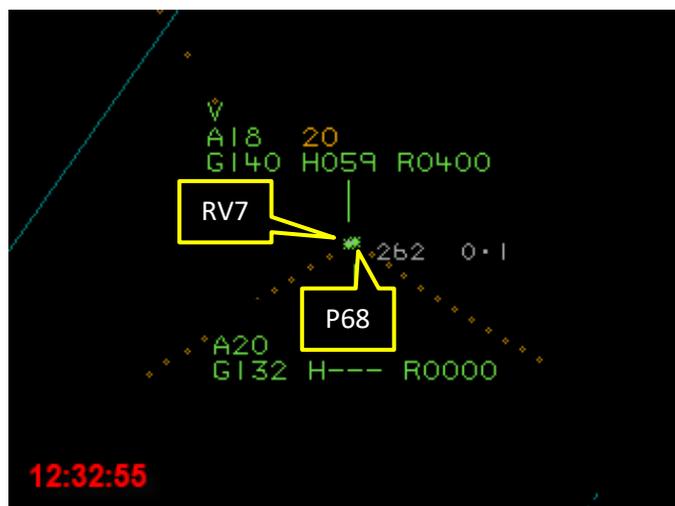
Figure 1

The closest point of approach between [the RV7] (indicated as V on radar) and [the P68] occurred at **1232:55**, measured on the Multi-Track Radar Display as 0.1NM and 200ft (Figure 1).

The Closest Point of Approach occurred at **1232:55** and was recorded on Multi-Track Radar as 0.1NM and 200ft.
