AIRPROX REPORT No 2021197

Date: 26 Sep 2021 Time: 1313Z Position: 5155N 00050W Location: 1.5NM WSW Pocklington

PART A: SUMMARY OF INFORMATION REPORTED TO UKAB

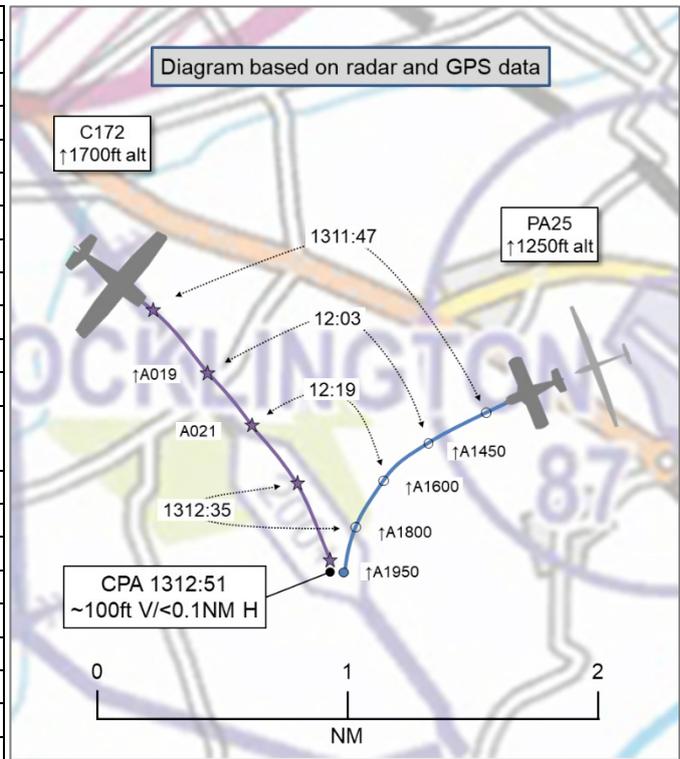
An analysis of the NATS radar replay was undertaken on which the routing and the altitude of the C172 only could be seen, the PA25 was not detected by the NATS radars; however, the pilot was able to supply a GPS log file which has been used and combined with the radar data to produce the diagram above and determine the CPA. It should be noted that the aircraft positions have been determined using different data sources and, whilst there is a high degree of confidence regarding the lateral positions, more interpretation was required in the vertical plane. This is reflected in the vertical separation being recorded as an approximation.
