AIRPROX REPORT No 2021201

Date: 29 Sep 2021 Time: 1208Z Position: 5028N 00020W Location: 3NM W Conington

PART A: SUMMARY OF INFORMATION REPORTED TO UKAB

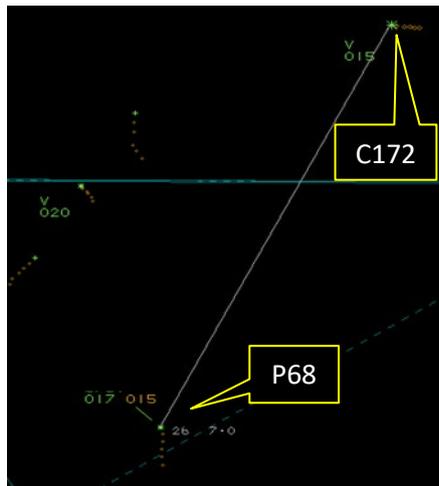
Figure 1- Unrelated Traffic Information passed.

The P68 was passed Traffic Information regarding other conflicting tracks. Separation was 7NM and 200ft.

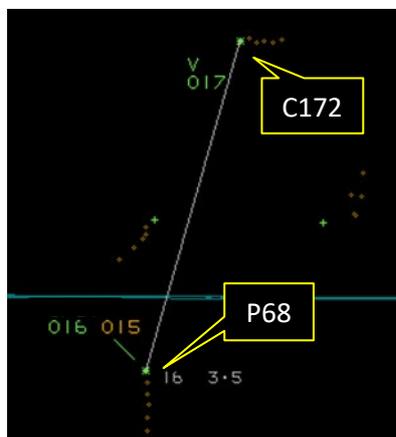
Figure 2 - Further Traffic Information provided to the P68 pilot.

The Wittering Controller provided further Traffic Information 1min 41sec later regarding further unrelated traffic. The P68 pilot reported not visual with this traffic. Separation was 3.5NM and 100ft.

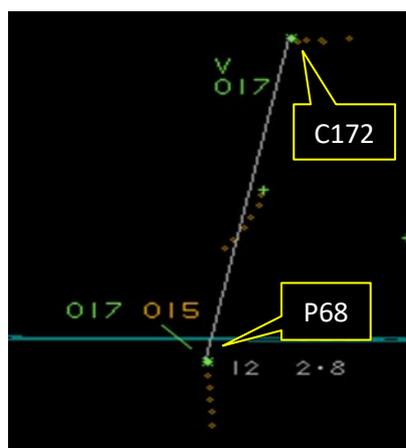
Figure 3 - Further Traffic Information provided to the P68 pilot.

Further Traffic Information was passed regarding another unrelated track which was acknowledged by the P68 pilot. Separation reduced to 2.8NM and 0ft.

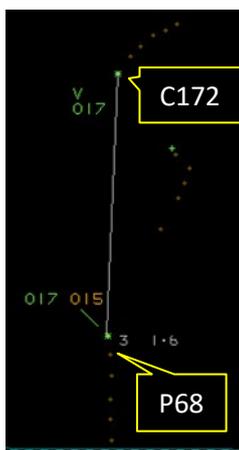
Figure 4 – Traffic Information passed which included C172.

Traffic Information regarding the C172 and two other conflicting tracks was passed 26sec after the last set of Traffic Information. Separation decreased to 1.6NM and 0ft. Fifteen seconds after the Traffic Information was passed the P68 pilot reported that they had the traffic.

Turning to the actions of the Wittering Radar controller, it was noted by the Board that they had been busy in the time prior to the Airprox and, although they had passed Traffic Information to the P68 pilot on a number of occasions regarding other aircraft, specific Traffic Information regarding the C172 had been first passed when the distance between the two aircraft had reduced to 1.6NM, which would have been later than preferred (**CF1**).

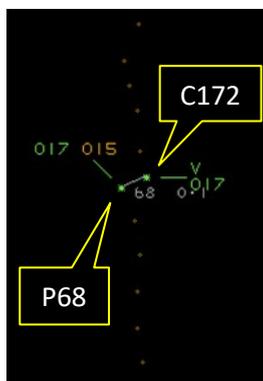
Figure 5 - CPA.

The CPA was measured at 0.1NM and 0ft.
