AIRPROX REPORT No 2021202

Date: 04 Oct 2021 Time: 1047Z Position: 5316N 00421W Location: Mona visual circuit

PART A: SUMMARY OF INFORMATION REPORTED TO UKAB

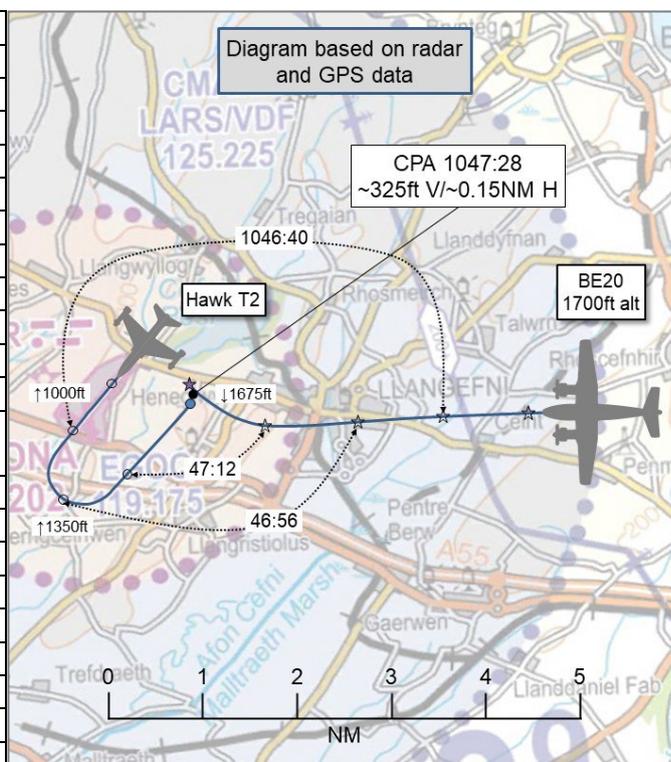
GPS logs were used by the UKAB Secretariat to both construct the diagram and determine the CPA. The time stamps from the GPS logs at CPA do not exactly align and so some interpolation of aircraft tracks and altitudes between data points was used to determine the time and separation.

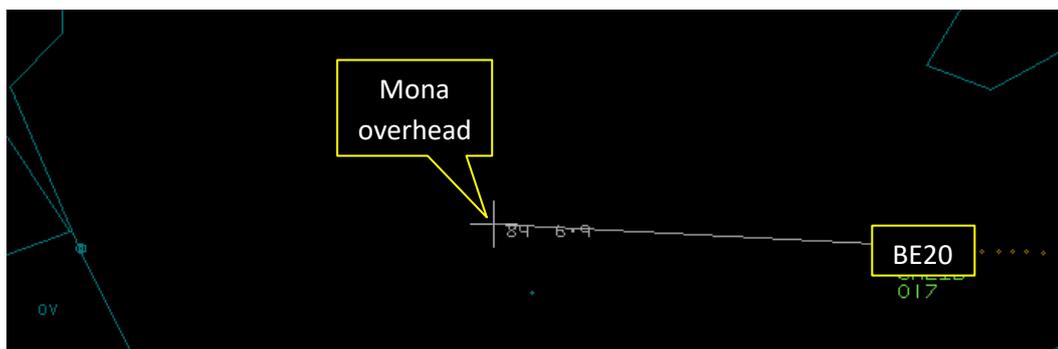
Figure 1 – BE20 informed that there was a Hawk in the Mona circuit.

The Valley Director controller informed the BE20 pilot that there was a single Hawk in the Mona circuit 53 seconds after the last set of Traffic Information was passed regarding other conflicting traffic in the Menai Strait. Separation from the Mona overhead was 6.9NM (Figure 1).

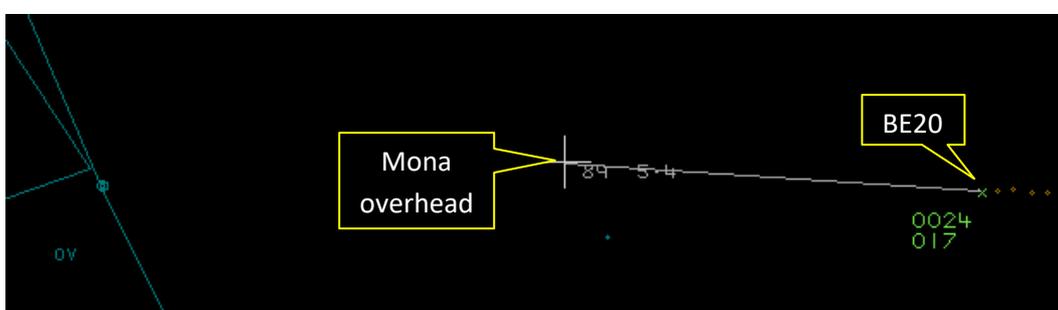
Figure 2 – The Valley Director controller confirmed the intended turn out.

One minute and 21sec later the BE20 pilot queried whether they would need a left- or a right-hand turn out, during which the controller passed another control instruction to the other Hawk. The Valley Director controller confirmed they require a right-hand turn. Immediately following this, the Valley Director controller passed Traffic Information to the Mona ADC. Separation decreased to 5.4NM from the Mona overhead (Figure 2).

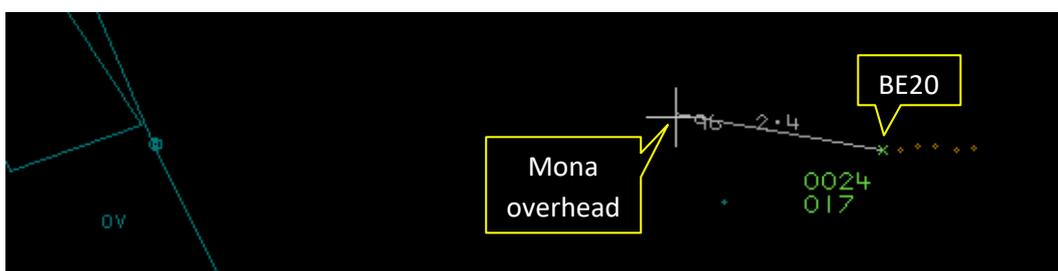
Figure 3 – MATZ crosser information passed to the Hawk pilot.

The Mona ADC informed the Hawk pilot of the MATZ crosser, stating that there was “*one aircraft transiting from east-to-west, at height 1500ft, calibrator aircraft inbound to Valley*”. Five seconds after the Mona ADC began to pass Traffic Information to the Hawk pilot, the Valley Director controller provided the BE20 pilot with updated Traffic Information, stating “*traffic west, 2 miles, tracking east, indicating 300 feet below, Hawk, in Mona circuit*”. This was acknowledged by the BE20 pilot and they confirmed they were in the right-hand turn outbound. The Hawk pilot questioned the height of the BE20 which was confirmed as 1500ft, this was corrected by the Hawk pilot who stated that the BE20 was at 1000ft. Separation decreased to 2.4NM from the Mona overhead when the initial Traffic Information was passed to the Hawk pilot (Figure 3).

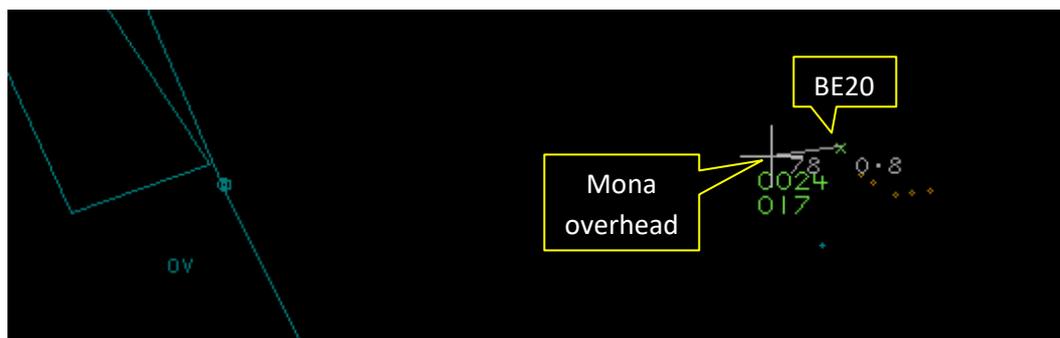
Figure 4 – CPA to Mona overhead.

As the Hawk did not appear on the radar replay, a CPA could not be determined; however, the minimum separation from the Mona overhead was measured as 0.8NM. This distance from RAF Valley was 6.5NM (Figure 4).
