AIRPROX REPORT No 2021208

Date: 10 Oct 2021 Time: 0842Z Position: 5249N 00144W Location: Tatenhill

PART A: SUMMARY OF INFORMATION REPORTED TO UKAB

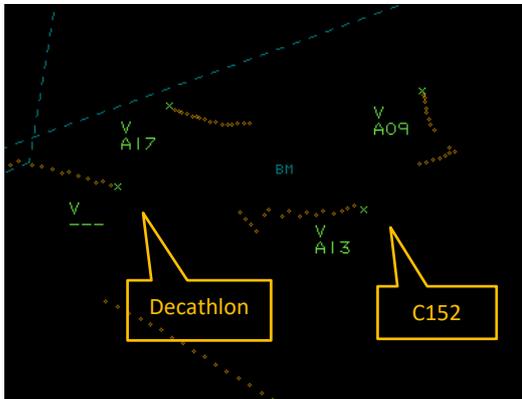
Figure 1 - 0839:19

Tatenhill does not record its RT and so a transcript was not available. Blithfield reservoir is situated 5NM west of Tatenhill; analysis of the NATS radars showed the Decathlon operating in the vicinity of the reservoir at 0838, squawking 7000 but with no Mode C. By 0839 the Decathlon had set course for returning to Tatenhill, the C152 was downwind at this point, with other circuit traffic ahead (Figure 1). By 0840:59 (Figure 2) the Decathlon was established downwind, although on a tighter circuit than the one flown by other circuit traffic and the C152 had turned onto a base leg.

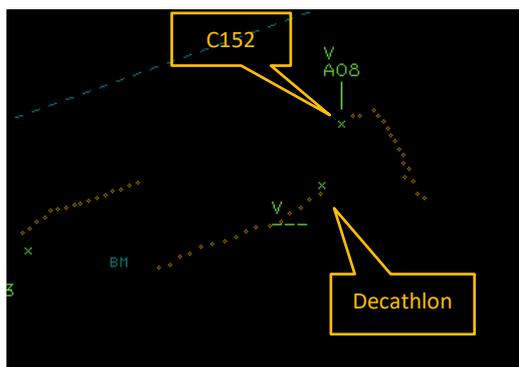
Figure 3 - 0842:00

At 0842:00 (Figure 3) the C152 was established on final and begun their descent, the Decathlon was late downwind. The radar was then subjected to some jitter and the Decathlon did not display on the radar until at 0842:15 (Figure 4) when it reappeared 0.1NM away from the C152, which was indicating 700ft.

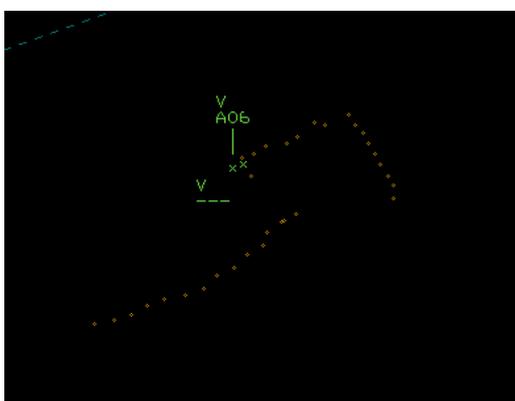
Figure 5 - 0842:19

The C152 crossed ahead of the Decathlon and both aircraft continued on finals in close proximity, although the radar returns again suffered from jitter (Figure 6) and the SSR labels appeared to switch positions, until the C152 could be seen going around (Figure 7).

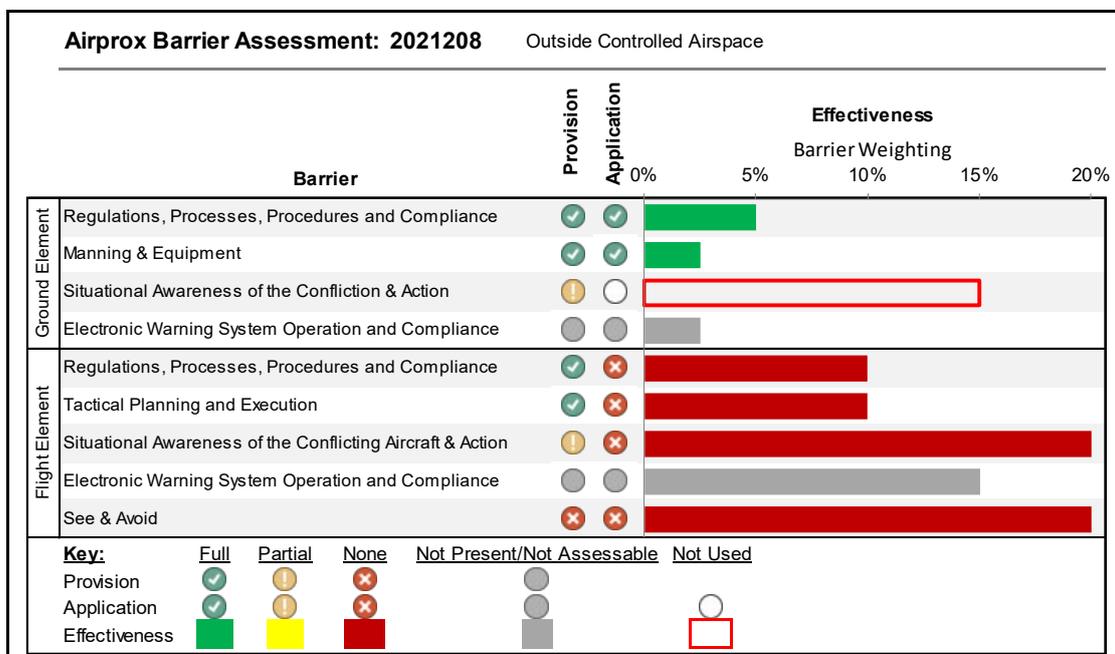
In assessing the effectiveness of the safety barriers associated with this incident, the Board concluded that the key factors had been that:

Situational Awareness of the Confliction and Action were assessed as **not used** because the AGO was not required to sequence the aircraft.

Regulations, Processes, Procedures and Compliance were assessed as **ineffective** because the Decathlon pilot was required to integrate with the C152 established in the circuit.

Tactical Planning and Execution was assessed as **partially effective** because the Decathlon pilot did not conform with the pattern of traffic formed by the C152.

Situational Awareness of the Conflicting Aircraft and Action were assessed as **ineffective** because neither pilot had any prior situational awareness that the other was in the immediate vicinity.

See and Avoid were assessed as **ineffective** because neither pilot saw the other aircraft until after the Airprox.
