## AIRPROX REPORT No 2021212

Date: 12 Oct 2021 Time: 1405Z Position: 5105N 00247W Location: 8NM NW Yeovilton

### PART A: SUMMARY OF INFORMATION REPORTED TO UKAB

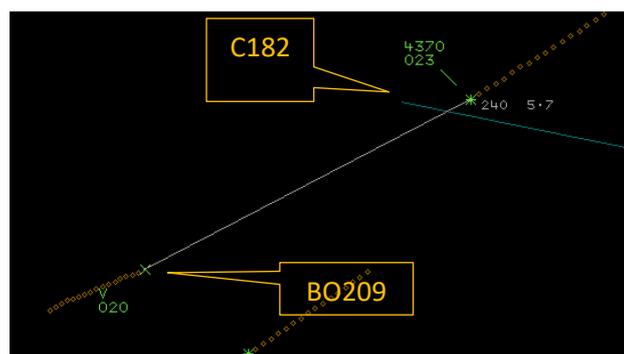
Figure 1 - 1403:28

An analysis of the NATS radars was undertaken, which was not utilised by the Yeovilton controller and therefore not necessarily what could be seen by the Yeovilton controller. The NATS radar showed the C182 displaying 4370 and indicating FL023. The BO209 was squawking 7000 and indicating FL020, the two aircraft were 5.7NM apart (Figure 1).

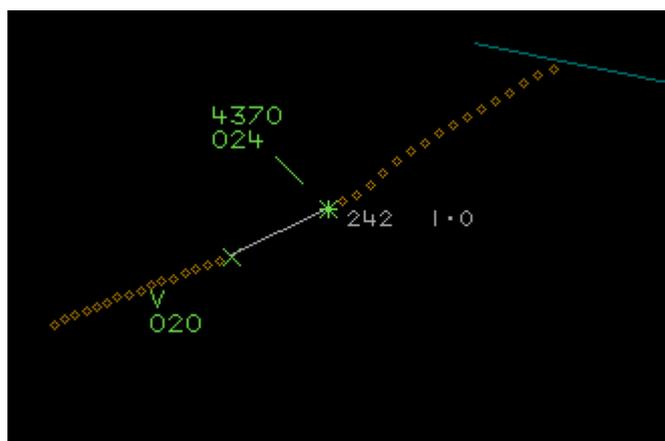
Figure 2 – 1404:43

By 1404:43 the two aircraft had closed to 1NM and were indicating 400ft vertical separation, Figure 2.

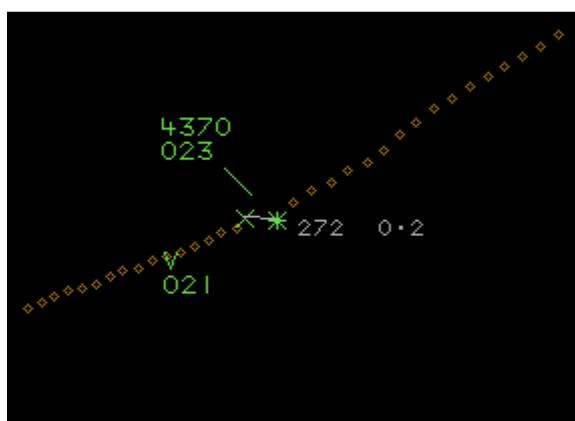
Figure 3 -1404:55

The two aircraft continued to close until 1404:55 when both aircraft appeared to make a slight turn to the left. CPA occurred at 1404:59, radar separation indicated 200ft and 0.1NM.

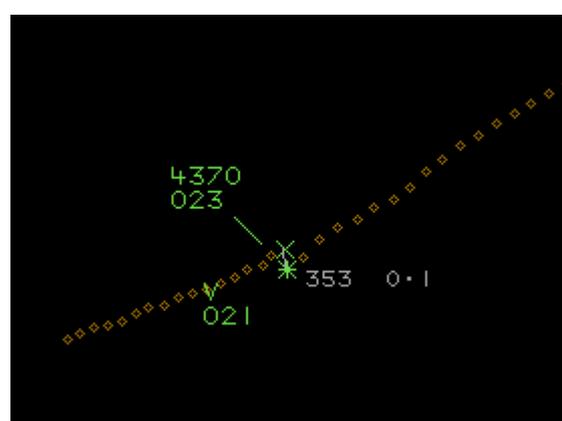
Figure 4 – 1404:59 CPA

The C182 and BO209 pilots shared an equal responsibility for collision avoidance and not to operate in such proximity to other aircraft as to create a collision hazard.<sup>2</sup> If the incident geometry is considered as head-on or nearly so then both pilots were required to turn to the right.<sup>3</sup>
