AIRPROX REPORT No 2021217

Date: 20 Oct 2021 Time: 0919Z Position: 5814N 00257W Location: 14NM SSE Wick

PART A: SUMMARY OF INFORMATION REPORTED TO UKAB

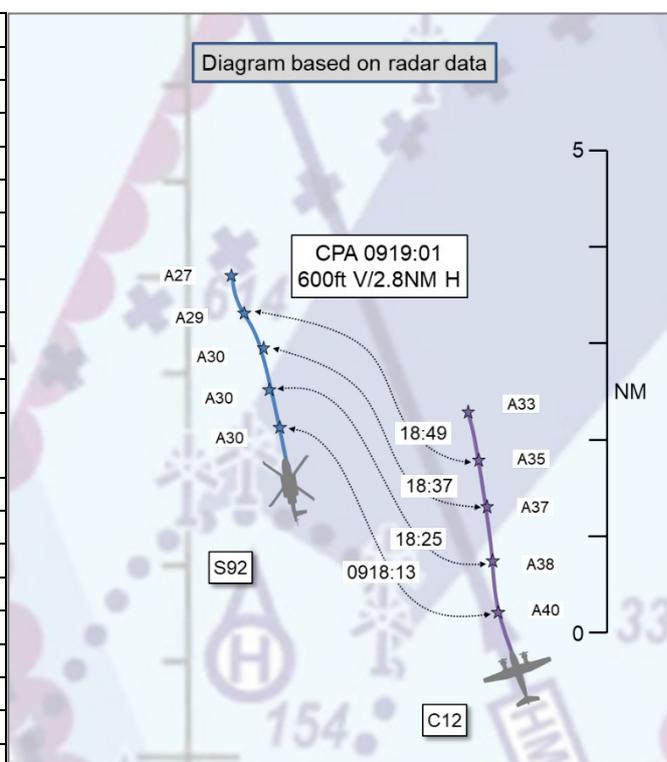
Recorded	Aircraft 1	Aircraft 2
Aircraft	S92	C12 Huron
Operator	Civ Comm	Foreign Mil
Airspace	Scottish FIR	Scottish FIR
Class	G	G
Rules	IFR	IFR
Service	Basic	Procedural
Provider	Wick	Wick
Altitude/FL	2700ft	3300ft
Transponder	A, C, S	A, C, S
Reported		
Colours	White, blue, red	White
Lighting	HISL, anti-col, position, landing	Nav, anti-col, recognition
Conditions	VMC	VMC
Visibility	>10km	>10km
Altitude/FL	3000ft	3550ft
Altimeter	QNH (985hPa)	QNH (985hPa)
Heading	350°	030°
Speed	135kt	220kt
ACAS/TAS	TCAS II	TCAS II
Alert	None	None
Separation at CPA		
Reported	500ft V/<1NM H	Not seen
Recorded	600ft V/2.8NM H ¹

¹ The S92 and C12 subsequently closed to 0.7NM horizontal separation by 0925Z but by that time the aircraft were in level flight with 2000ft vertical separation. CPA is given in the context of the C12 descending below cleared altitude and then climbing again.

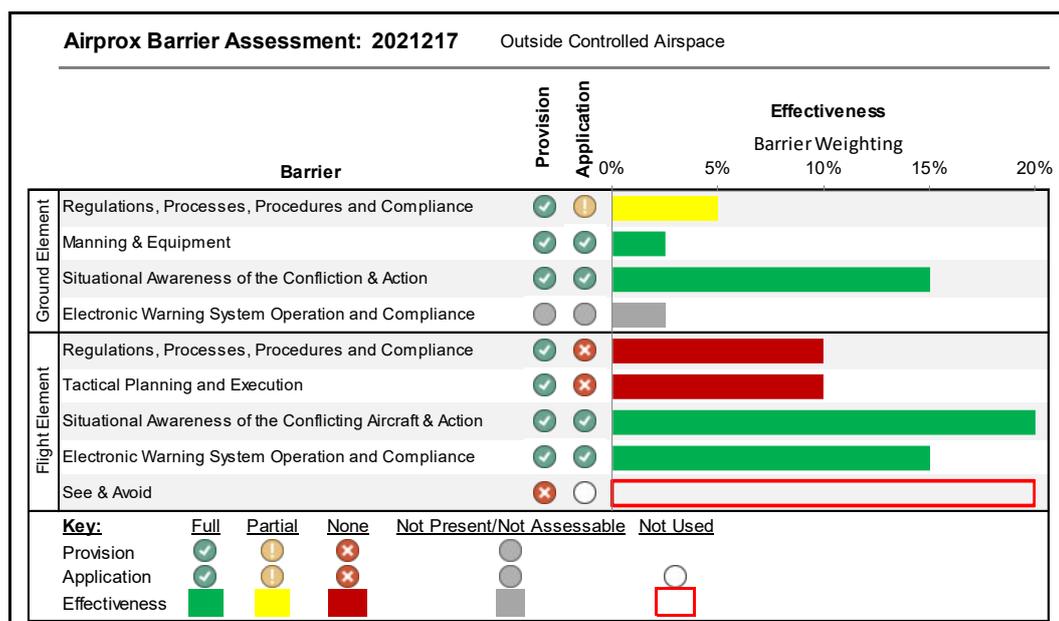
Regulations, Processes, Procedures and Compliance were assessed as **partially effective** because the Wick ATCO did not use ‘hectopascals’ when initially passing the QNH and did not correct the incorrect readback of levels/altitudes by the C12 pilot.

Regulations, Processes, Procedures and Compliance were assessed as **ineffective** because the C12 pilot descended below their cleared altitude.

Tactical Planning and Execution was assessed as **ineffective** because the C12 pilot did not set the correct QNH and did not adhere to international standards of R/T phraseology.

See and Avoid were assessed as **not used** because the see-and-avoid barrier was not employed.
