AIRPROX REPORT No 2021223

Date: 02 Nov 2021 Time: 1513Z Position: 5307N 00236W Location: 4.5NM SW Winsford

PART A: SUMMARY OF INFORMATION REPORTED TO UKAB

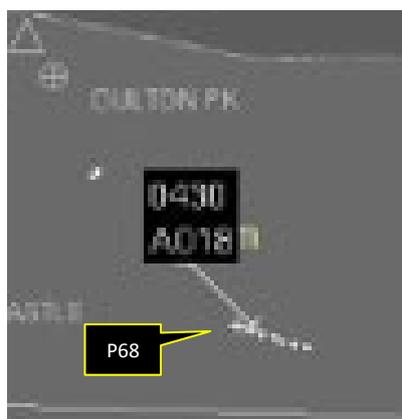
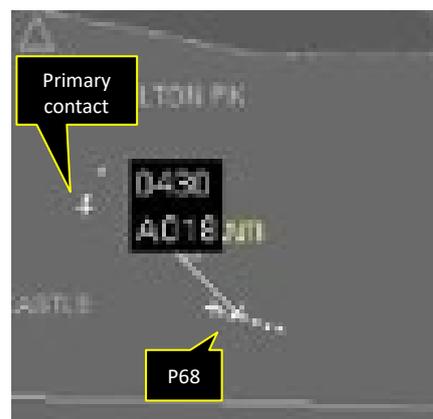
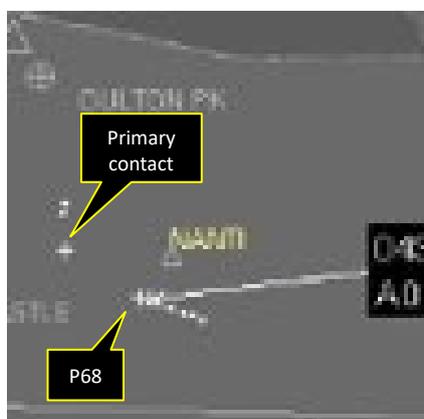
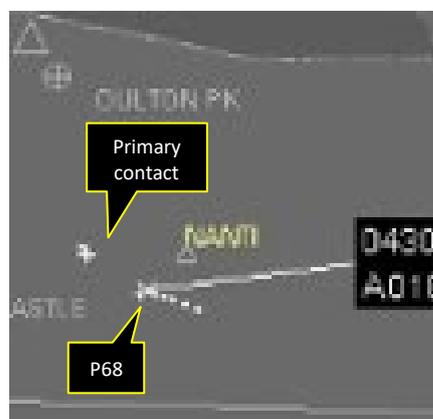
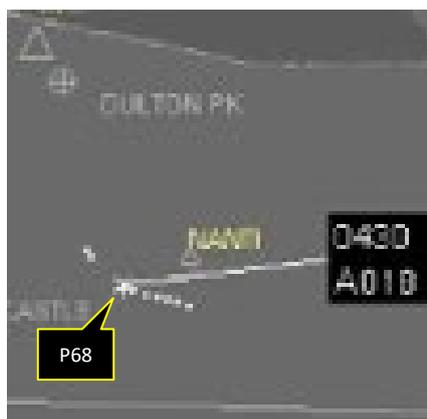
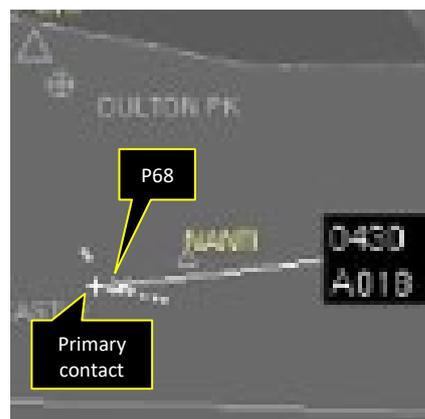
For the portion of [the P68 pilot's] flight when the pilot was in communication with Hawarden Radar the aircraft was provided with a Basic Service and was not formally Radar Identified, to which end the ATCO discharged their obligations correctly. As the screen shots indicate (Figures 1 – 6), the aircraft which was believed to have been in conflict with [the P68] was a primary only contact and only displaying on the radar display intermittently. It is not uncommon to observe this type of radar return at Hawarden Radar due to the performance levels and impact of high ground on coverage. At the time of the Airprox the Hawarden Radar ATCO was working other Hawarden traffic, including a pilot in receipt of a Traffic Service, whilst trying to effect coordination with Liverpool Radar using the direct telephone line which was going unanswered. There was no report of the Airprox received by Hawarden Radar either at the time or by the ATSU after the pilot had landed. There was also no concern noted in the pilot's voice as they transferred to their [next frequency].

According to the Hawarden radar screenshots the unknown aircraft was an intermittent primary-only contact between 1511:40 and CPA at 1512:30. However, the controller was providing a Basic Service to the P68, had not formally identified the aircraft (it was on a conspicuity, not a unique, squawk) and they were not required to continuously monitor its track. During this period the controller was also providing a Traffic Service to a training aircraft at Hawarden and dealing with its missed approach instructions and further training requirements, whilst also controlling another inbound, an outbound and a transit aircraft. No reference to an Airprox was made by the pilot of the P68 at the time.
