AIRPROX REPORT No 2021230

Date: 13 Nov 2021 Time: 1147Z Position: 5130N 00138W Location: 3NM NW Membury

PART A: SUMMARY OF INFORMATION REPORTED TO UKAB

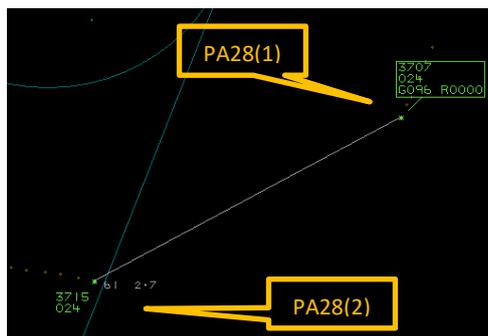
Figure 1:
Showing the converging headings of PA28(1) and PA(2).

One minute prior to the Airprox, the trails of both aircraft suggested a potential conflict. It is reported that the controller was distracted by the airfield incursion at this point. Separation at this point was 2.7NM and 0ft vertically.

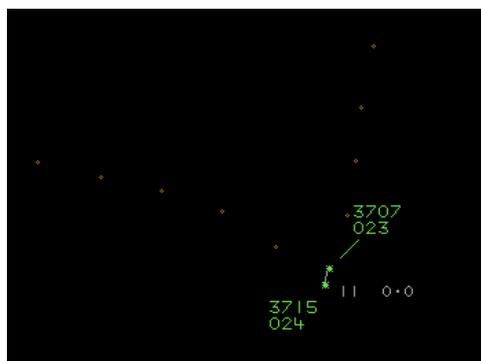
Figure 2:
CPA.

CPA was measured at 100ft vertically and 0.0NM horizontally. The PA28(1) pilot reported the Airprox to the controller 11 seconds later.
