**AIRPROX REPORT No 2021233**

Date: 22 Nov 2021 Time: 1237Z Position: 5058N 00054W Location: 2.5NM SSE Petersfield

**PART A: SUMMARY OF INFORMATION REPORTED TO UKAB**

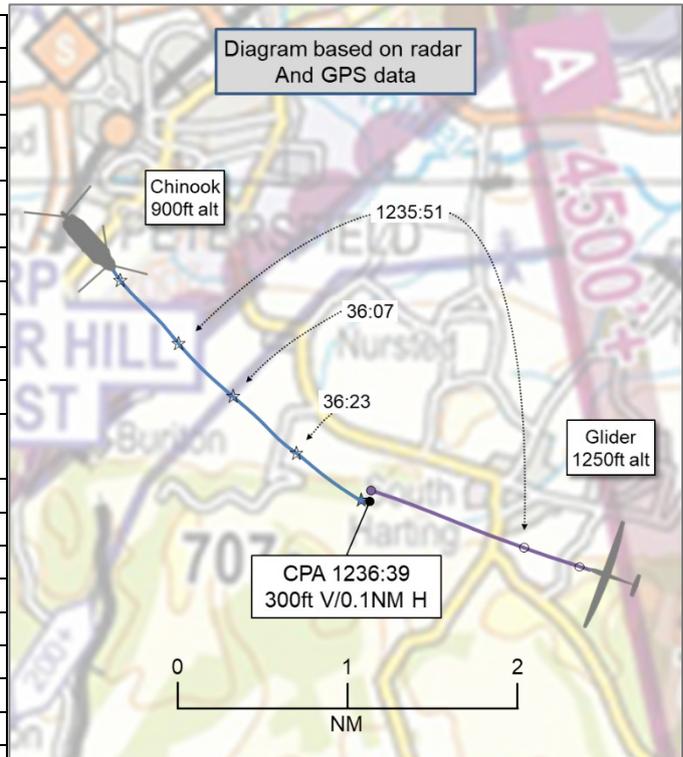
An analysis of the NATS radar replay was undertaken on which the routing and the altitude of the Chinook only could be seen, the glider was not detected by the NATS radars; however, a GPS data log file for the flight was available and has been used and combined with the radar data to produce the diagram above and determine the CPA. It should be noted that the aircraft positions have been determined using different data sources.

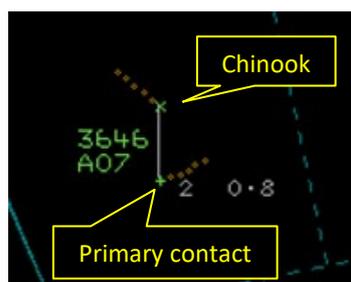
Figure 1 - CPA.

Figure 1 shows the positions of the Chinook and the primary contact believed to be the glider during the Airprox. The screenshot is taken from a replay using the NATS radars which are not utilised by the Odiham controller, therefore, may not be entirely representative of the picture available to the controller.

This was the closest point at which a primary contact believed to be the glider came to the Chinook, although the glider had already passed ahead of the Chinook. Separation was measured at 0.8NM with an unknown height.

The Approach controller was limited by the unserviceable surveillance equipment which resulted in the controller not being able to see the confliction to enable Traffic Information to be passed. It is not known whether the controller was aware of gliding activity in the area from NOTAMs or glider site notification although, even with this knowledge, any Traffic Information that could have been passed would have been limited as the glider was not transponding and the Chinook was operating at low level.
