## AIRPROX REPORT No 2021241

Date: 11 Dec 2021 Time: 1119Z Position: 5223N 00126W Location: Coventry

An Airprox was reported when a TB10 and a PA28 flew into proximity in the Coventry visual circuit at 1119Z on Saturday 11<sup>th</sup> December 2021. Both pilots were operating under VFR in VMC, both were in receipt of a AFIS from Coventry.

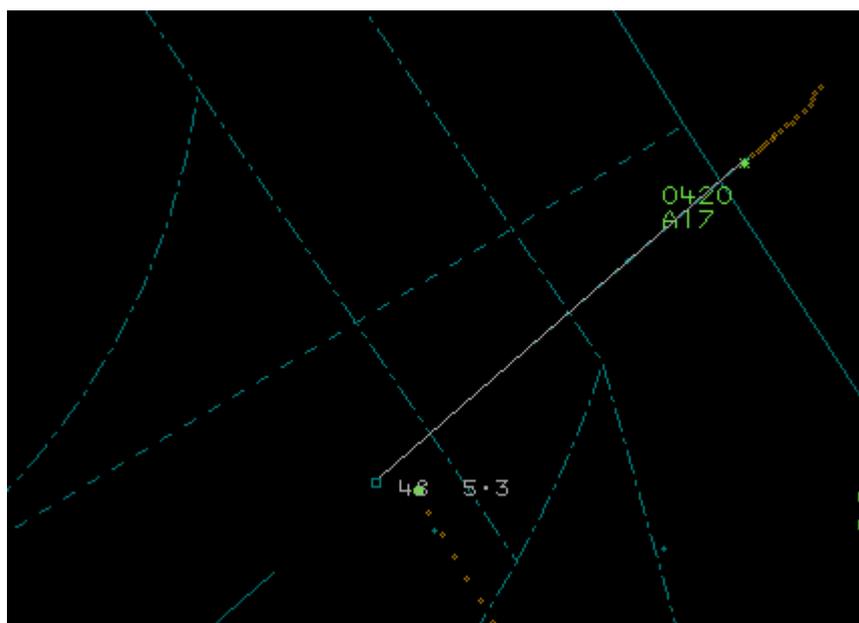
Figure 1 - 1117:25

Analysis of the NATS radar showed the TB10 squawking 0420, unfortunately the PA28 did not show  
on the radar. The TB10 was visible in the Nuneaton area, as reported by the pilot. The aircraft then  
positioned for a long straight in approach and at Figure 1 could be seen 5.3NM from Coventry.

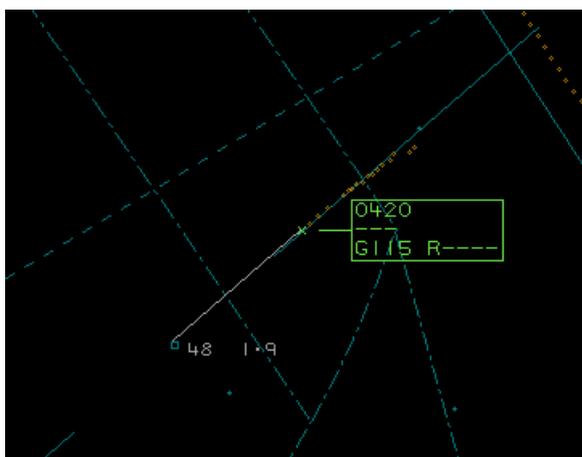
Figure 2 - 1119:39

At 1119:39 (Figure 2), when 1.9NM from the airfield, the Mode C on the TB10 dropped out, indicating  
that the TB10 pilot may have changed height rapidly, and on the following few radar sweeps the  
TB10 track jittered, but the aircraft appeared to have completed a right turn (Figure 3). This was  
likely to be when the Airprox took place.
