AIRPROX REPORT No 2021246

Date: 17 Dec 2021 Time: ~1301Z Position: 5627N 00324W Location: Perth visual circuit

PART A: SUMMARY OF INFORMATION REPORTED TO UKAB

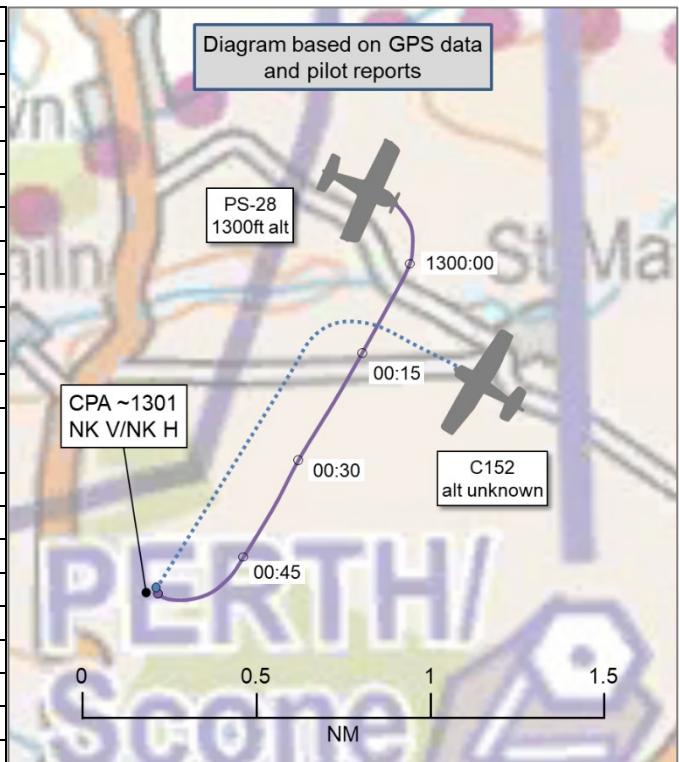
The Airprox took place below the coverage of the NATS radars. However, the PS-28 furnished the UKAB with their GPS log file from the flight, from which it was possible to establish the PS-28's track and altitude whilst in the Perth visual circuit. Because no such data was available for the C152, it has not been possible to measure the CPA.
