AIRPROX REPORT No 2021248

Date: 21 Dec 2021 Time: 1515Z Position: 5142N 00158W Location: Cirencester

PART A: SUMMARY OF INFORMATION REPORTED TO UKAB

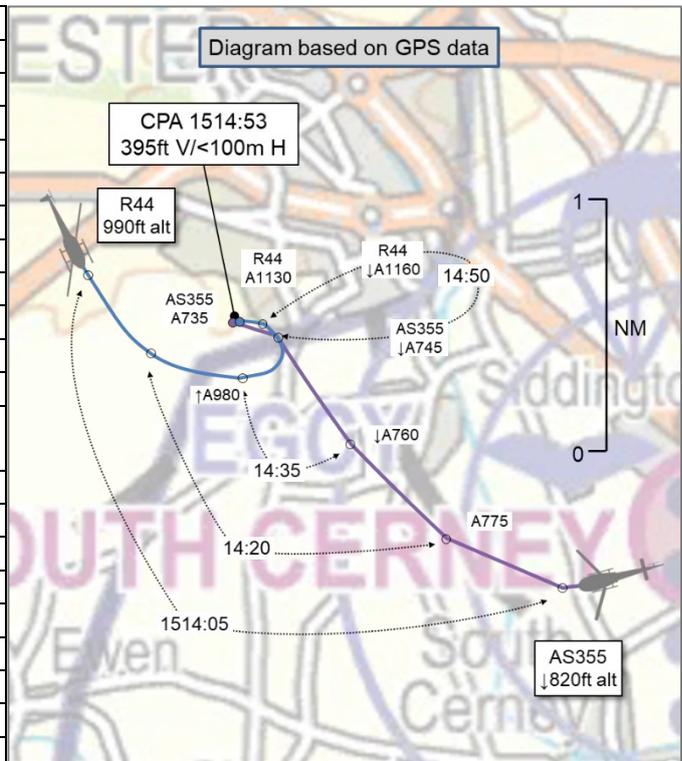
Both of the aircraft had been below NATS radar coverage at the time of the event, however both pilots had been able to supply GPS data log files for their respective flights and this information has been used to construct the diagram and to measure the CPA.

An Airprox was reported when an R44 and an AS355 flew into proximity at Cirencester at 1515Z on Tuesday 21st December 2021. Both pilots were operating under VFR in VMC, the R44 pilot in receipt of a Basic Service from Gloster Approach and the AS355 pilot was not in receipt of an ATS.

separation, they had continued toward the R44 to an extent that the R44 pilot had become concerned. It was however agreed that, had the AS355 pilot deemed it necessary, the AS355 pilot had had the capacity to manoeuvre to further increase separation. The Board then considered the recorded separation and concluded that there had been no risk of collision, although safety had been reduced. Accordingly, the Board assigned a Risk Category C to this Airprox.

Recommendation: The CAA reviews whether the Centralised Aviation Data Service (CADS) procedures, (Ref: UK IAIP ENR 1.10) generate the publication of sufficiently detailed information about operations below 500ft to enable other airspace users to accurately determine where the activity is taking place.
