AIRPROX REPORT No 2021251

Date: 27 Oct 2021 Time: 1028Z Position: 5140N 00013E Location: 2.2NM ENE of Stapleford

PART A: SUMMARY OF INFORMATION REPORTED TO UKAB

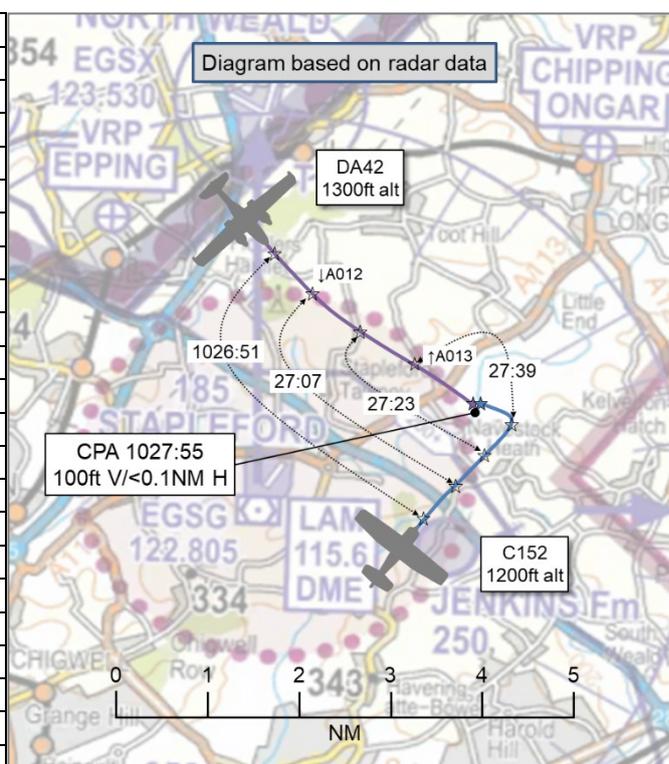
Recorded	Aircraft 1	Aircraft 2
Aircraft	C152	DA42
Operator	Civ FW	Civ FW
Airspace	London FIR	London FIR
Class	G	G
Rules	VFR	VFR
Service	AGCS	None ¹
Provider	Stapleford Radio	None
Altitude/FL	1200ft	1300ft
Transponder	A, C, S	A, C, S
Reported		
Colours	White, red	White
Lighting	Beacon, landing	Strobes
Conditions	VMC	VMC
Visibility	>10km	>10km
Altitude/FL	1200ft	1300ft
Altimeter	QNH (NR hPa)	NK
Heading	'Base leg of circuit'	100°
Speed	65-70kt	120kt
ACAS/TAS	Not fitted	TCAS I
Alert	N/A	None
Separation at CPA		
Reported	50ft V/150m H	100ft V/1NM H
Recorded	100ft V/<0.1NM H

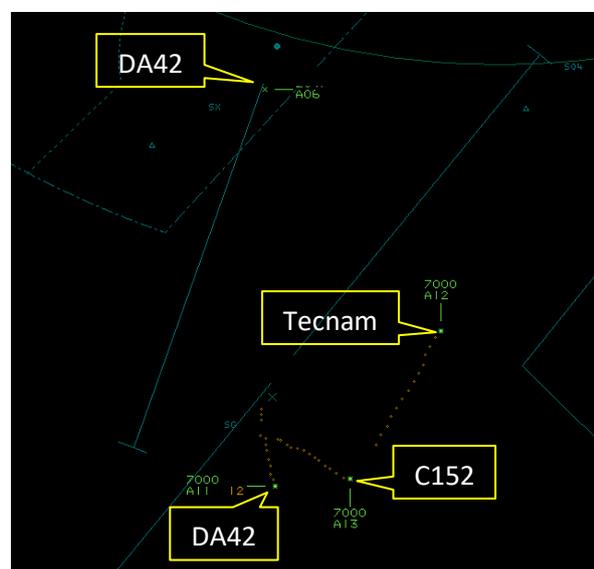
Figure 1 – 1026:11

An analysis of the NATS radar replay was undertaken. The C152 was recorded by the NATS radars in the Stapleford circuit, established on crosswind in the circuit between a Tecnam on downwind and a DA42 on climb-out behind the C152. The Airprox DA42 was first detected by the NATS radars at 1026:11 (see Figure 1). The DA42 climbed-out, turned left onto a track of approximately 135°, established at an altitude of 1200ft and then passed the Tecnam, which was on base-leg in the Stapleford circuit (albeit outside the ATZ) at 1027:23 (see Figure 2).

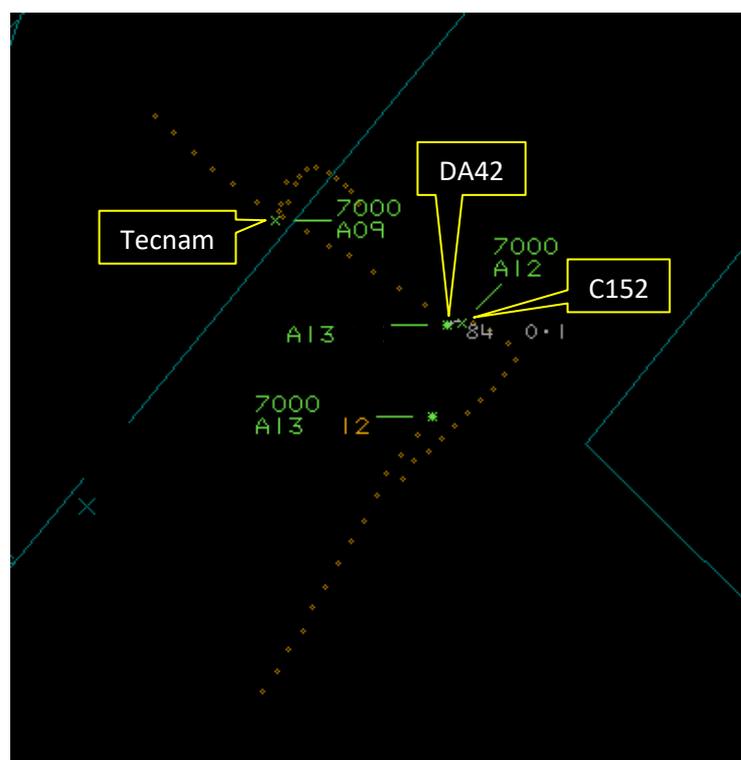
Figure 3 – 1027:55 - CPA

The DA42 continued on track and then encountered the C152 shortly after it had turned onto base-leg, following a similar ground track to the Tecnam ahead of it in the circuit. CPA was recorded at 1027:55 with a vertical separation of 100ft and a horizontal separation of <0.1NM (see Figure 3).

Finally, the Board considered the risk involved in this Airprox. Members noted that there was a significant difference in both pilots' estimations of horizontal separation, but that the NATS radar data clearly showed that there had been very little lateral distance between the aircraft at CPA. Members also noted that both pilots had reported sighting the other aircraft and taking action to ensure separation. Notwithstanding the actions of the 2 pilots, the Board agreed that there had been very little separation between the aircraft at CPA – as evidenced by the recorded data – and, therefore, safety had not been assured and a risk of collision had existed (**CF10**). Accordingly, the Board assigned a Risk Category B to this event.

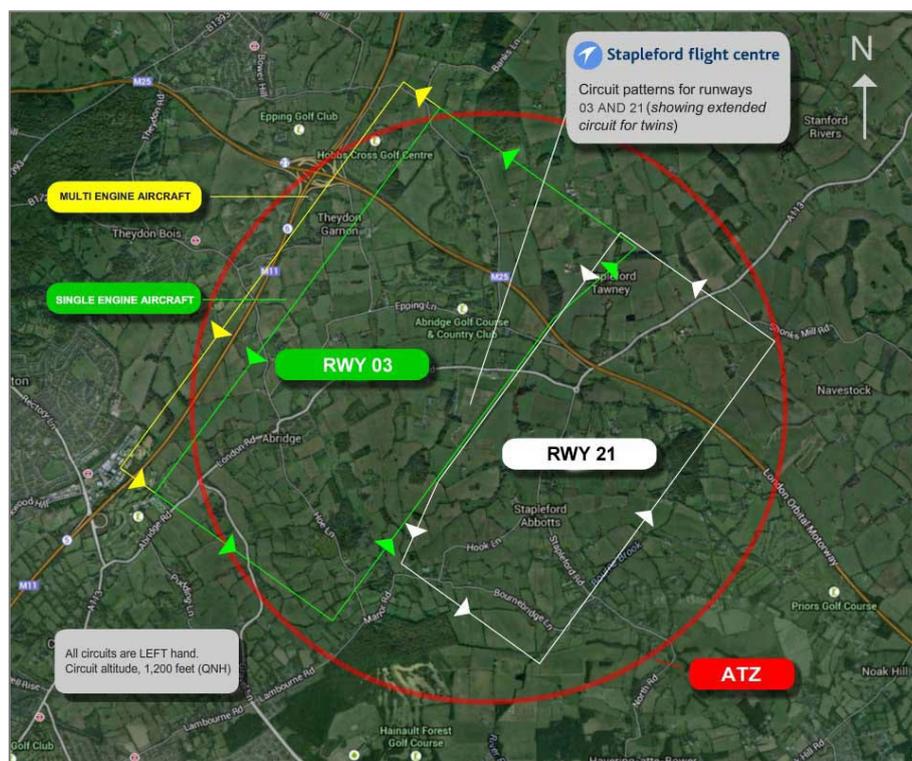
Figure 4 – Stapleford Circuit Diagram⁵

The Board first considered the actions of the C152 pilot and heard from a GA pilot member that the Stapleford circuit noise abatement procedures require large circuits to be flown, which can often extend outside the ATZ (see Figure 4). Members noted that the C152 had not been carrying any electronic conspicuity equipment and, although it could not be guaranteed that this would have had any influence on the outcome of this Airprox, the Board wished to highlight to pilots that additional funding has been made available for electronic conspicuity devices through the CAA's Electronic Conspicuity Rebate Scheme, which has been extended until 31st March 2023.⁴ The Board noted that the Stapleford Air Ground operator had highlighted the presence of the DA42 to all pilots on the Stapleford frequency, but it seemed likely to the Board that the C152 pilot had not heard this transmission. Therefore, members agreed that the C152 pilot had not had any situational awareness of the presence of the DA42 (**CF7**)

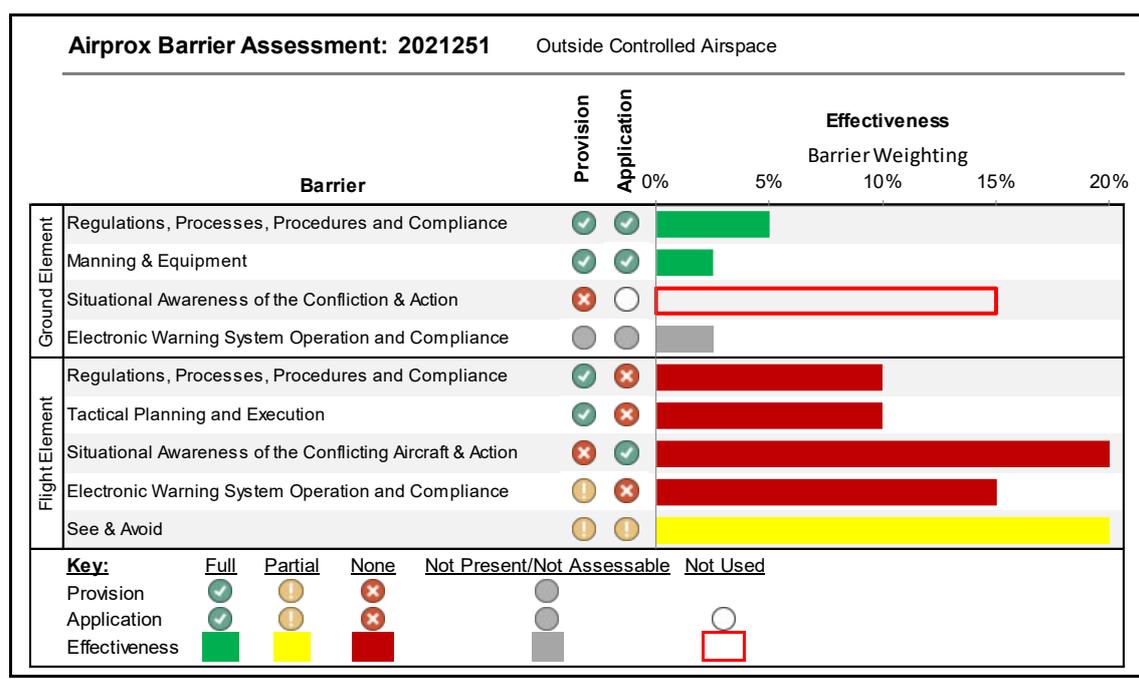
Situational Awareness of the Confliction and Action were assessed as **not used** because the C152 pilot was operating with an Air Ground Communications Service and, although the Air Ground Operator did attempt to pass information to pilots about the DA42, this was not in time for the C152 pilot take account of the information.

Regulations, Processes, Procedures and Compliance were assessed as **ineffective** because the DA42 pilot entered the Stapleford ATZ without contacting the Stapleford Air Ground Operator, which is not in accordance with Rule 11 of The Rules of the Air Regulations 2015.

Tactical Planning and Execution was assessed as **ineffective** because, on departure from North Weald, the DA42 pilot did not plan to avoid the Stapleford ATZ by a greater margin and also did not take sufficient action to avoid the C152 when they first sighted it at a distance of 1NM.

Situational Awareness of the Conflicting Aircraft and Action were assessed as **ineffective** because neither pilot had any situational awareness of the presence of the other aircraft until they saw it.

Electronic Warning System Operation and Compliance were assessed as **ineffective** because the electronic conspicuity equipment on the DA42 would have been expected to alert the DA42 pilot to the presence of the C152, but no alert was received.

See and Avoid were assessed as **partially effective** because the DA42 pilot initially sighted the C152 at a range of 1NM but subsequently lost sight of it prior to CPA, and the C152 pilot only saw the DA42 once they had turned on to base-leg and had to take immediate action to increase separation.
