**2022AIRPROX REPORT No 2022005**

Date: 18 Jan 2022 Time: 1311Z Position: 5346N 00303W Location: Blackpool RW10

**PART A: SUMMARY OF INFORMATION REPORTED TO UKAB**

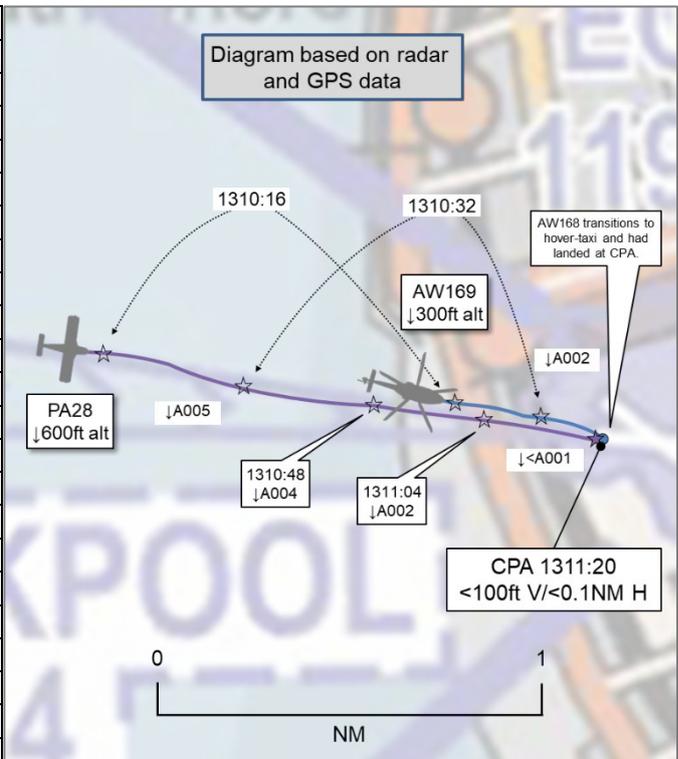
Both of the aircraft had been visible on the NATS radar replay until **1110:44**, after which point the return from the AW169 had faded, however GPS data has been obtained that enabled both the AW169 and the PA28 to be tracked to the point at which the PA28 climbs following the pilot's go-around, which is coincidental with CPA. This data has been used to produce the above diagram and determine CPA.

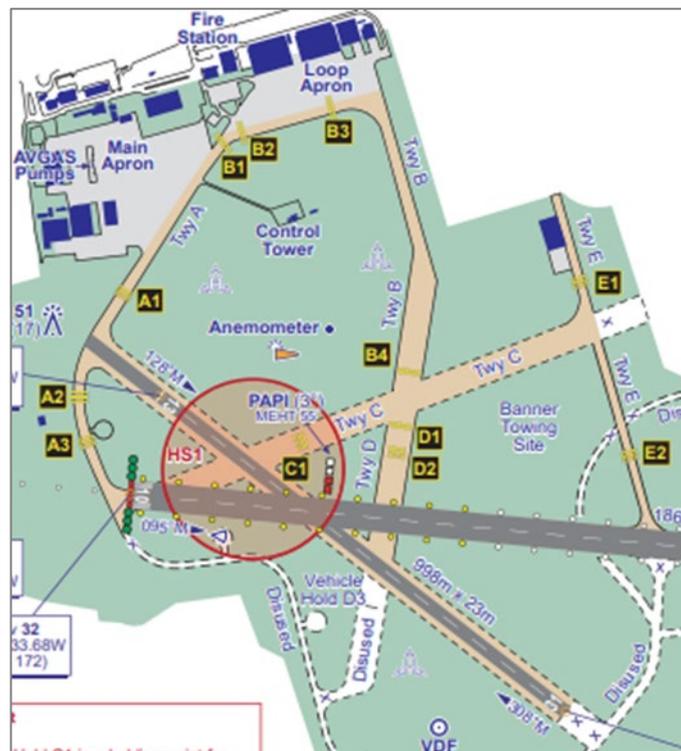
Figure 1 - RW10 exits and holding points

At **1307:20** the AW169 pilot was passed the surface wind and instructed, *“RW10 cleared to land, and after landing vacate left at Delta, hold at Delta one.”* The pilot readback, which was slightly muffled, was incorrect, the pilot read back, *“cleared to land 10, and vacate right, to hold at Delta one.”* The incorrect readback was not picked up by the controller. (Figure 1)

The AW169 pilot had been instructed to vacate the runway left at Delta and hold at Delta 1 and the pilot readback vacate right at Delta and hold at Delta 1. The incorrect readback was not picked up by the controller. The PA28 pilot reported seeing the AW169 when they were on 0.5NM final and the AW169 was hovering over the runway in a left turn as if to vacate to the left onto Delta, but subsequently turned to the right and remained on the runway. The controller also reported this series of events.

The incorrect readback by the AW169 pilot of the instructions to vacate the runway were not picked up by the controller and the pilot initially turned in the wrong direction when attempting to vacate. This is likely to have taken the PA28 pilot and the controller by surprise and resulted in a delay in the helicopter vacating the runway. The PA28 pilot appears to have taken timely go-around action and this was followed by the controller issuing them with go around instructions. This is normal operations at busy GA Airfields.

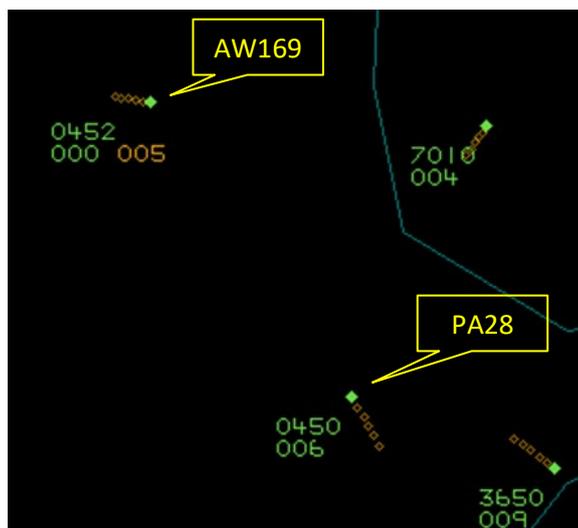
Figure 2 – 1308:10

At **1308:10** Traffic Information was then passed to the AW169 pilot, *“traffic approaching St Anne's Pier is going to position behind you, it's a Cherokee.”* The AW169 pilot advised that they were looking for the traffic. The controller asked the AW169 pilot for their range and the pilot responded with 3NM. The controller turned their attention to the PA28 pilot and said *“[PA28 c/s] you should be able to see that traffic now, out to the west it's got its light on, it's quite clear, just approaching 3 miles.”* The pilot responded, *“not visual but we do have it on TCAS.”* (Figure 2).

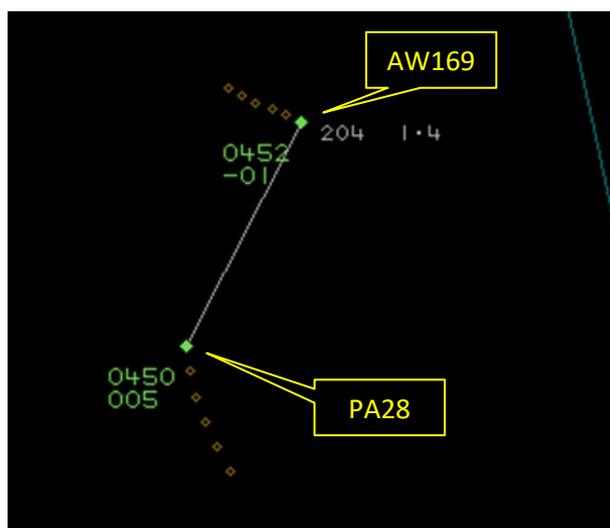
Figure 3 – 1309:30

At **1309:30** the controller advised the PA28 pilot that they had them in sight and asked if the pilot was visual with the helicopter. The pilot responded with "affirm". The pilot was instructed to report final number 2. This was read back correctly by the pilot. (Figure 3)

At **1309:30** the PA28 pilot confirmed that they had the AW169 in sight, the AW169 was 1.4NM to the northeast of the PA28 at this point. The PA28 pilot was instructed to report final and advised that they were number 2, (Figure 2). The controller reported continuously having both aircraft in sight and being happy with the separation between them. One minute later the PA28 pilot reported final with the AW169 in sight and was instructed to continue approach and expect a late landing clearance. The PA28 was just over 0.6NM behind the AW169 at this point. The radar contact of the AW169 faded 14 seconds later and at **1311:20** the controller issued go-around instructions to the pilot of the PA28. The PA28 pilot indicated in their report that they had already commenced the go-around before receiving the instructions from the controller. This was confirmed by the staff in the vehicle, who reported that they saw the landing gear on the PA28 being retracted before the go-around instructions were issued.

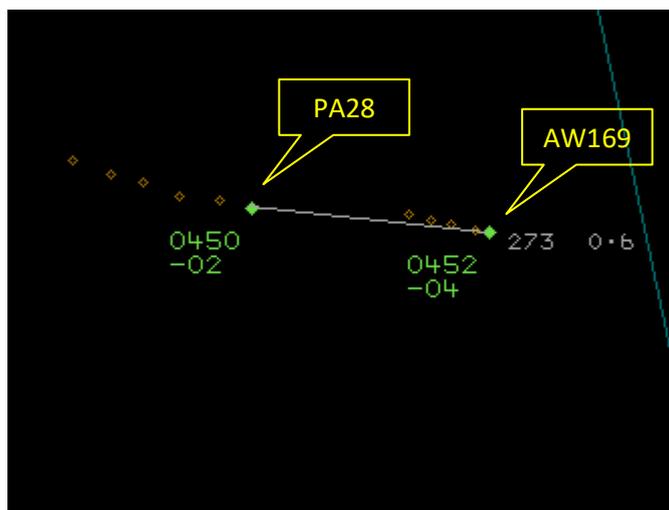
Figure 4 - 1310.44

At **1310:44** the radar replay indicated distances of 0.6NM horizontally and 200ft vertically between the two aircraft. The AW169 radar contact faded from the radar immediately after this screenshot was taken (Figure 4).
