AIRPROX REPORT No 2022007

Date: 30 Jan 2022 Time: 1252Z Position: 5233N 00012W Location: Peterborough

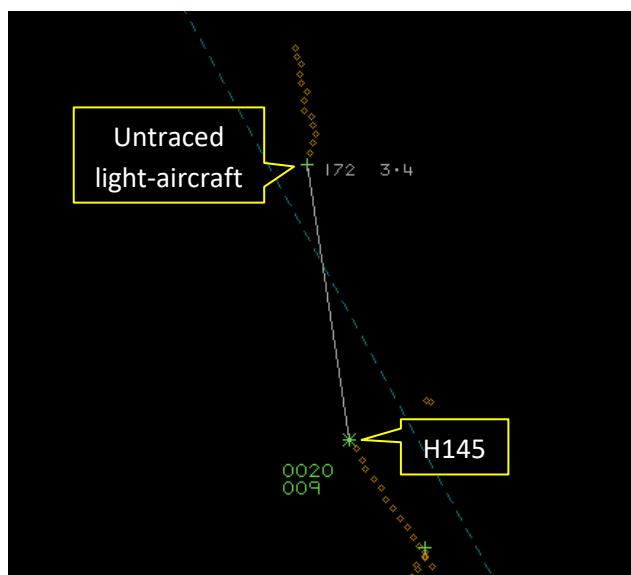
Figure 1 – 1250:27

An analysis of the NATS radar replay was undertaken. The H145 was detected by both primary and secondary surveillance radars and could be seen tracking in a north-westerly direction, towards Peterborough, at approximately 1400ft (altitude data is presented on the radar as flight levels and the QNH entered into the radar processor was 1031hPa; therefore, 486ft should be added to the displayed flight level to determine aircraft altitude). The untraced light-aircraft was detected by primary radar only and could be seen tracking in a southerly direction (see Figure 1). The H145 continued on track, gradually descending from 1400ft to 1000ft as it crossed the path of the untraced light-aircraft. CPA was measured on the radar as 0.1NM laterally with an unknown vertical separation due to the lack of Mode C information from the untraced light-aircraft (see Figure 2).

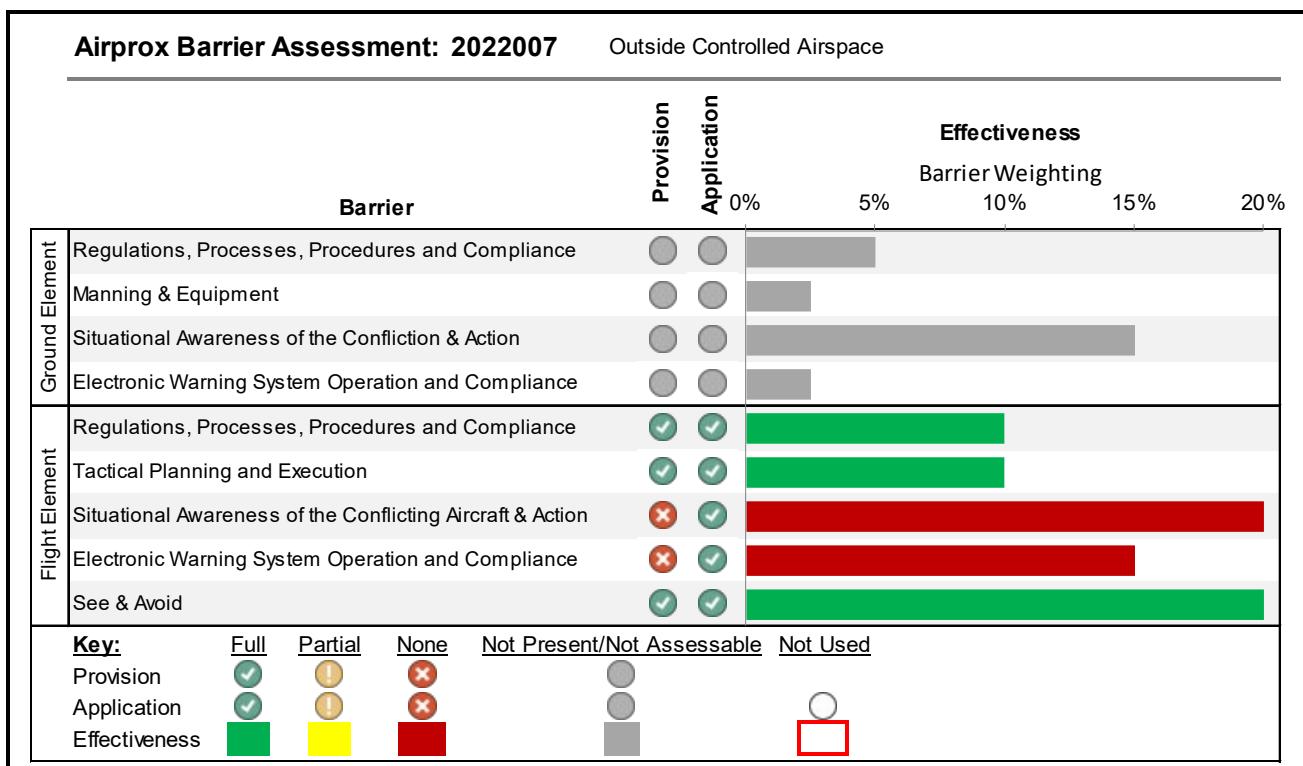
Situational Awareness of the Conflicting Aircraft and Action were assessed as **ineffective** because the H145 pilot did not have any situational awareness regarding the presence of the untraced light-aircraft.

Electronic Warning System Operation and Compliance were assessed as **ineffective** because the TAS fitted to the H145 could not detect the non-transponding light-aircraft.
