**AIRPROX REPORT No 2022008**

Date: 02 Feb 2022 Time: 1635Z Position: 5138N 00129W Location: 2.5NM NW Wantage

**PART A: SUMMARY OF INFORMATION REPORTED TO UKAB**

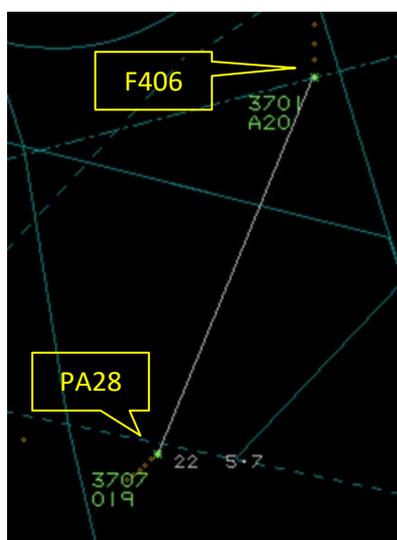
Figure 1 - F406 leaving the Brize CTR.

Immediately prior to the F406 leaving the Brize CTR, the Zone controller was completing a handover of another aircraft on recovery to Brize. On completion of the handover the Zone controller advised a second aircraft that was positioning for a tactical approach to Brize Norton that they would be positioned behind the aircraft they had taken the handover for. Separation was 5.7NM and 100ft.

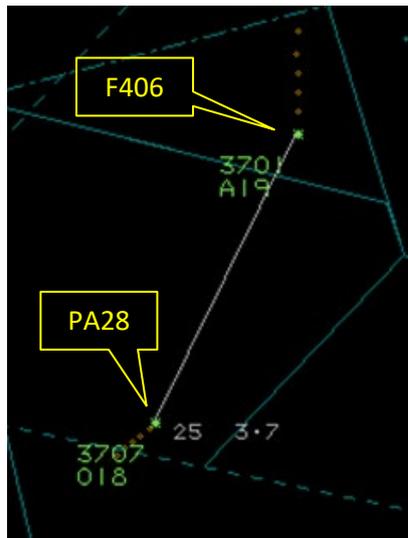
Figure 2 - Exchange between Zone controller and radar traffic complete.

Over the course of the 25sec from the handover from Swanwick Mil, the Zone controller was engaged in an exchange with another aircraft. Separation decreased to 3.7NM and 100ft.

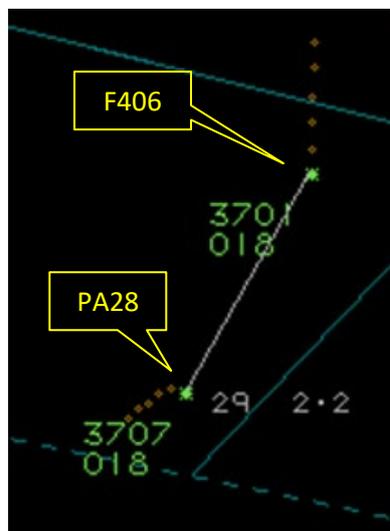
Figure 3 - Zone Controller took control of other radar traffic.

Following on from the exchange with the other radar traffic, the Zone controller then identified the aircraft handed over from Swanwick Mil [other aircraft 3]. The aircraft pilot was given control instructions and the information code was updated. Separation decreased to 2.2NM and 0ft.

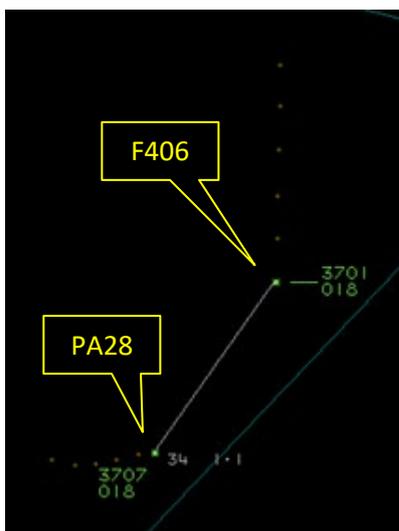
Figure 4 - Further exchanges with unrelated radar traffic.

The Zone controller had further exchanges with the radar traffic. Separation decreased to 1.1NM and 0ft.

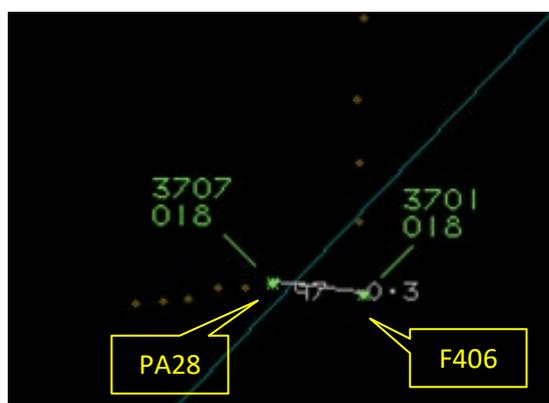
Figure 5 - CPA.

Fifteen seconds later the Zone controller passed Traffic Information to another aircraft that was 10NM away from their location. CPA occurred at the same time between the F406 and the PA28. Separation was 0.3NM and 0ft.
