### **AIRPROX REPORT No 2022011**

Date: 11 Feb 2022 Time: 1553Z Position: 5154N 00001E Location: 1NM N Puckeridge VRP

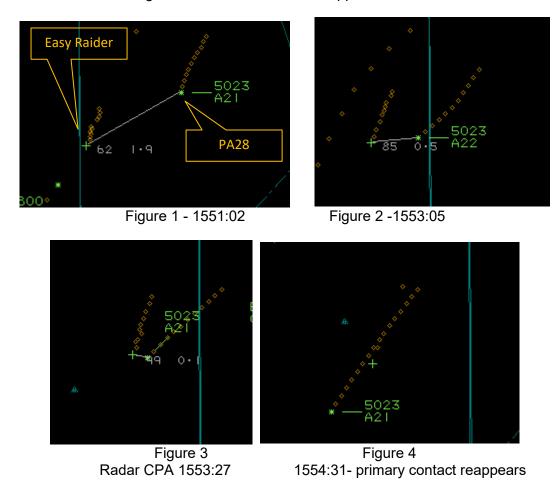
An analysis of the NATS area radar replay was undertaken. The PA28 could be seen tracking southwest squawking 5023 (Farnborough LARS North) and indicating 2100ft (radar QNH 1032hPa). The Easy Raider was not fitted with a transponder and so could not be positively identified on the radar, however, a primary contact could be seen following the profile described by the Easy Raider pilot. The two aircraft converged as seen in Figures 1 and 2, until, at 1553:28, the Easy Raider primary contact faded from radar. It is likely that CPA occurred shortly afterwards. The Easy Raider primary contact could not be seen again until 1554:31 when it reappeared behind the PA28.
