AIRPROX REPORT No 2022014

Date: 15 Feb 2022 Time: 1630Z Position: 5328N 00306W Location: 2NM NW Seaforth VRP

PART A: SUMMARY OF INFORMATION REPORTED TO UKAB

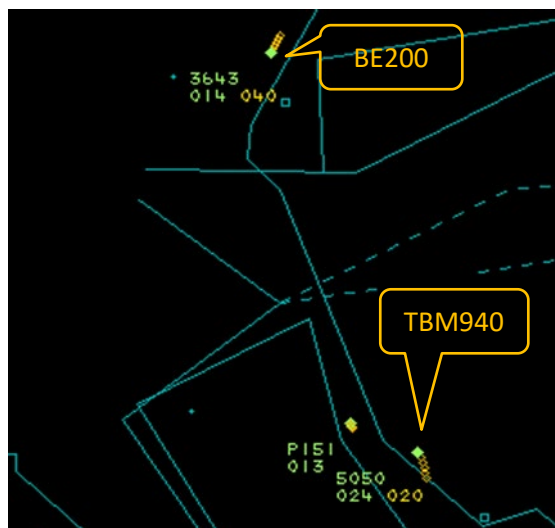
Figure 1 - 1627.00

At 1627.00 the TBM940 pilot was transferred from the Tower controller to the Radar controller and advised the Radar controller that they were outbound via Seaforth at 2000ft. The controller acknowledged the call, instructed the pilot to report at Seaforth and passed Traffic Information on unrelated traffic, *“you may see a police helicopter to your left 10 o’clock 2 miles manoeuvring 1000ft below”*. The pilot responded, *“we have him on TCAS”*. The controller then passed reciprocal Traffic Information to the pilot of the other aircraft (Figure 1).

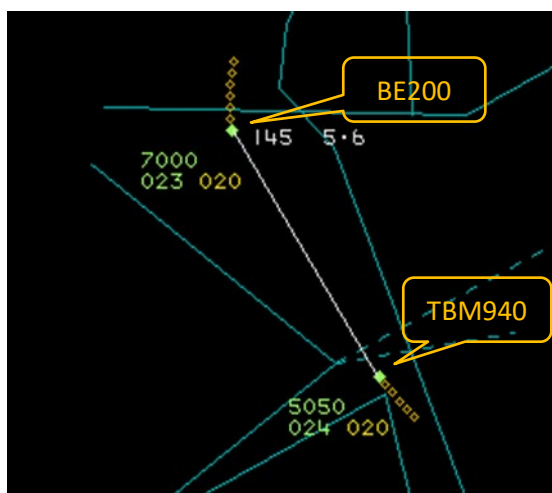
Figure 2 - 1629.00

At 1629.00 the BE200 pilot called the Liverpool Radar controller and requested a Traffic Service and Zone transit. The controller instructed the pilot to squawk 5055 and pass their details. The pilot read back the squawk and advised that they were a *“Beech 200, [departure airfield] routing now back to [destination], currently 1500ft, just routing southbound along the coast, requesting transit via Wallasey Whitegate.”* The controller responded, *“callsign, Traffic Service outside, I do have traffic just leaving my zone at Seaforth 2000ft currently still tracking north bound it’s a TBM940.”* The pilot responded, *“roger that’s copied thanks and sorry, clarify the squawk code?”* The controller repeated the squawk and the pilot read this back (Figure 2).

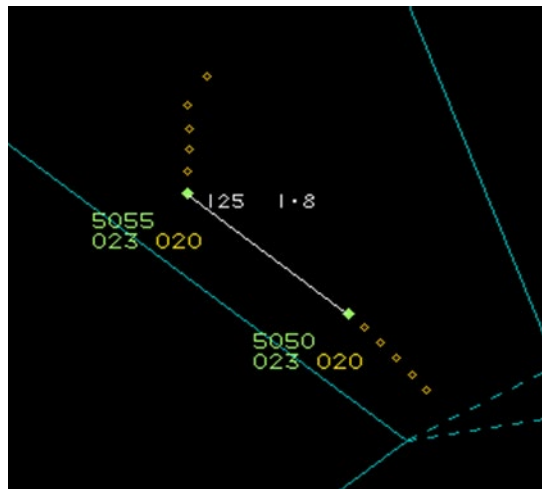
Figure 3 - 1629.40

At 1629.40 the controller advised the TBM940 pilot, “*you’re leaving controlled airspace now, keep a look out, traffic at your 12 o’clock 2 miles right to left indicating 1800ft.*” The pilot responded, “*We have him on TCAS, and we are turning to the west, taking up heading of 270°.*” The controller advised that it would be a Basic Service outside controlled airspace and the pilot read back, “*Basic Service*” (Figure 3).

The TBM940 pilot was passed specific and accurate Traffic Information on the BE200 when there was 1.8NM between the two aircraft and the pilot reported having the BE200 on TCAS. The TBM940 pilot took the decision to turn onto a westerly heading at this point, and this took the TBM940 into conflict with the BE200 and into their TCAS RA envelope.

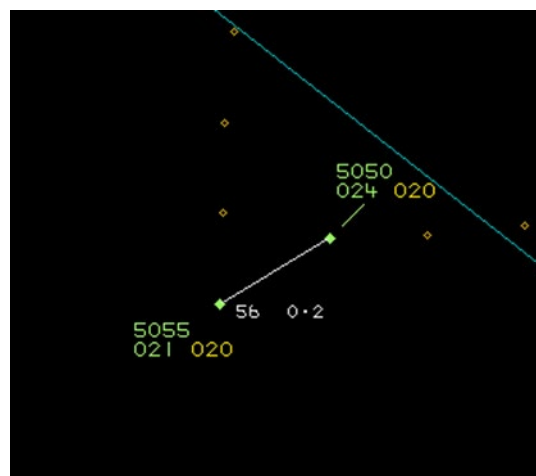
Figure 4 - 1630.07 CPA

At 1630.07 CPA occurred with the aircraft separated by 0.2NM laterally and an indicated 300ft vertically (Figure 4).
