AIRPROX REPORT No 2022029

Date: 15 Mar 2022 Time: 1103Z Position: 5149N 00007W Location: 1.5NM NW Hertford

PART A: SUMMARY OF INFORMATION REPORTED TO UKAB

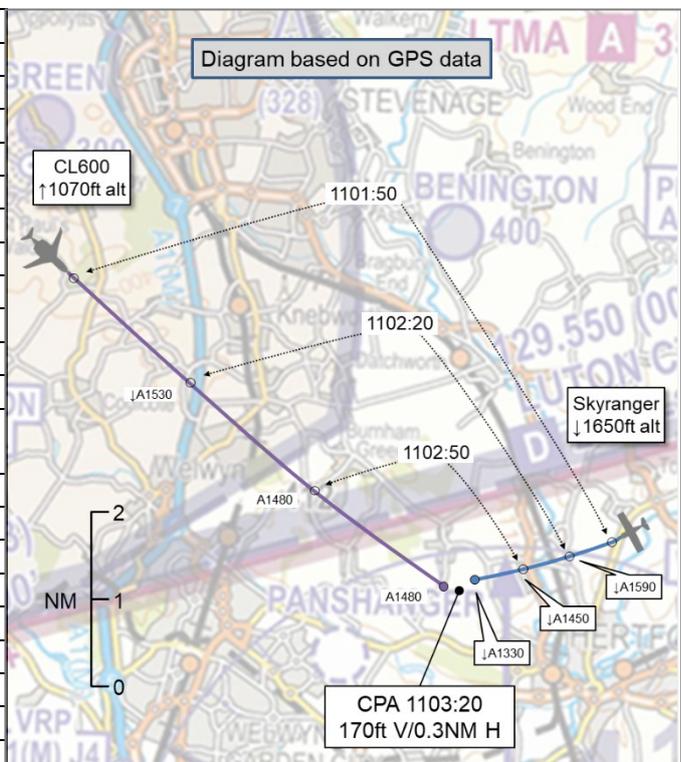
Closest Point of Approach occurred at **1103:26** and was recorded on Multi-Track Radar as 0.2NM. Vertical distance could not be ascertained as [the Skyranger] was not transponder equipped.

GPS data files had been obtained relating to the flight profiles of both the CL600 and the Skyranger. The GPS data included altitude data and this has been used to construct the diagram above and determine CPA.

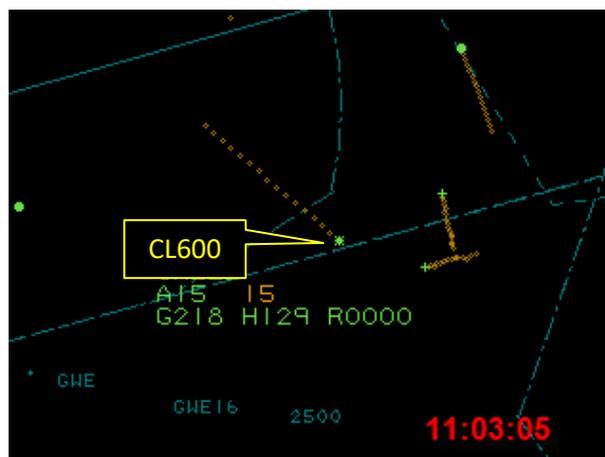
Figure 1

The GW INT controller had an R/T discussion with an unrelated aircraft and following this, at **1102:56**, provided the pilot of [the CL600] Traffic Information of *"traffic left eleven o'clock, two miles left-to-right, no height information."* The pilot of [the CL600] responded *"looking"*, followed by a further transmission of *"we have traffic in sight, no factor"* at **1103:05** (see Figure 1).

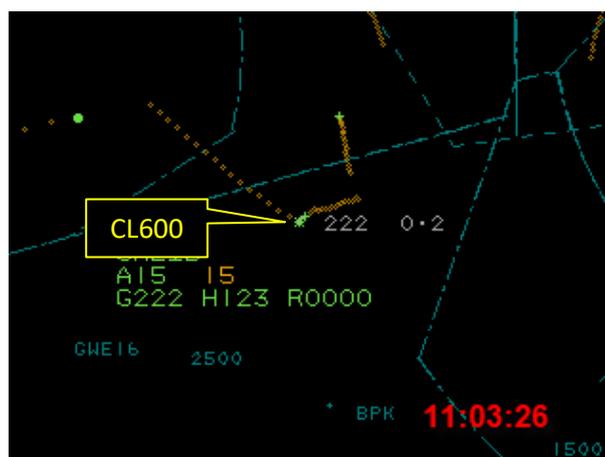
Figure 2

The closest point of approach between [the CL600] and the primary target occurred at **1103:26** with a lateral distance of 0.2NM, 3.9NM bearing 351° from position BPK (see Figure 2).
