AIRPROX REPORT No 2022080

Date: 14 May 2022 Time: 1035Z Position: 5224N 00131E Location: 4.5NM SW Beccles Airfield

PART A: SUMMARY OF INFORMATION REPORTED TO UKAB

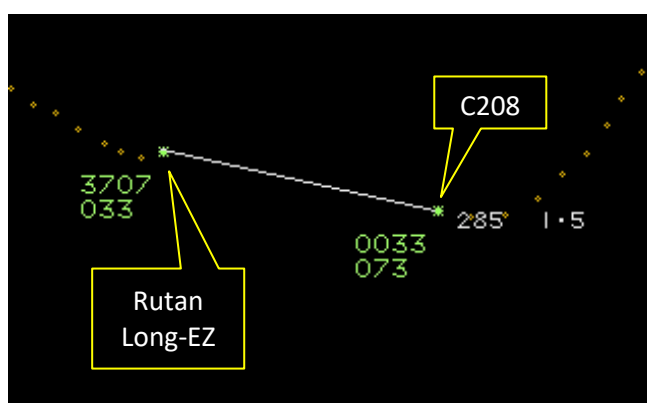
Figure 1 – 1035.00

At 1035:00 the controller passed Traffic Information to the C208 pilot on the Rutan Long-EZ, “*there is traffic in your right two o’clock range of 2 miles crossing right left beneath you, is with me, indicating 3400 feet in the slow climb.*” The pilot responded, “*yep copied the traffic [callsign] and looking.*” (Figure 1).

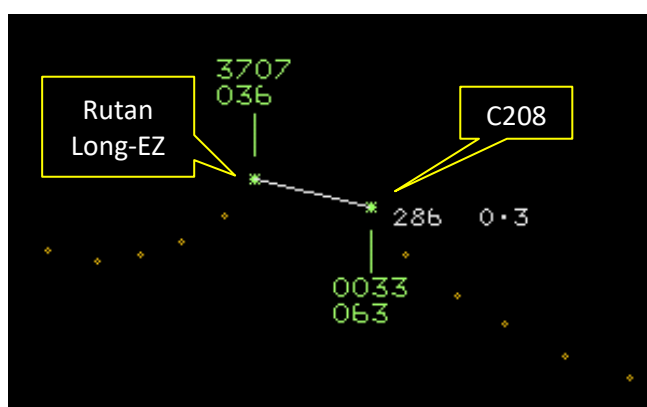
Figure 2 - 1035.20

At 1035:20 the controller passed traffic to the Rutan Long-EZ pilot, “[callsign] *keep a good look out, parachute traffic out of [departure airfield] is east abeam yourself by just less than a mile, 4000 feet, correction 3500 above, descending rapidly into [destination airfield].*” The pilot responded, “*copied that and turning to the north.*” The controller responded, “*he’s also turning to the north I believe, just over the top of you now about 2000 feet above.*” The pilot responded, “*looking.*” (Figure 2).

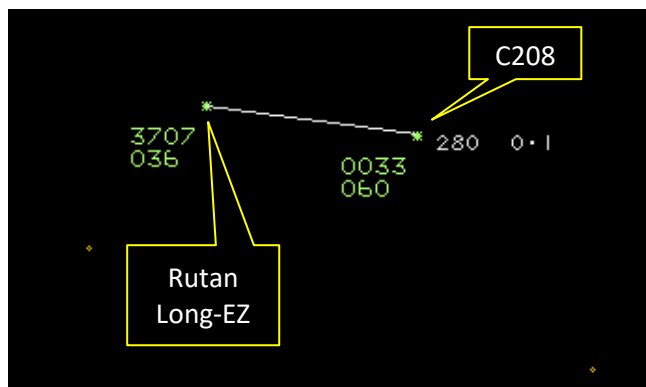
Figure 3 - 1035.22 CPA

At 1035:22 CPA as measured resulted in the two aircraft being separated by an indicated 0.1NM laterally and 2400ft vertically (Figure 3).

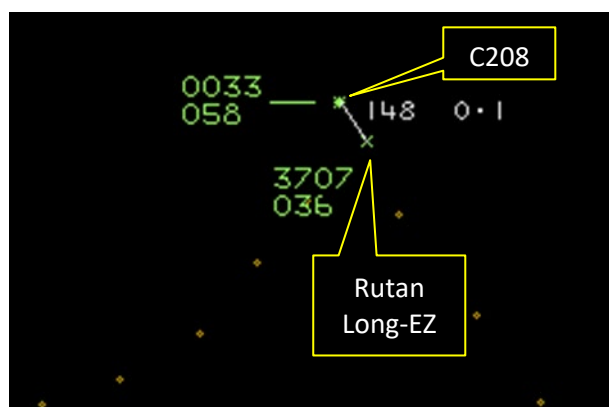
Figure 4 – 1035.25 post CPA (as measured)

After the next radar sweep, timed at 1035:25 the Rutan Long-EZ was displayed as having passed behind the descending C208. The C208 displayed an indicated level of FL058 and the Rutan Long-EZ FL036. It is therefore probable that the vertical separation was less than 2400ft as the aircraft tracks crossed (Figure 4).

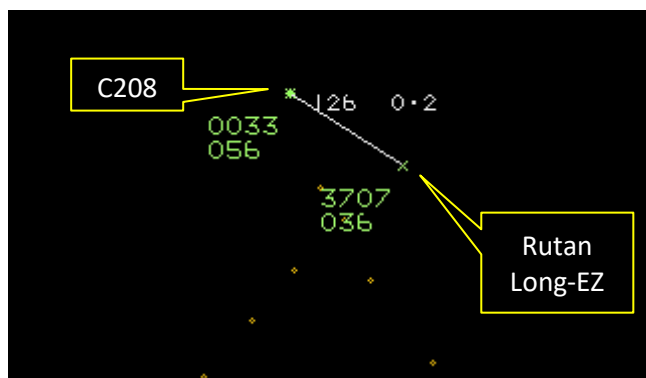
Figure 5 - 10:35.30

At 1035:30 the controller updated the Traffic Information to the C208 pilot, “[callsign] *that traffic is beneath you, by er by 1000, er 2200 feet.*” The pilot responded, “*yeah copied thanks, we’re heading towards the zone at Beccles.*” The controller acknowledged with, “*roger.*” (Figure 5).

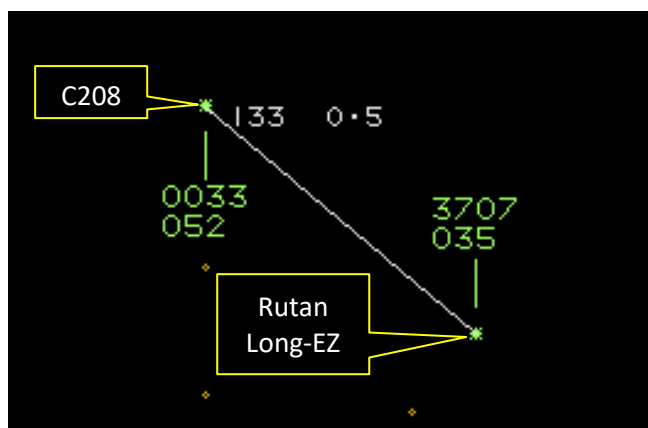
Figure 6 - 1035.40

At 1035:40 the C208 pilot requested a frequency change and the controller updated the Traffic Information again, “*roger that, traffic is southeast of you by less than a mile, northeast bound and 1000 feet below.*” The pilot responded, “*er copied the traffic.*” (Figure 6).

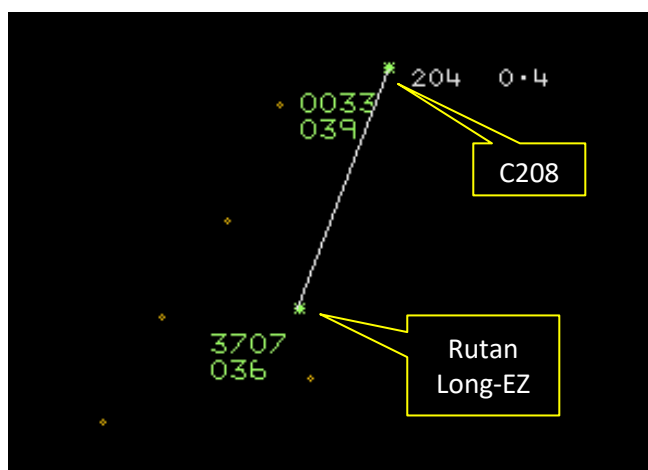
Figure 7 - 1036.00

At 1036:00 the controller updated the Traffic Information to the Rutan Long-EZ pilot, “[callsign] *the parachute aircraft is just north abeam by less than probably half a mile, 800 feet above descending rapidly.*” The pilot responded, “*visual with the Cessna.*” The controller replied, “*roger thanks.*” (Figure 7).

At 1036:01 the aircraft were separated by an indicated 0.4NM laterally and 500ft vertically.

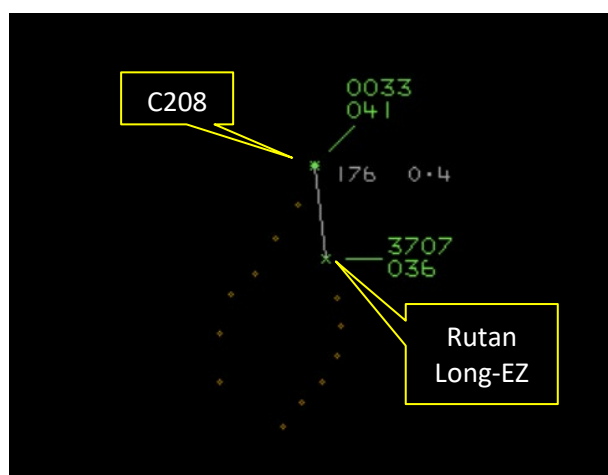
Figure 8 – 1035:56 C208 crossed in front of Rutan Long-EZ

Further examination of the NATS radar reply after the mathematical CPA reveals that, at 1035:56, the C208 crossed in front of the Rutan Long-EZ, left-to-right, descending through FL041. At this point the separation was 0.4NM horizontally and 500ft vertically. This point matches the Airprox as described in the report submitted by the Rutan Long-EZ pilot (Figure 8).
