AIRPROX REPORT No 2022096

Date: 03 Jun 2022 Time: 1640Z Position: 5214N 00042E Location: Bury St. Edmunds

PART A: SUMMARY OF INFORMATION REPORTED TO UKAB

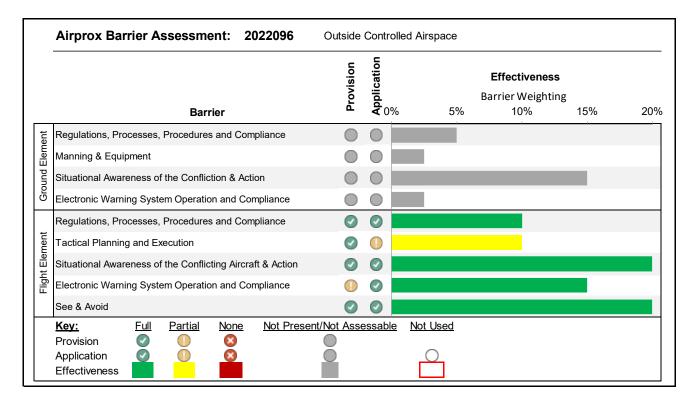
Tactical Planning and Execution was assessed as **partially effective** because, although they had visually checked the surrounding airspace prior to lift, the H145 pilot had not checked their ACAS display. After departure they had not avoided the pattern of traffic that had been established at Rougham or called on the Rougham frequency.
