AIRPROX REPORT No 2022128

Date: 04 Jul 2022 Time: 1019Z Position: 5113N 00145W Location: IVO Boscombe Down

PART A: SUMMARY OF INFORMATION REPORTED TO UKAB

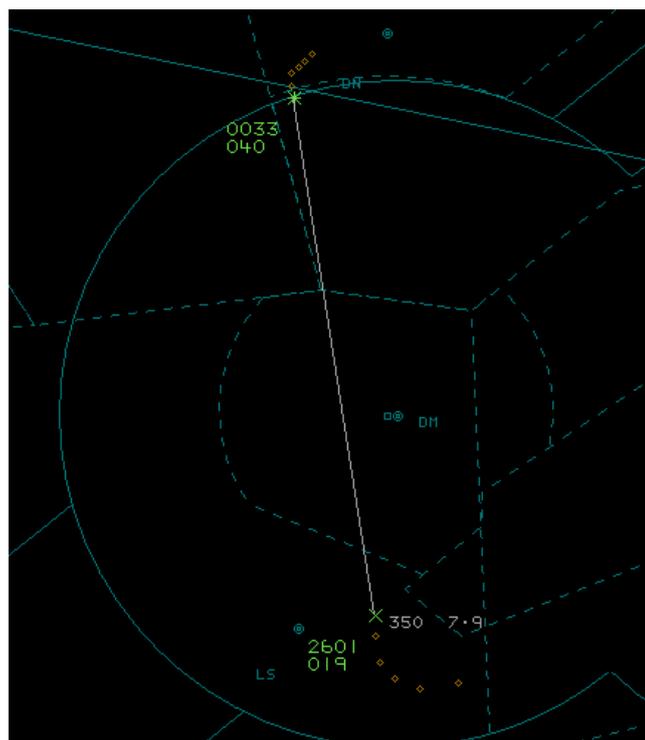
Figure 1:
1015:06 C208 enters Boscombe Down RA(T).

The C208, squawking 0033, 6min 42sec after being informed, entered Boscombe Down RA(T). No Traffic Information was passed to either the C208 pilot or the T50 lead pilot. Separation was measured as 7.9NM and 2100ft from lead T50 aircraft squawking 2601. No other aircraft from the formation were visible.

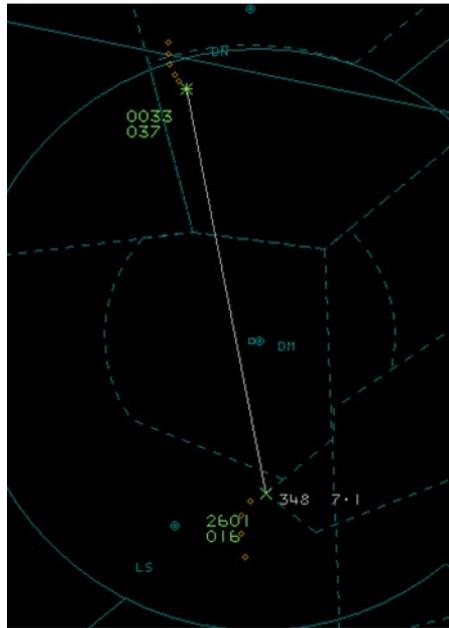
Figure 2:
1015:20 last known separation between C208 aircraft and lead T50 aircraft.

Figure 2 is the last known separation between the C208 and lead T50. Separation was measured at 7.1NM and 2100ft. No other aircraft from the formation were visible. No transmissions were made to the C208 pilot by the Boscombe Down LARS controller.

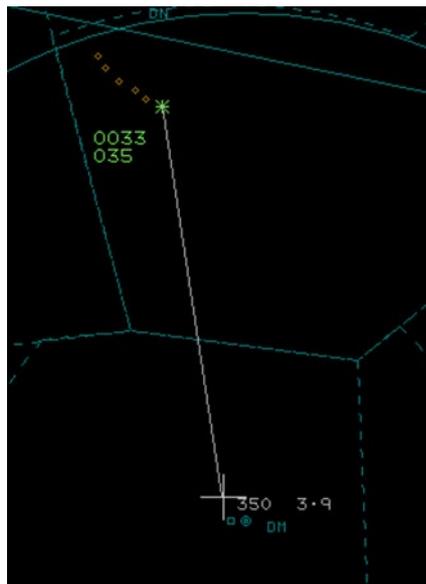
Figure 3:
1015:30 C208 distance from Boscombe Down Aerodrome Reference Point (ARP)
N51 09.20 W001 45.06.

By Figure 3, the T50 formation was no longer visible on radar. The C208 continued to transit south-easterly for 24sec upon entry of the Boscombe Down RA(T) prior to turning north. Separation from the ARP was 3.9NM at 3500ft. No transmissions were made to the C208 pilot by the Boscombe Down LARS controller.

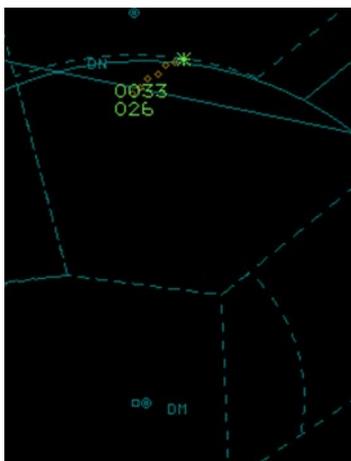
Figure 4:

1016:14 C208 departs the Boscombe Down RA(T).

It was a further 44sec before the C208 aircraft departed the Boscombe Down RA(T), having descended a further 900ft. No transmissions were made to the C208 pilot by the Boscombe Down LARS controller throughout this period.
