AIRPROX REPORT No 2022136

Date: 09 Jul 2022 Time: 1107Z Position: 5150N 00058W Location: 1NM S Westcott

PART A: SUMMARY OF INFORMATION REPORTED TO UKAB

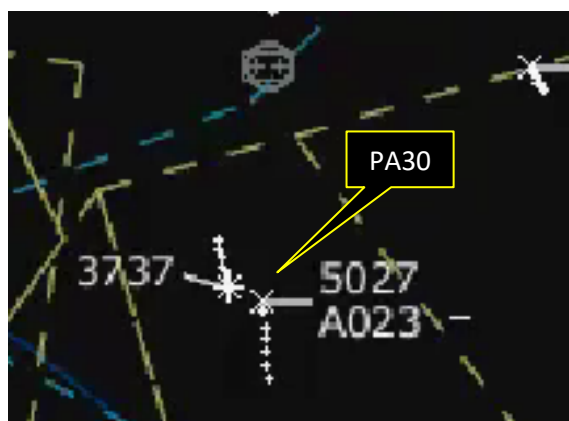
Figure 1: 1104:30

At 1104:30 [the PA30] (approximately 8NM south of WCO NDB) passed approximately 0.5NM to the east of opposite direction traffic with no Mode C, squawking 3737, Figure 1.

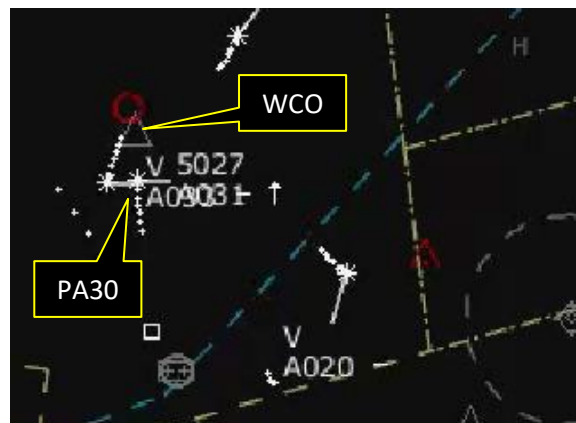
Figure 2 – 1107:28

At 1107:28, approximately 1NM south of WCO NDB, [the PA30], indicating A031, passed opposite direction traffic between a half and one mile east of a 7000 squawk indicating A033. This contact continued southbound but did not call Farnborough LARS North for a service, Figure 2.

The position and altitude report from [the PA28 pilot] correlated with the contact that had passed [the PA30] at 1107:28, just south of the WCO NDB.

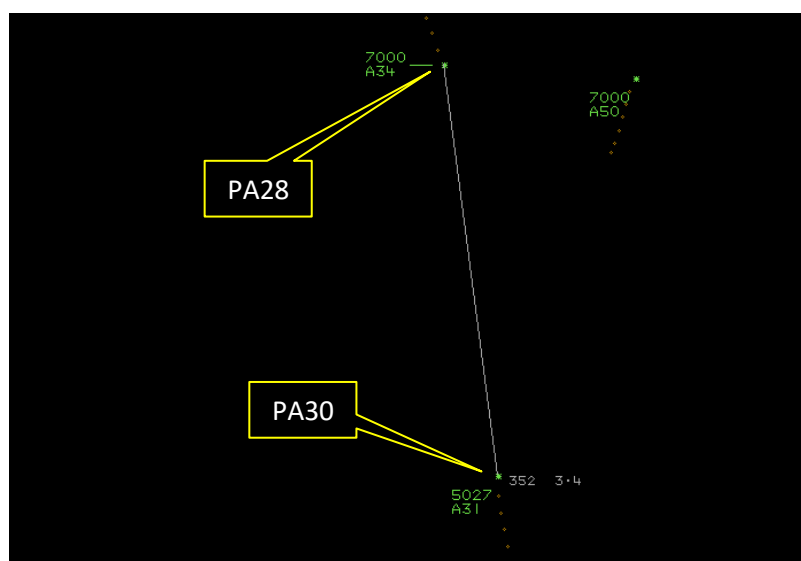
Figure 3 – 1106:42. PA28 Squawking 7000

An analysis of the NATS radar has been undertaken and both aircraft were detected and identified using Mode S data. In the lead-up to the Airprox the PA30 pilot had been displaying a squawk that had been assigned to them by Farnborough LARS North, and receiving a Basic Service. The PA28 pilot had been displaying an East Midlands LARS squawk until 1106:42 when, with the aircraft separated by 3.4NM, the squawk changed to 7000, Figure 3. This suggested that the PA28 pilot had been in receipt of a service prior to the Airprox, but had then changed frequency and therefore was not receiving a service at the time of the event. The PA28 pilot established contact with Farnborough LARS after the Airprox.

The PA28 and PA30 pilots shared an equal responsibility for collision avoidance and not to operate in such proximity to other aircraft as to create a collision hazard.² If the incident geometry is considered as head-on or nearly so then both pilots were required to turn to the right.³
