AIRPROX REPORT No 2022138

Date: 14 Jul 2022 Time: 1205Z Position: 5157N 00140W Location: 1NM E Stow-on-the-Wold

PART A: SUMMARY OF INFORMATION REPORTED TO UKAB

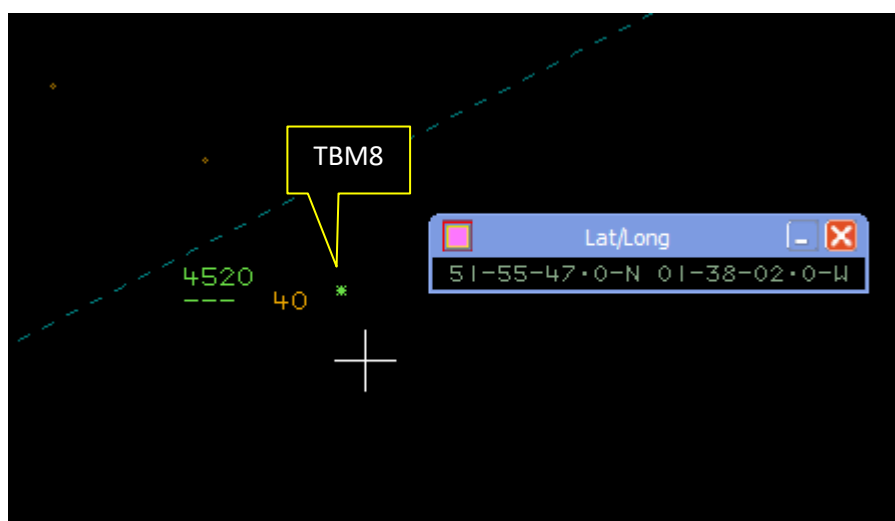
Figure 1 – 1205:10 (reported CPA)

At the reported CPA time of 1205:10 the traffic picture in the vicinity of the TBM8 was displayed (on the area radar) as depicted in Figure 1 below, with the reported position of the glider marked by the white cross.

The Oxford unit investigation report does not contain radar screenshots; it states that the replay of the Oxford radar recording resulted in confirmation that a primary-only radar contact was observed merging and garbling with the radar contact of the TBM8 at the point where the pilot had called the controller for re-join instructions.
