AIRPROX REPORT No 2022162

Date: 06 Aug 2022 Time: 1559Z Position: 5042N 00102W Location: 3NM ENE Bembridge

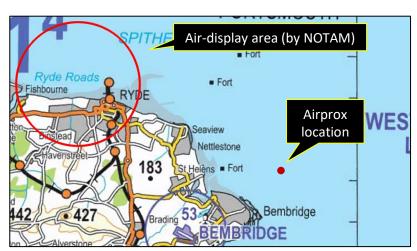
Figure 1 - The air-display area

There had been an active NOTAM for an air display at Ryde (see Figure 1):

H6027/22: Air display will take place Q) EGTT/QWALW/IV/M/W/000/040/5044N00111W002 AIR DISPLAY WI 1.5NM RADIUS 504421N 0011041W (RYDE ROADS, ISLE OF WIGHT). FOR INFO 07710 962288. 2022-08-0019/AS2.

LOWER: Surface, UPPER: 4,000 Feet AMSL FROM: 06 Aug 2022 15:45 GMT (15:45 UTC) TO: 06 Aug 2022 16:30 GMT (16:30 UTC)
